# Electromigration Update: SAC305 (and Cyclomax)

*Michael Meilunas*  
*April 1, 2026*

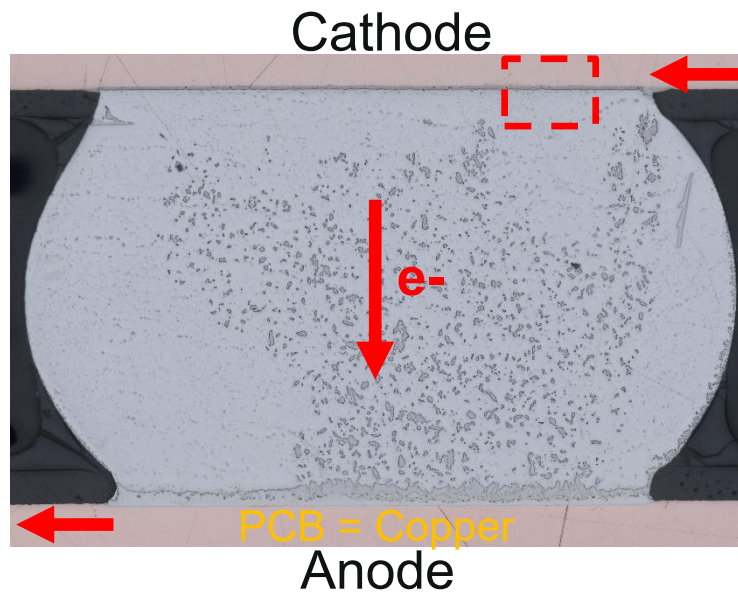
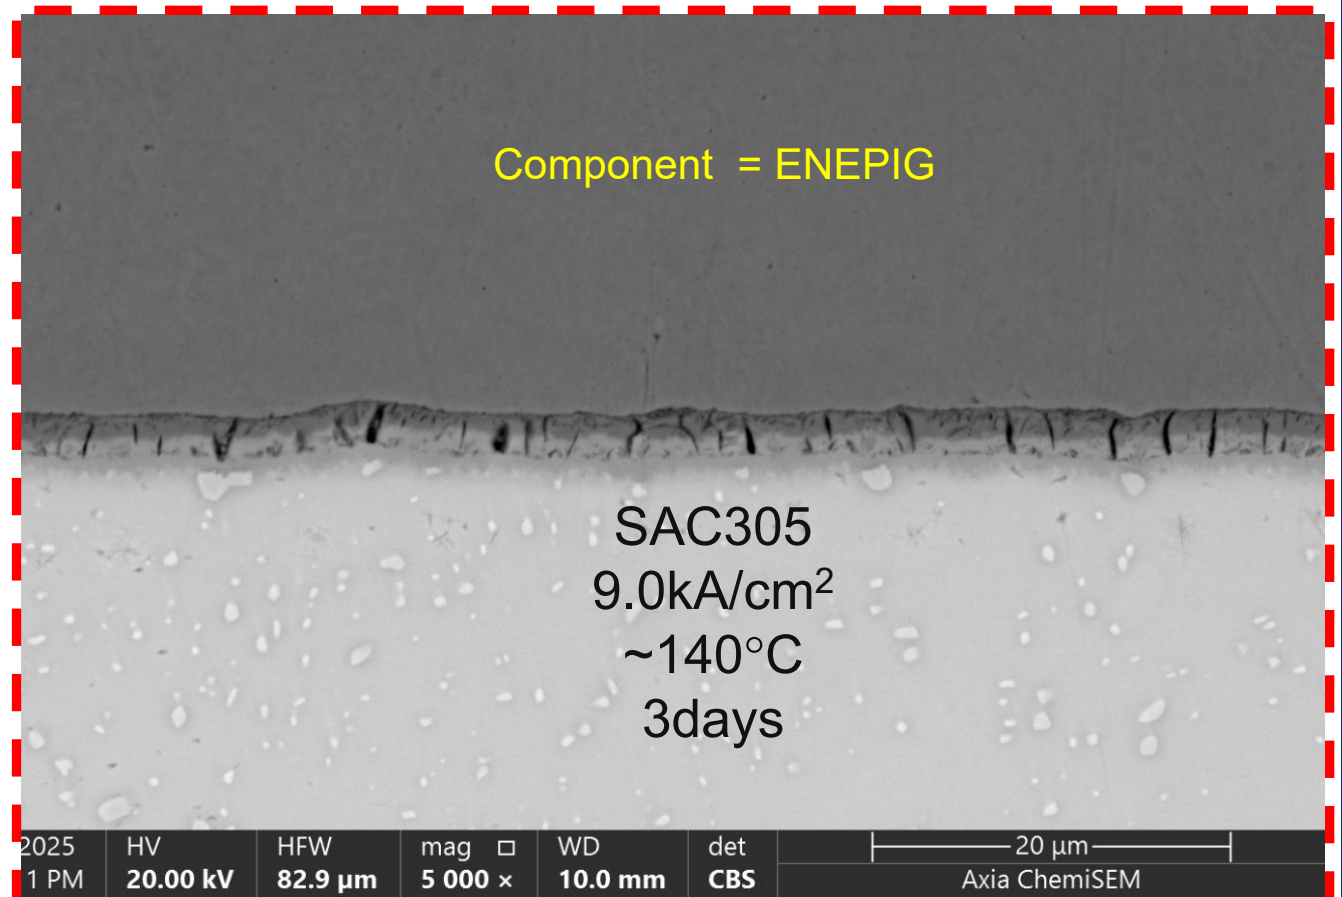
- Nickel barrier issue:
  - Resistance rise due to nickel break-down
  - Solder is in excellent condition
  - Issue is **most prevalent** when nickel is at cathode side
  - Observed in ENEPIG and ENIG samples (different suppliers)

+53% Resistance

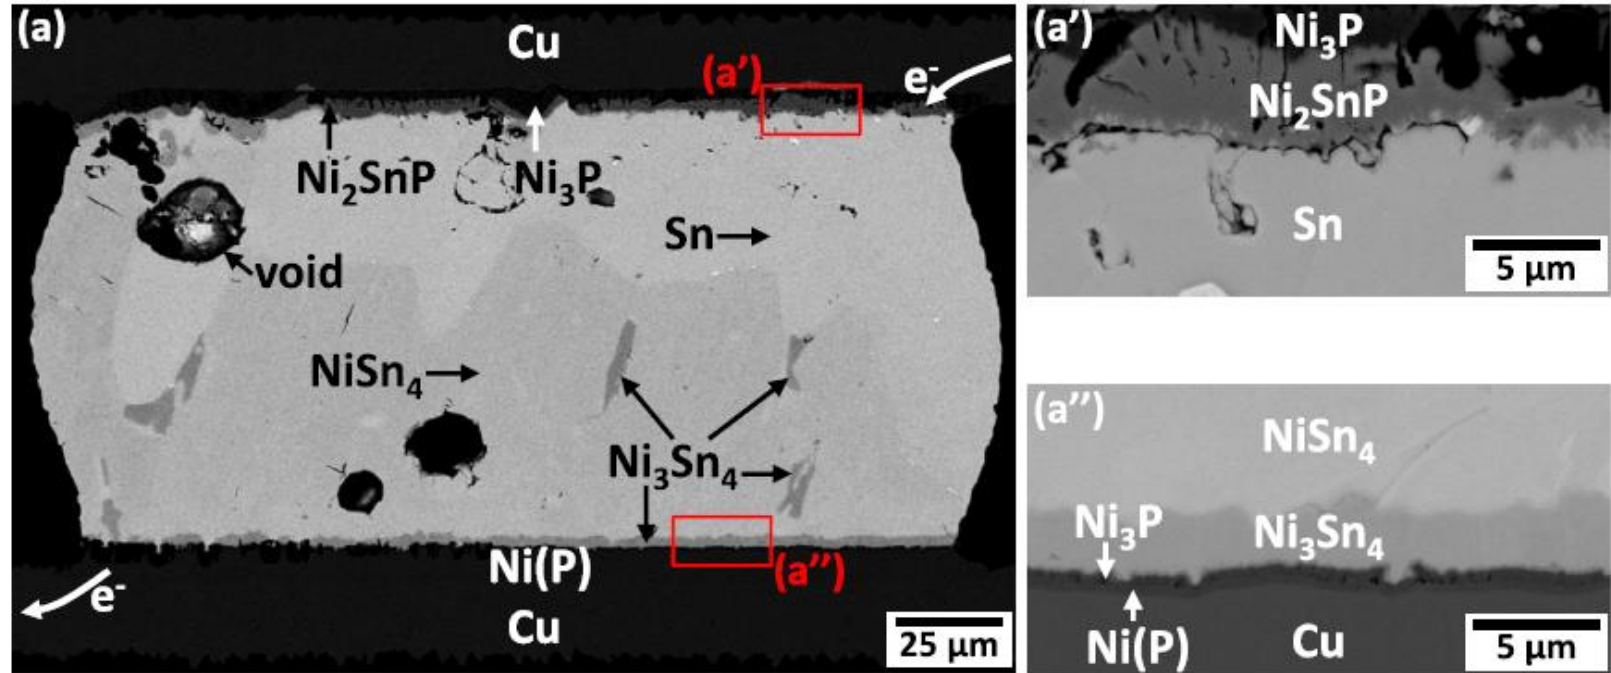
~153°C; 72hrs; 8kA/cm<sup>2</sup>

- In this example, the bottom pad nickel is clearly degraded
- This surprised me given my early findings that showed electron flow from solder to nickel did not seem to induce nickel consumption
  - Joint shown is very hot (NiSn IMCs likely to form)
  - Joints shown are “short” and probably have less electron flow uniformity compared to my samples

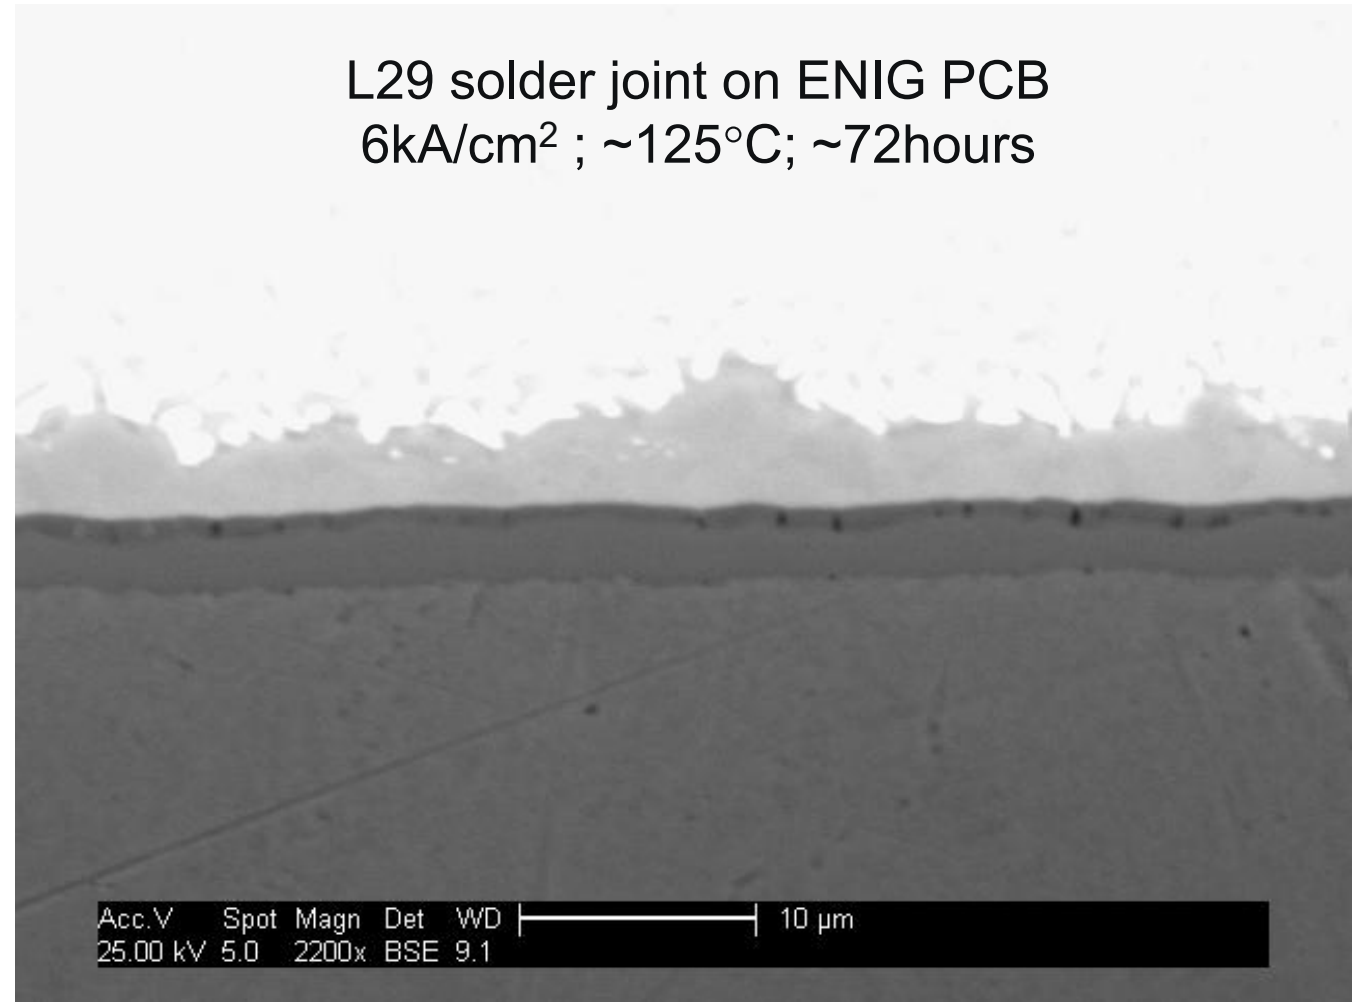
- I reviewed many hundreds of images from AREA's Low-Melt EM projects and found this singular image of possible Nickel degradation
  - These samples only survived a few days before “burn-out”, so I did not put much thought into this at the time

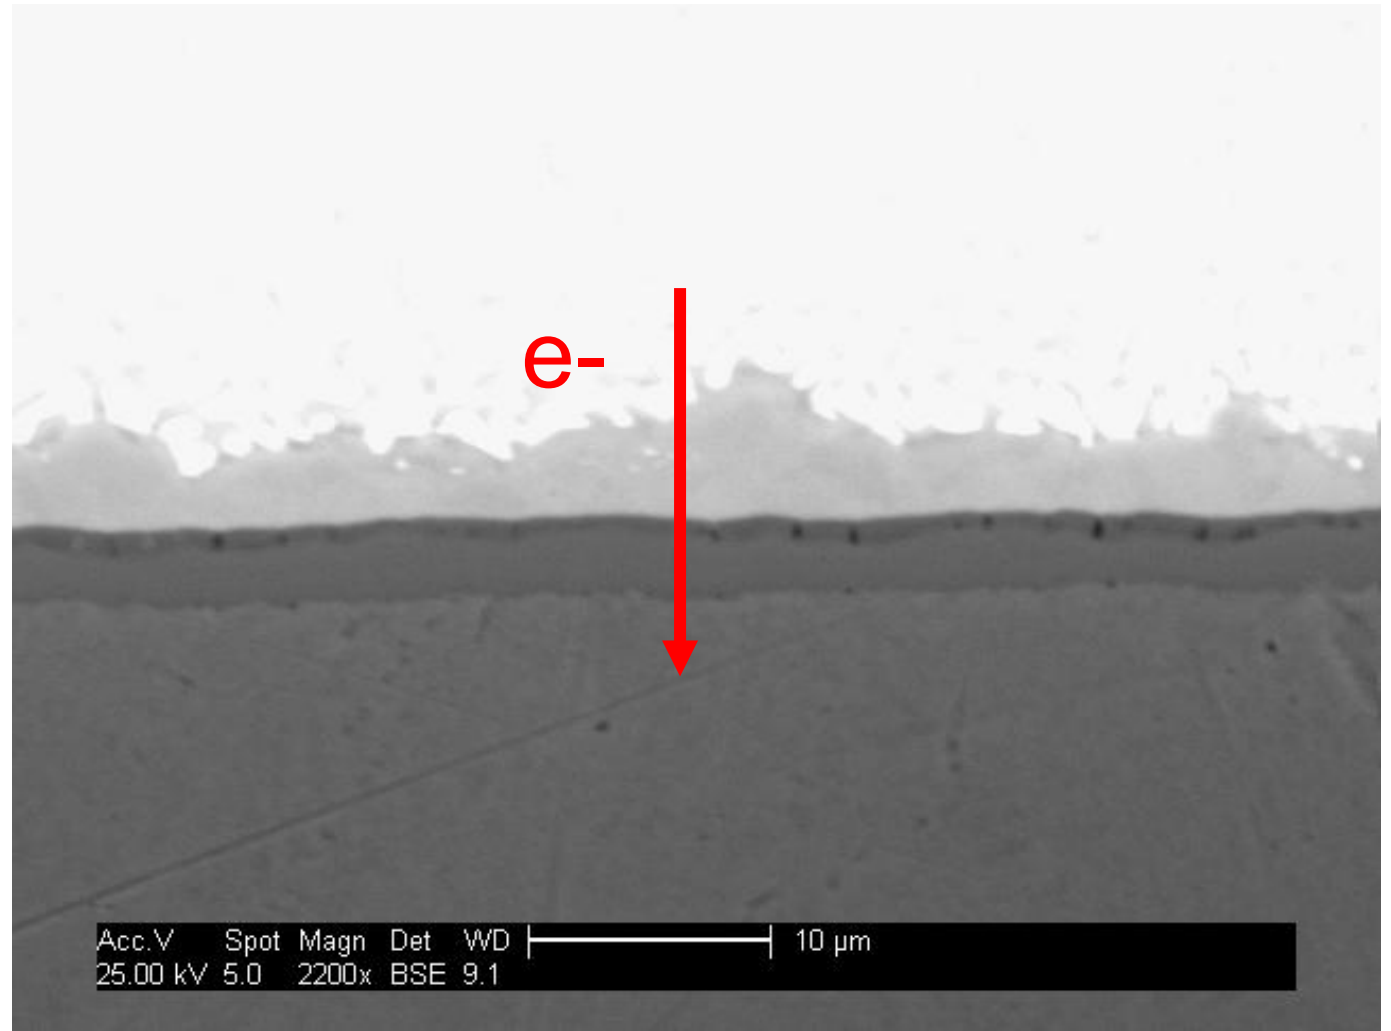
- I can confirm that this joint experienced electron flow “down”
  - This contradicts my previous narrative from October meeting
- Question: where/when does the nickel issue begin?
  - Upon plating?
  - Upon solder ball attach?
  - Upon reflow to PCB?
  - During “annealing”?
  - During EM stressing?

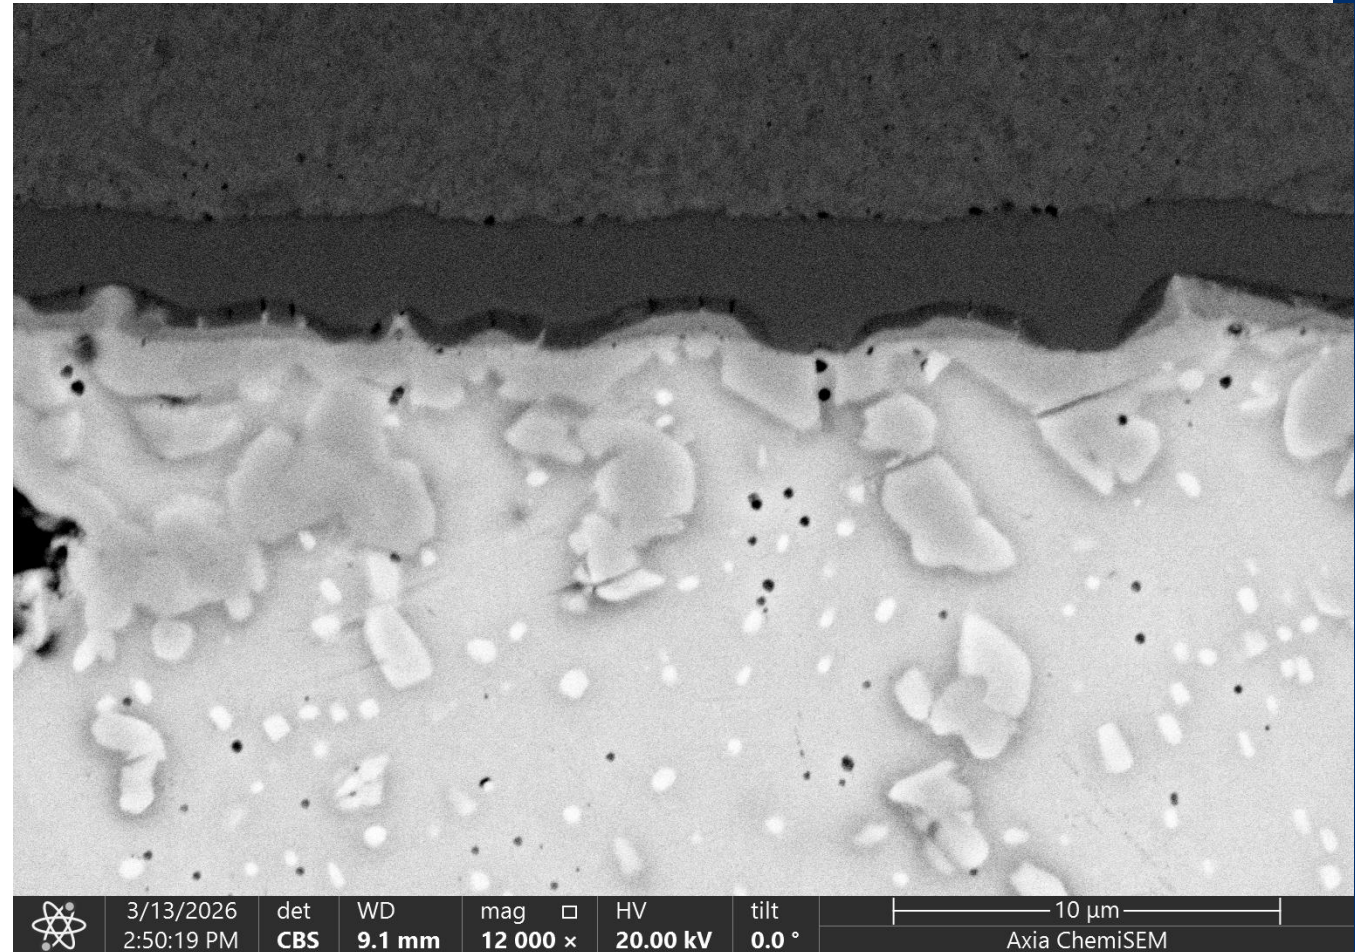
ENIG Component  
70°C for 60 days  
(no current)

- I re-examined several samples which contained significant nickel damage after EM stress testing
- Examined joints that were not exposed to current (but experienced elevated environmental temperature)
- Observed nickel issue
  - indicating that electron flow was not necessary
  - Some instances were quite bad (see image)

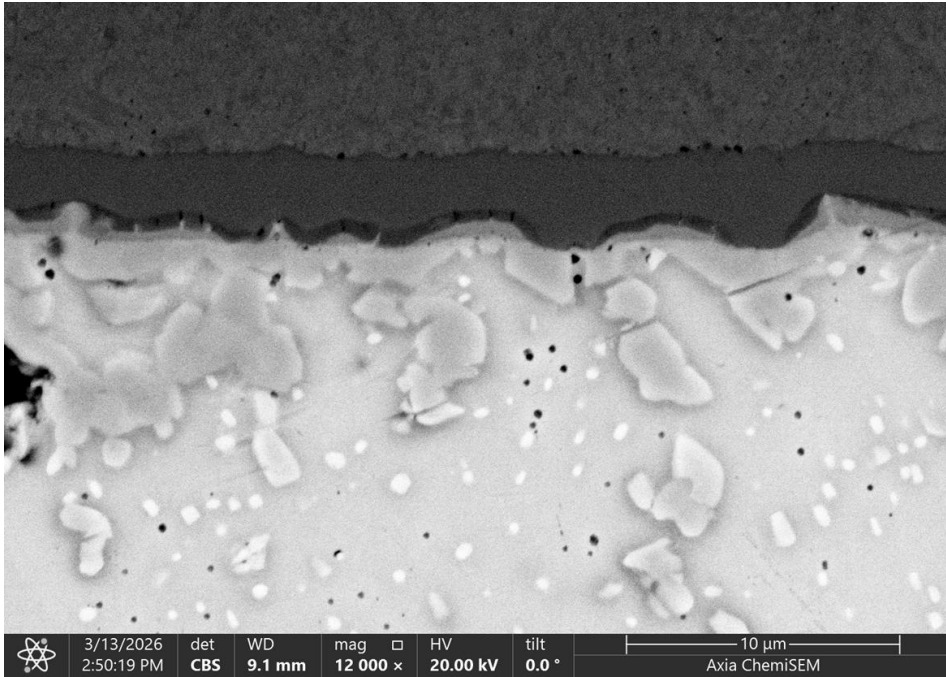
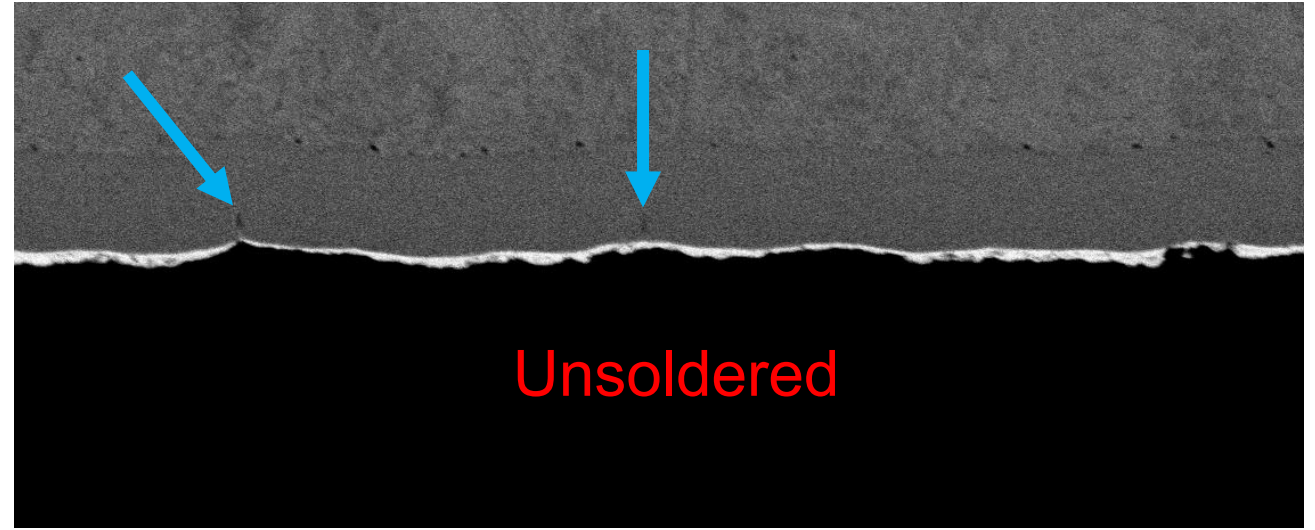
ENIG Component  
70°C for 60 days  
(no current)

- Pads that were not soldered still contain gold finish with some “divots” in the nickel layer, but nothing that would have led me to suspect a problem

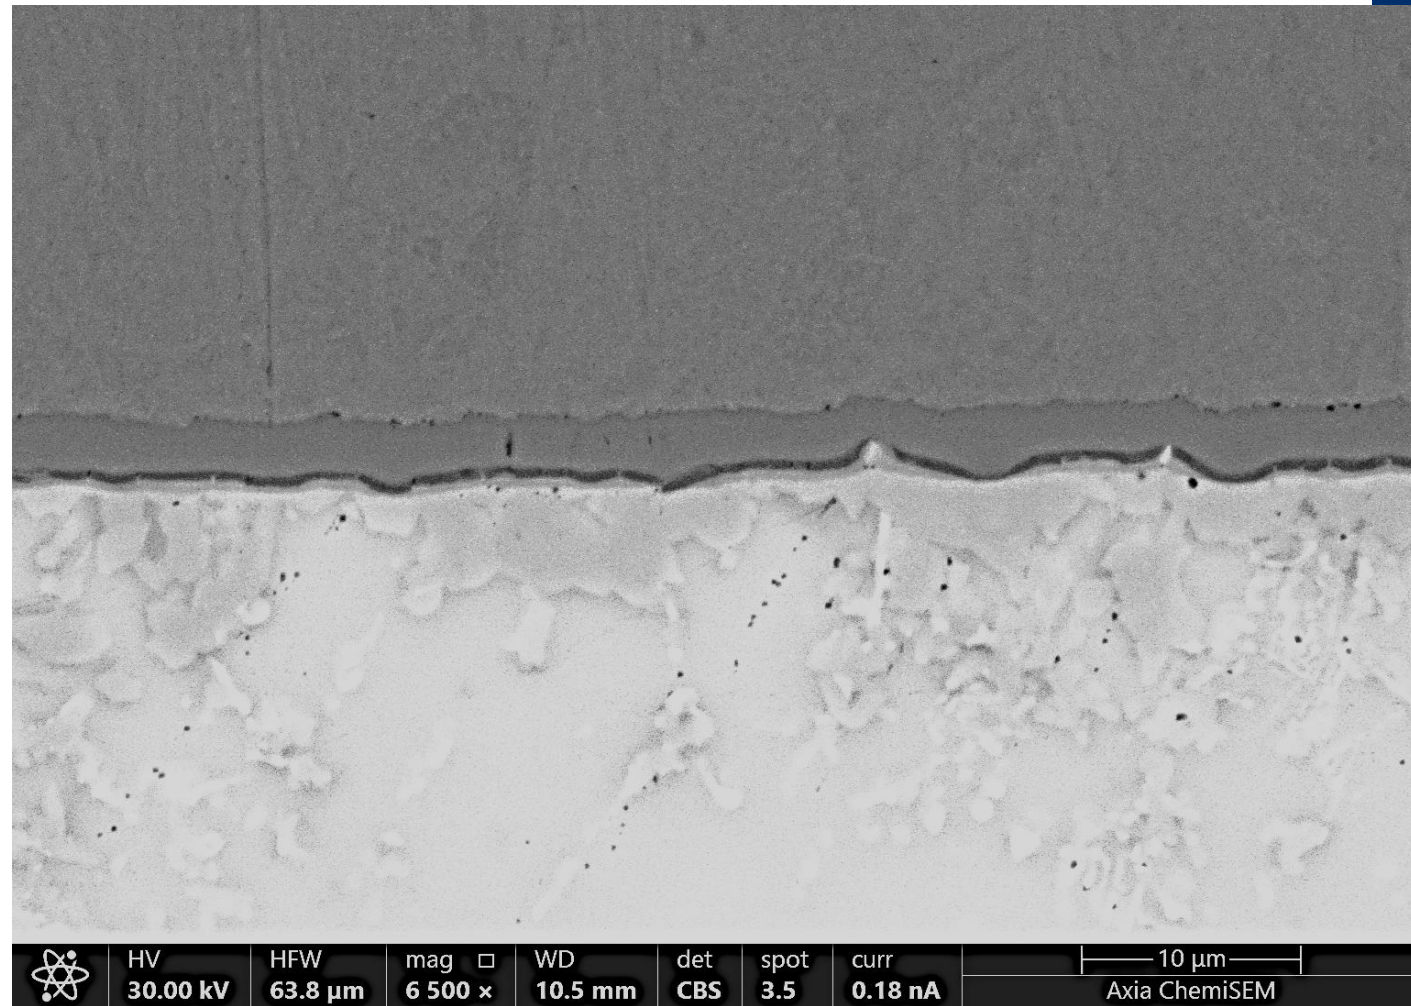
ENIG finish  
Cyclomax Solder  
Room Temperature ~100 days  
No Current

- I was able to find examples of nickel degradation when examining BGA devices that were assembled to PCBs but never tested (room temperature storage)
  - Selectively looking at samples from material sets where severe nickel degradation was observed after EM

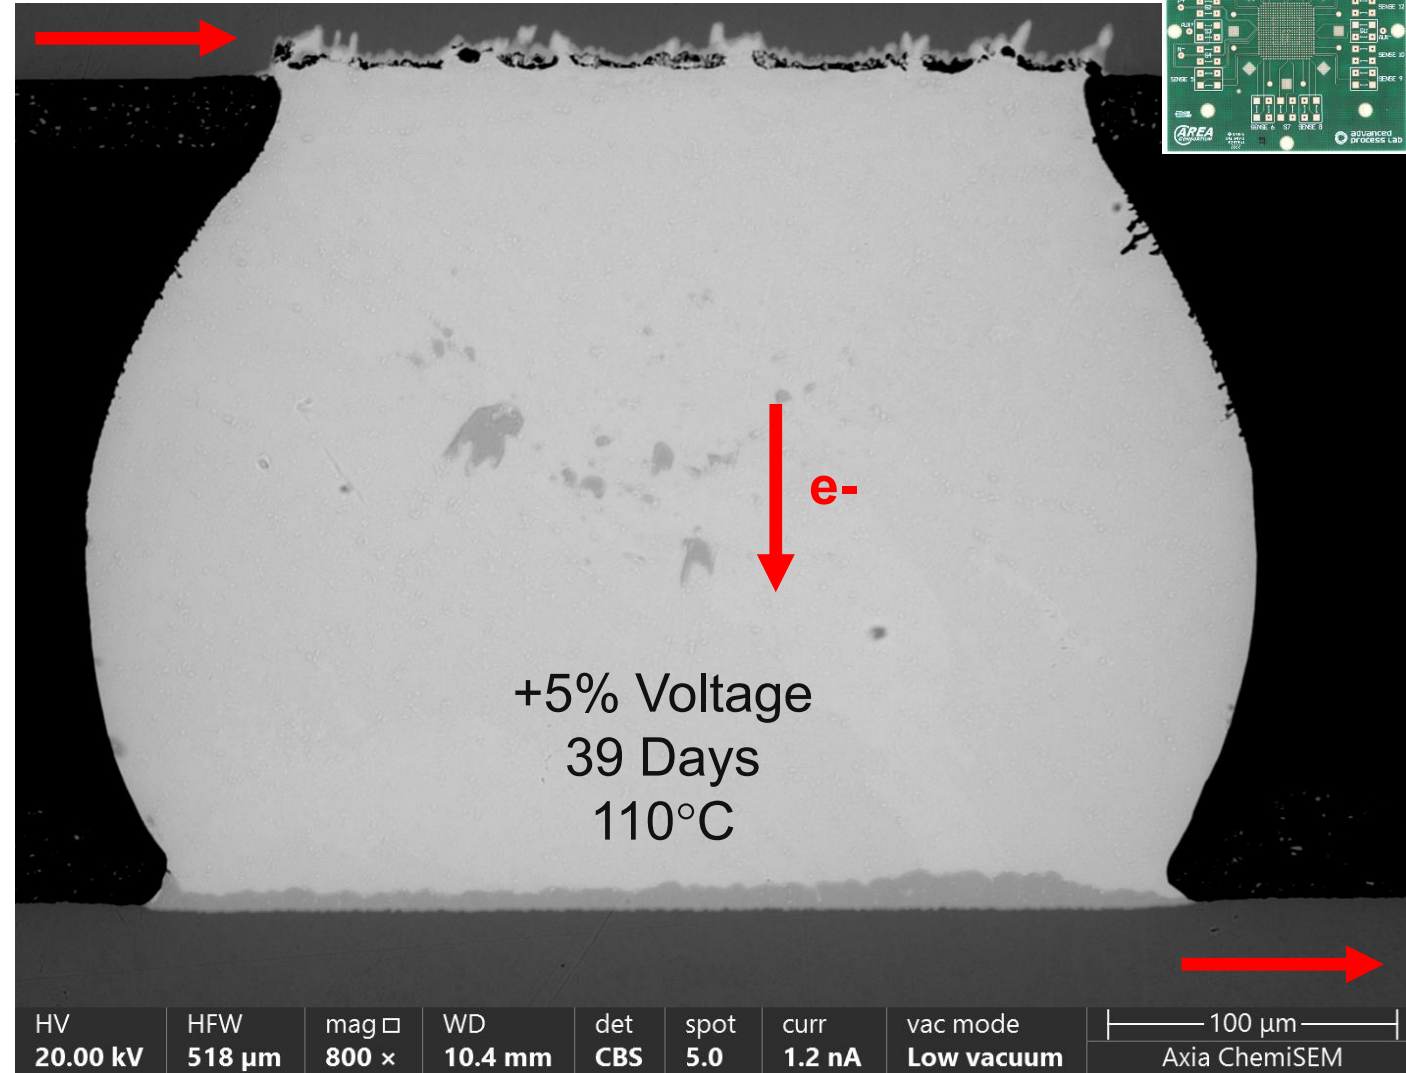
- The joint shows significant damage at the component pad interface (copper pad).
  - The actual “solder” appears to be in excellent condition.
- I will argue that this is effectively a failure as mechanical integrity is clearly compromised.
  - I also believe that thermal cycle reliability is severely compromised
- I will note that this joint looks similar to previously tested samples that demonstrated much larger voltage % increases

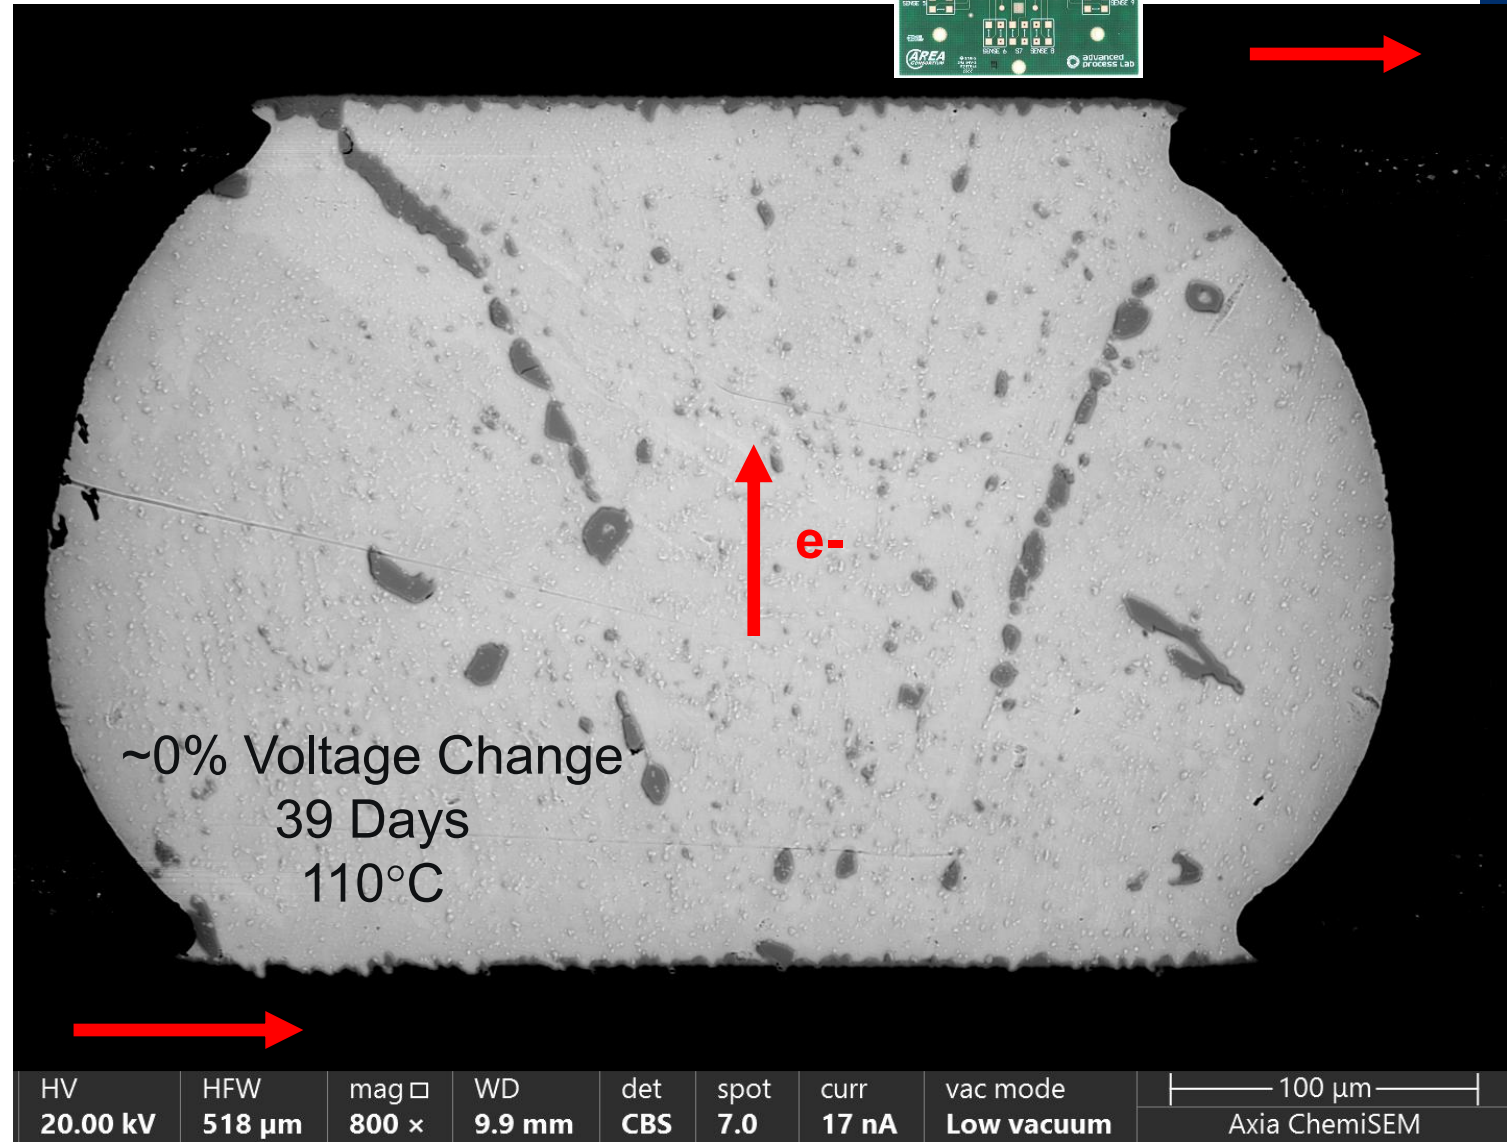
- Joints with electron flow from PCB to component show less damage with some degree of PCB pad degradation but no voiding at the interface.

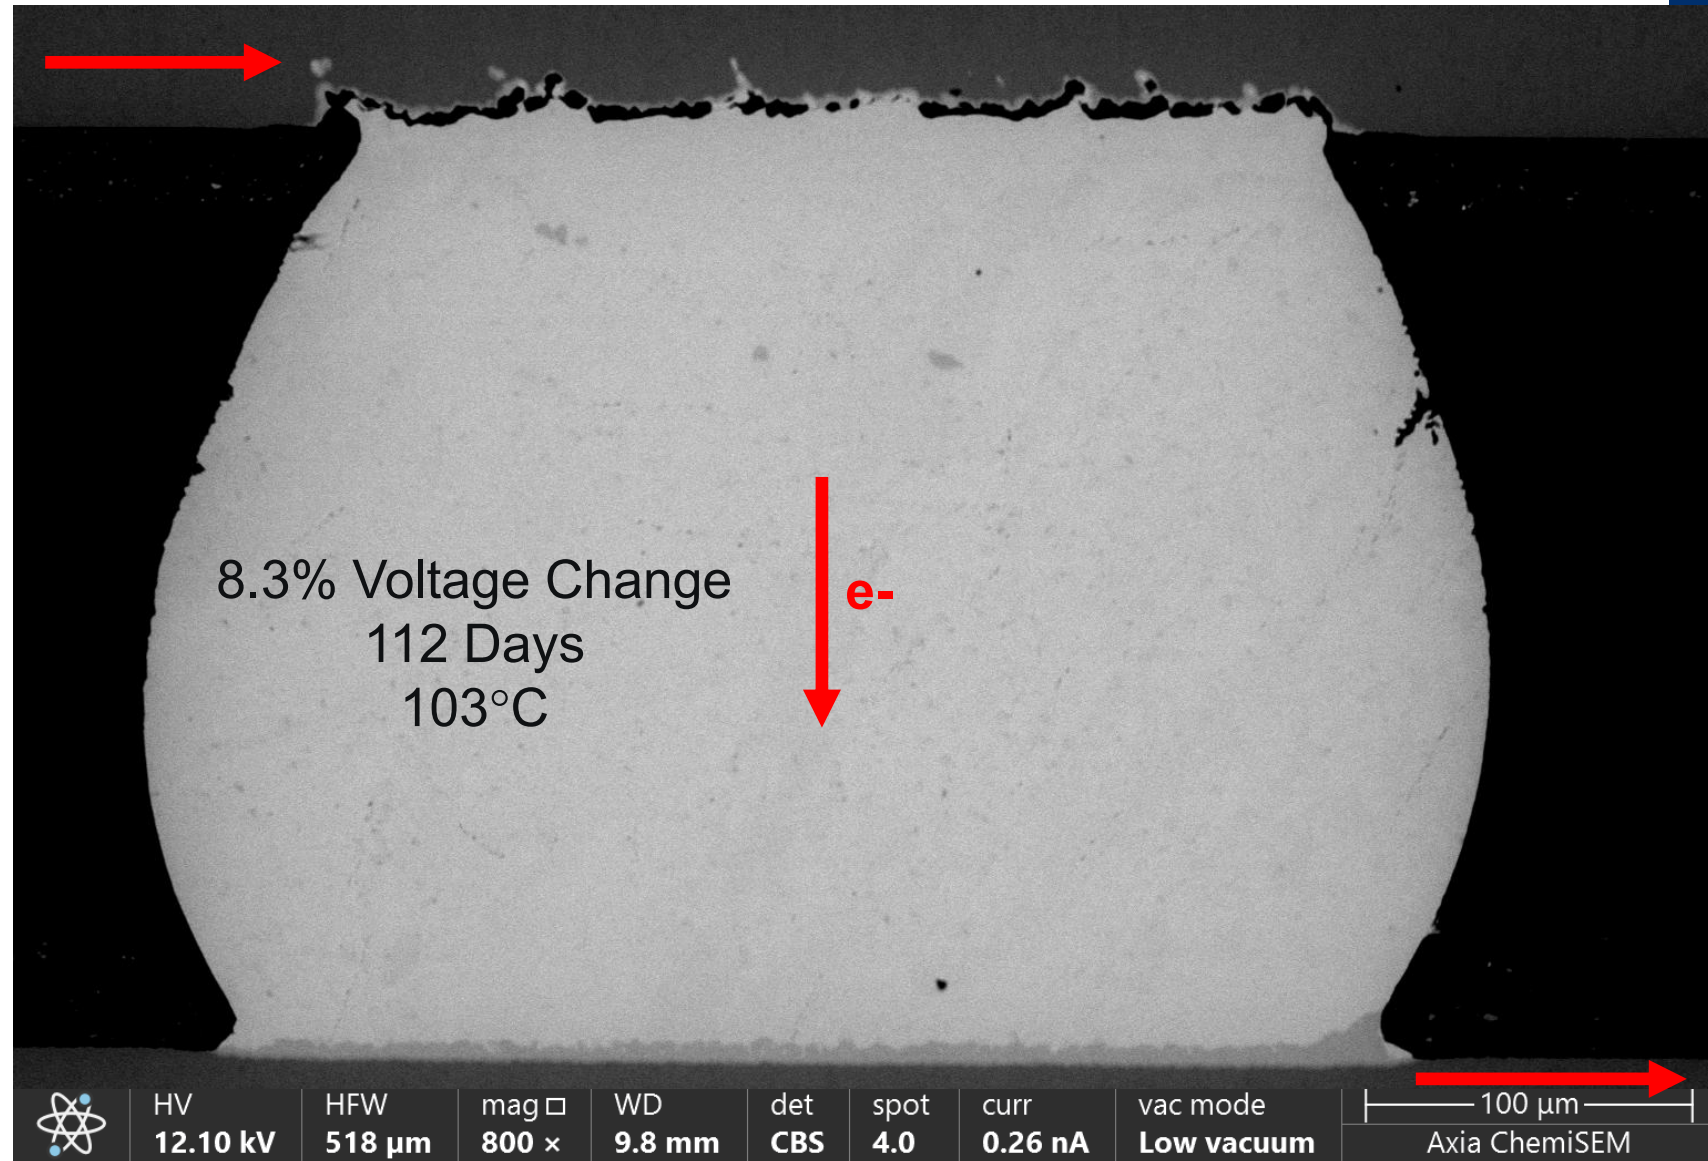
- Pad interface is nearly non-existent at +8.3%
- PCB side intermetallic is relatively thin in cross-section; it is probably thicker elsewhere

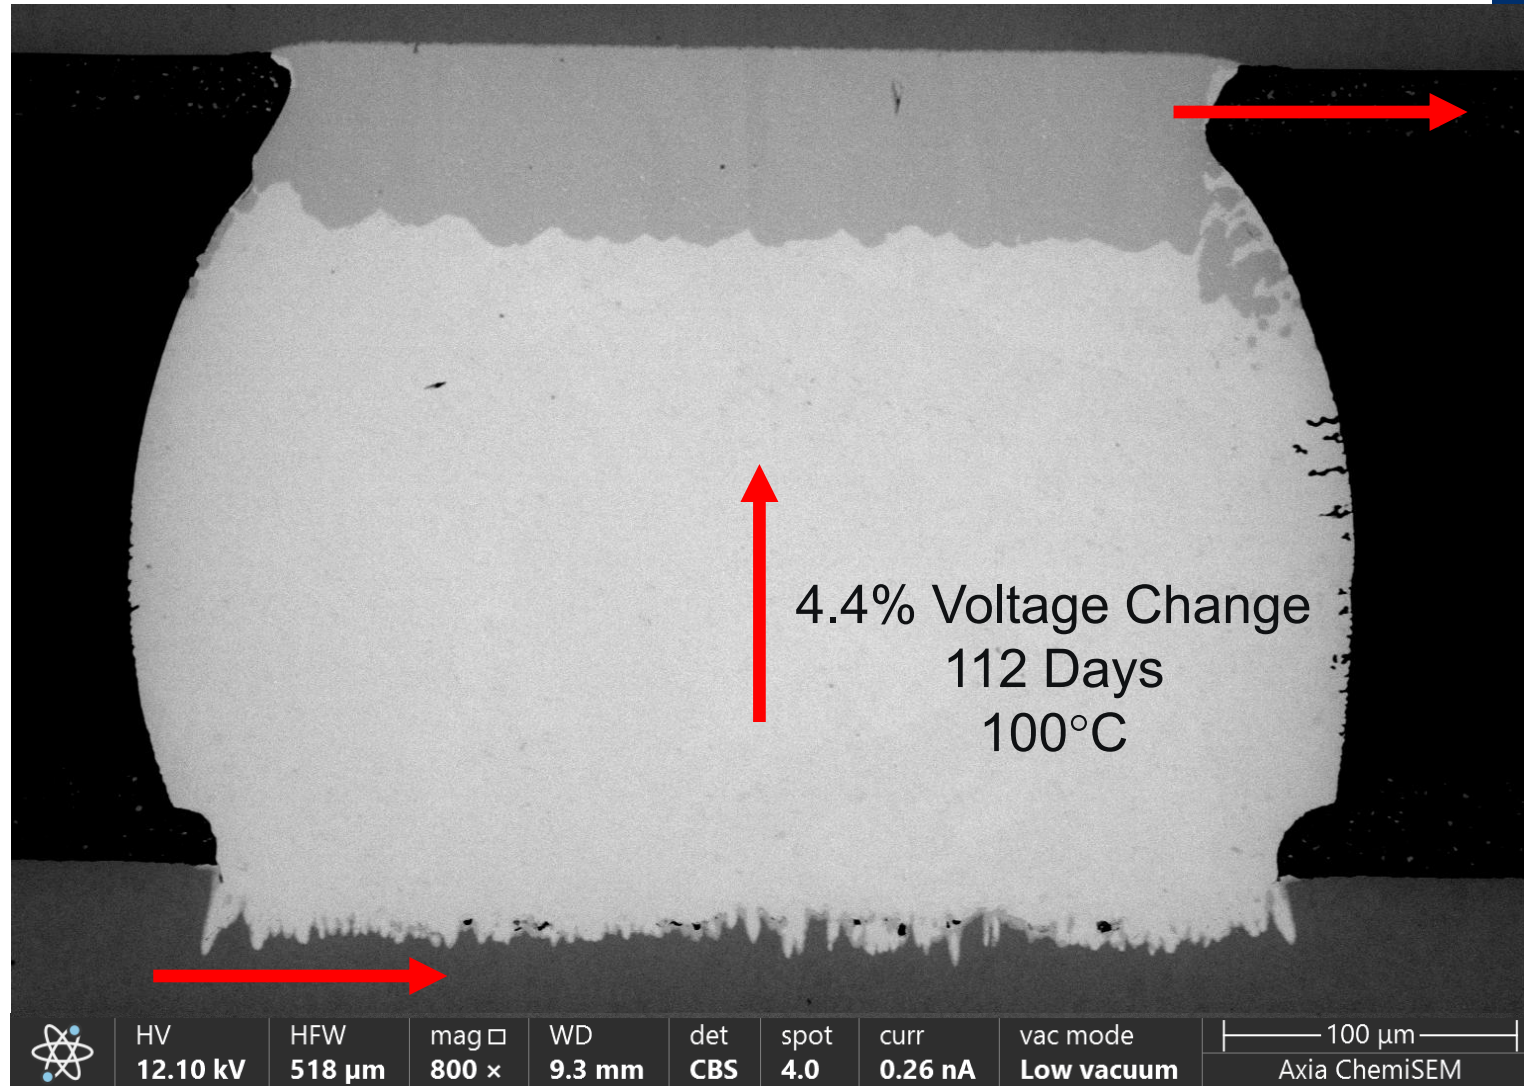
- +4.4%
- PCB side shows pad degradation, but is quite well intact
- What caused resistance increase?
  - CuSn thickness
  - Vacancies at PCB pad

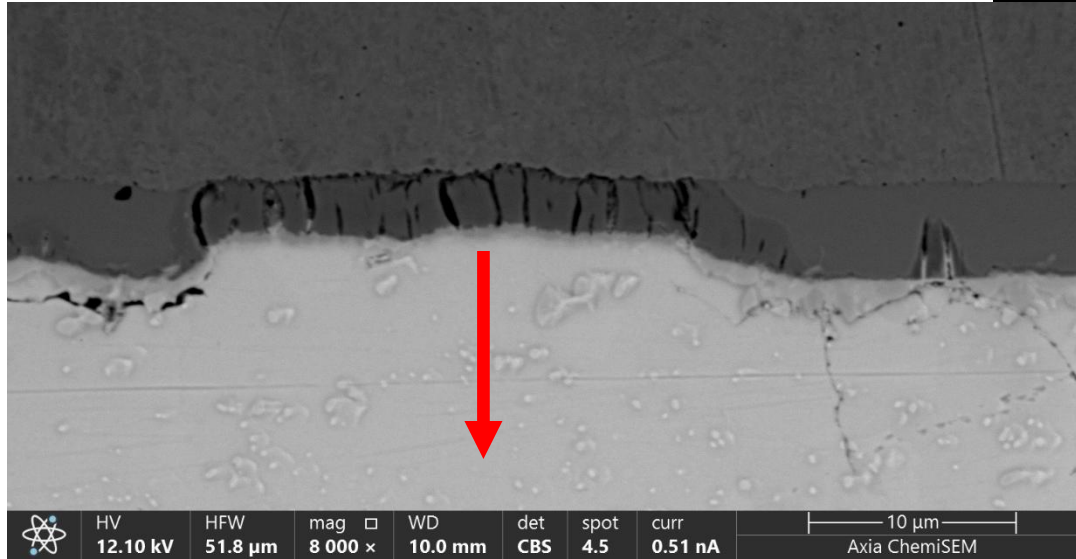
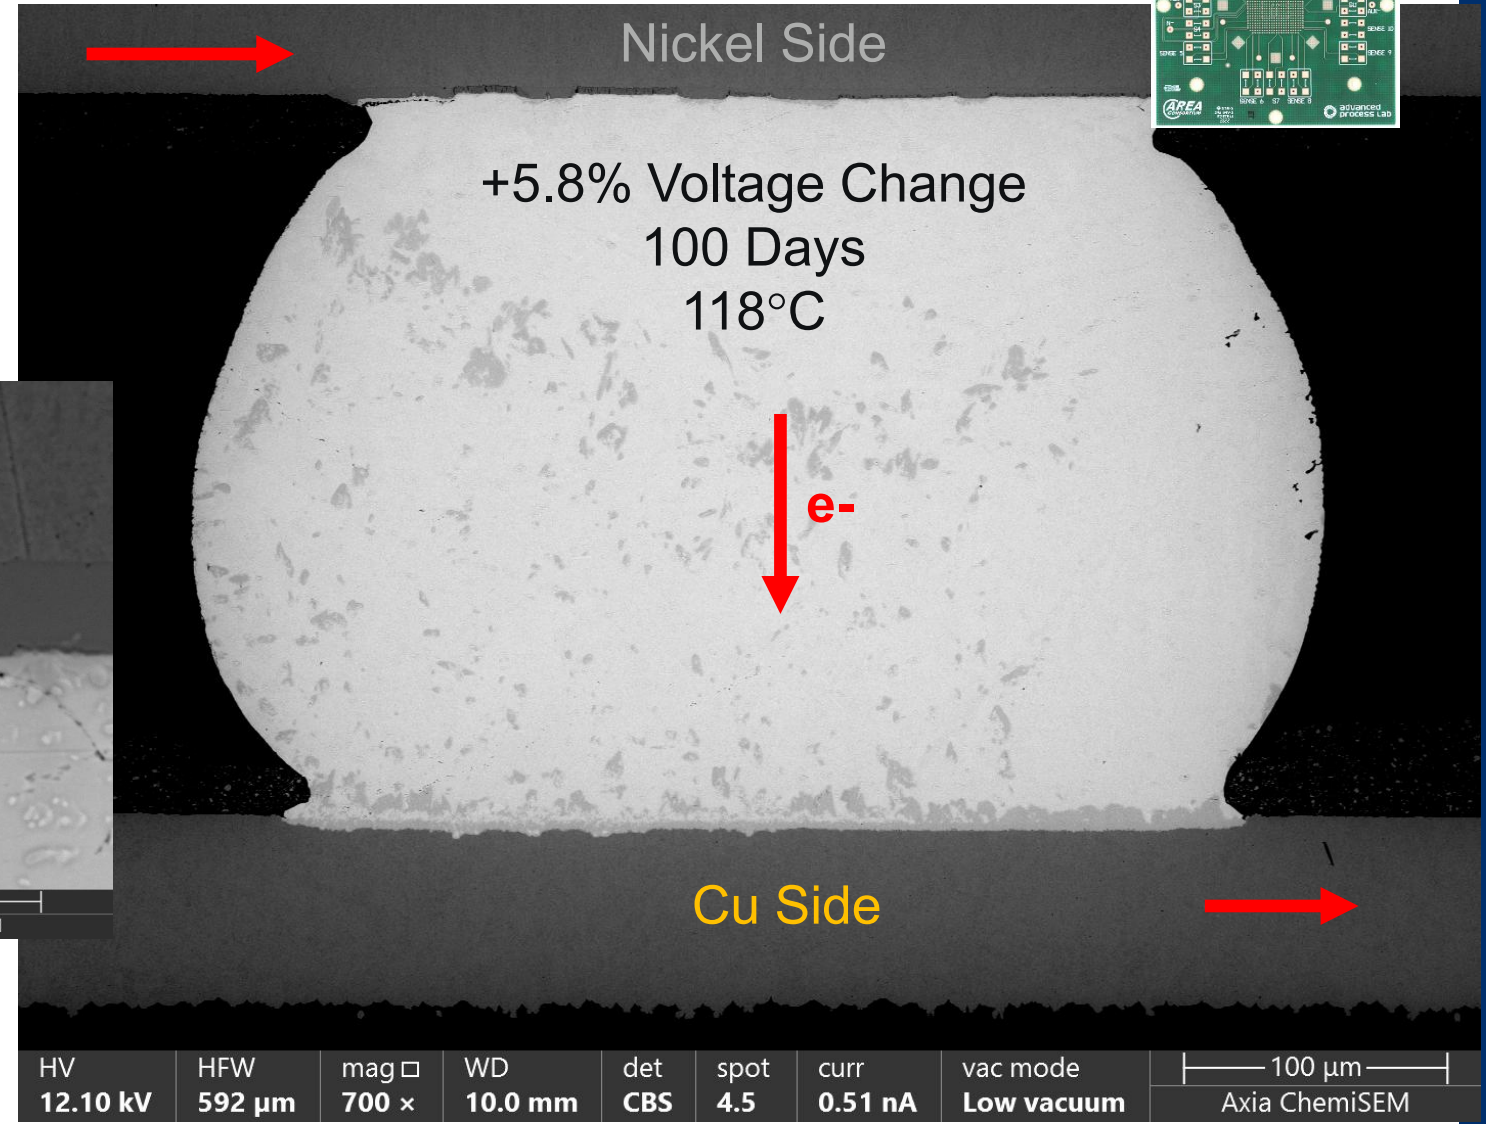
- There's a lot going on in this joint, but the primary concern is the ENEPIG nickel layer (BGA pad)

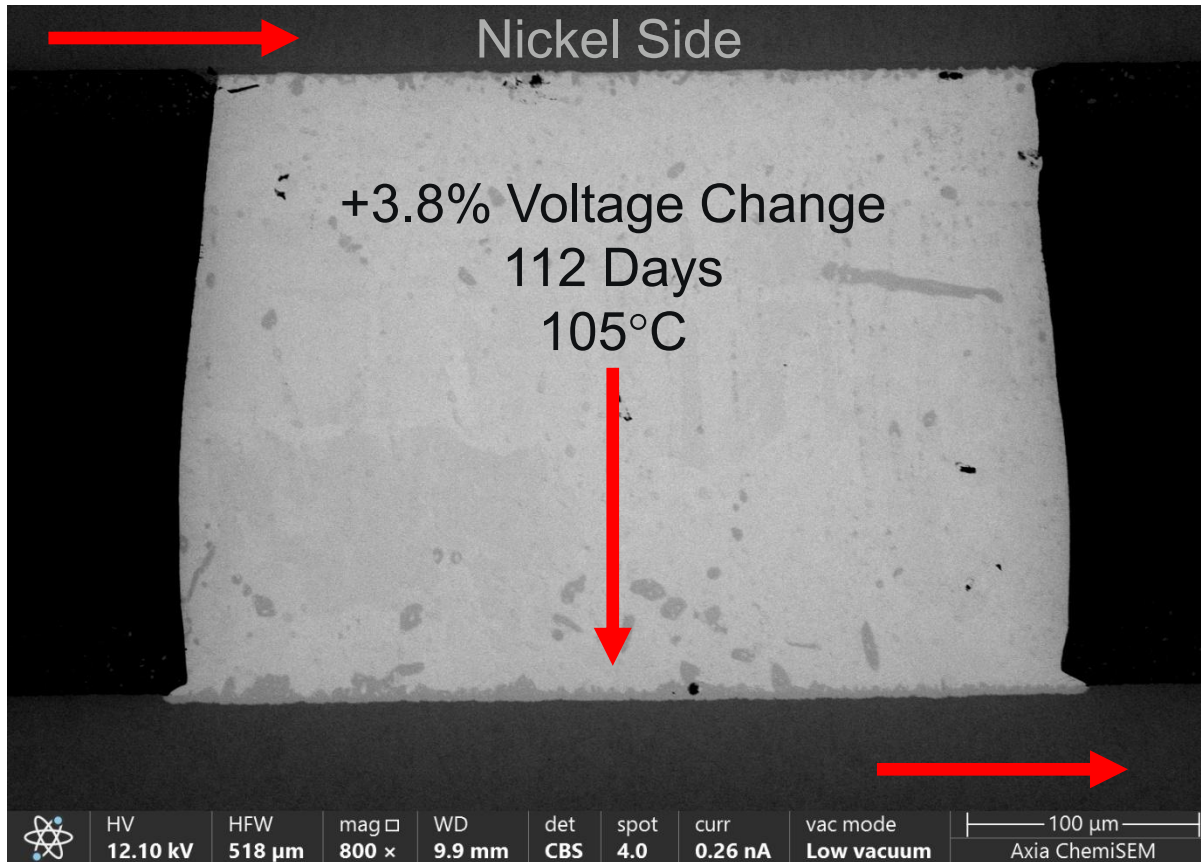
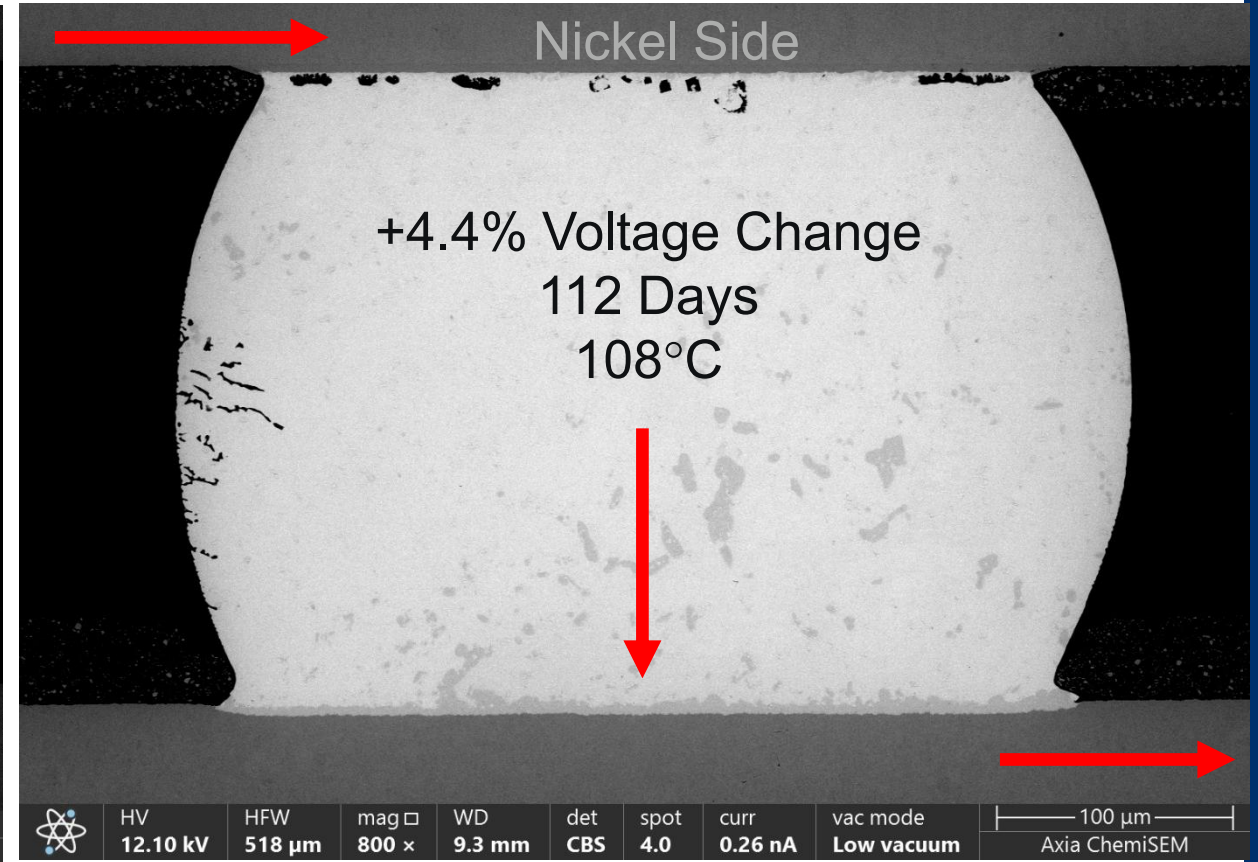
- Ignoring the shape of the left joint, these joints are unusual in that we see voids near the nickel side that look similar to dewetting / hot tearing

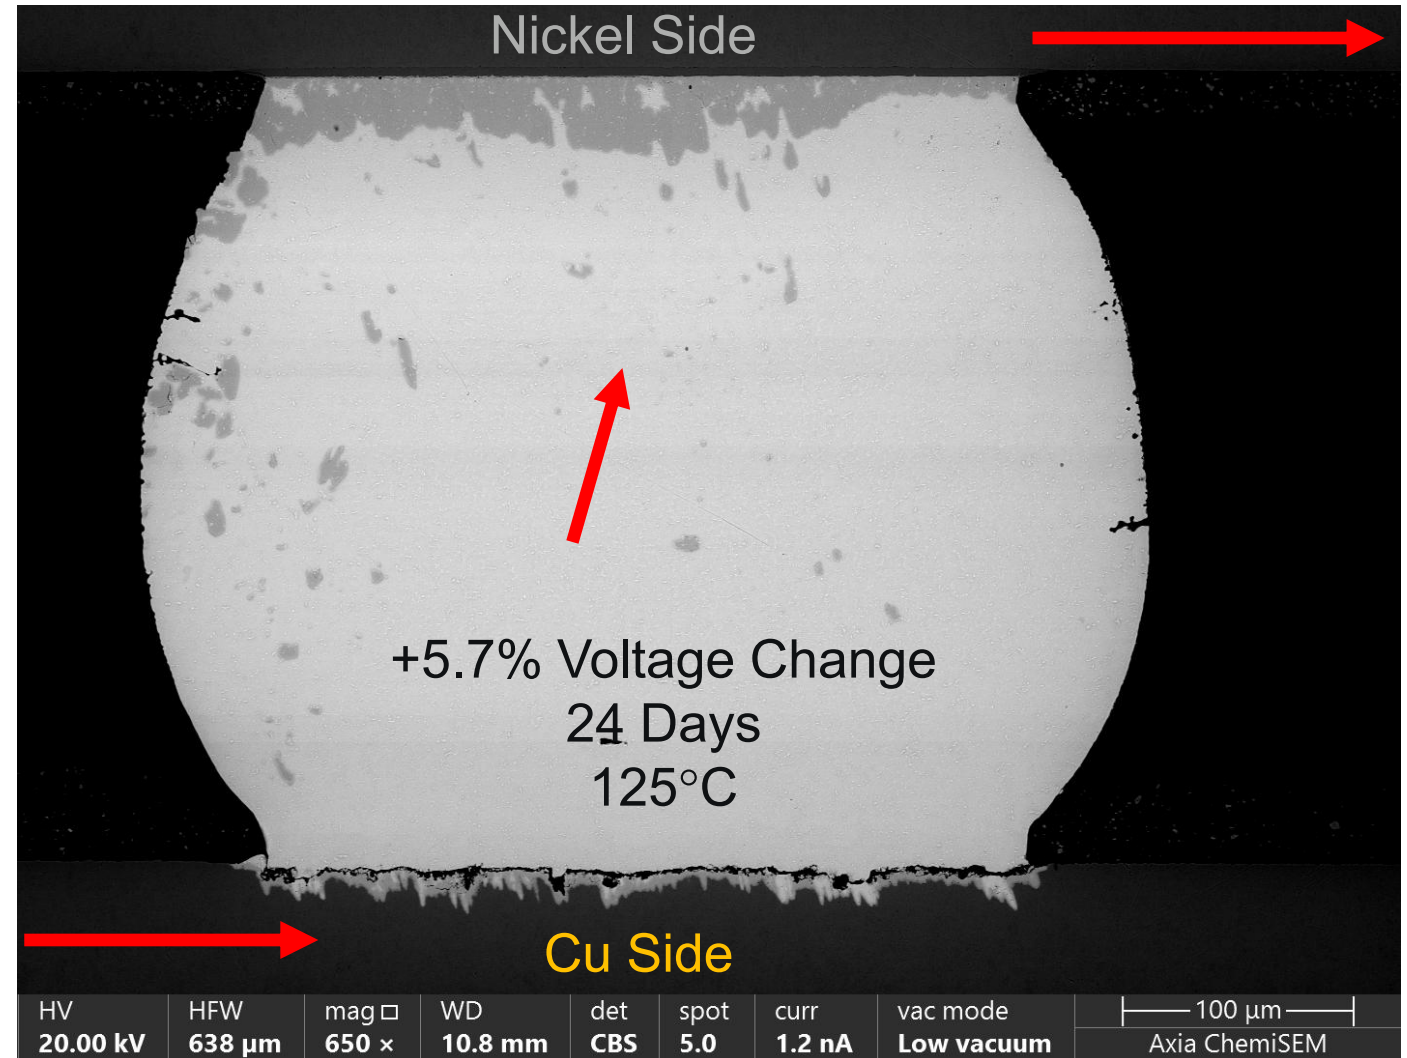
- First Cu / ENIG sample to reach +5% did so at an “electron up” solder joint
- This joint was believed to be one of the hotter joints in test
