# Electromigration Update: SAC305 (and Cyclomax)

*Michael Meilunas*  
*April 1, 2026*

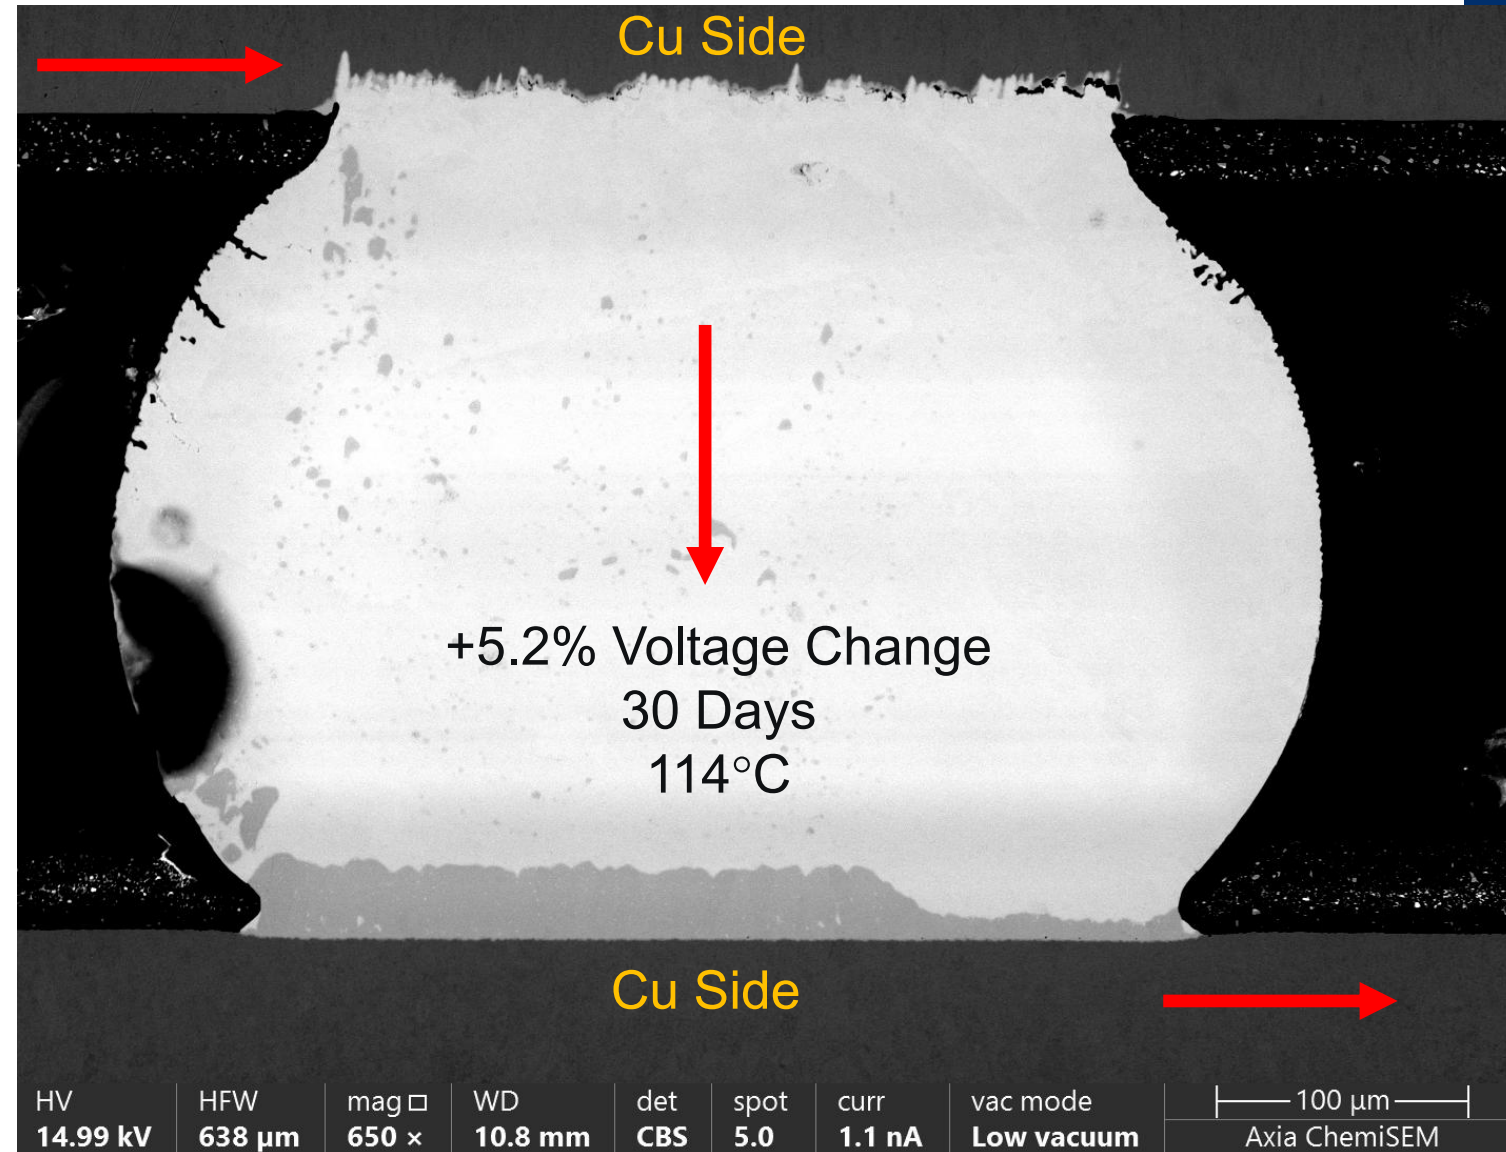
- Cu / Cu combination showing significant component side copper degradation and copper migration to PCB side
  - What drives resistance increase? Vacancies at component side?

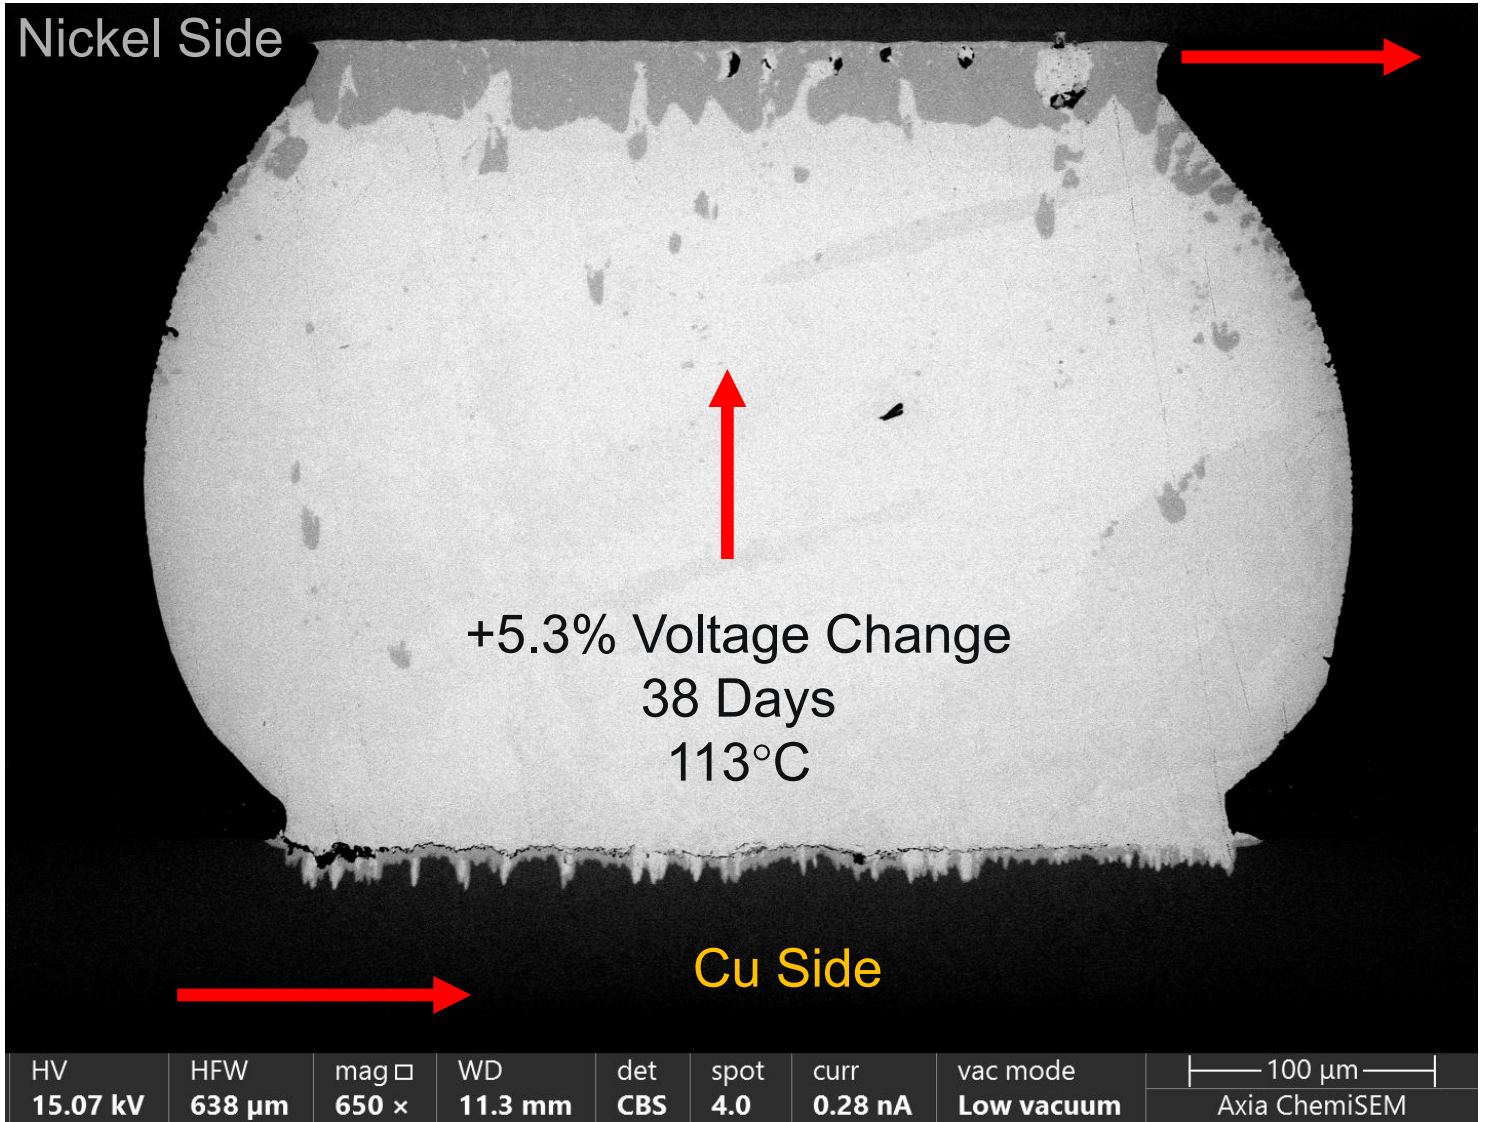
- More of the same... copper pad interface is seriously compromised, yet measured voltage change is just ~5%

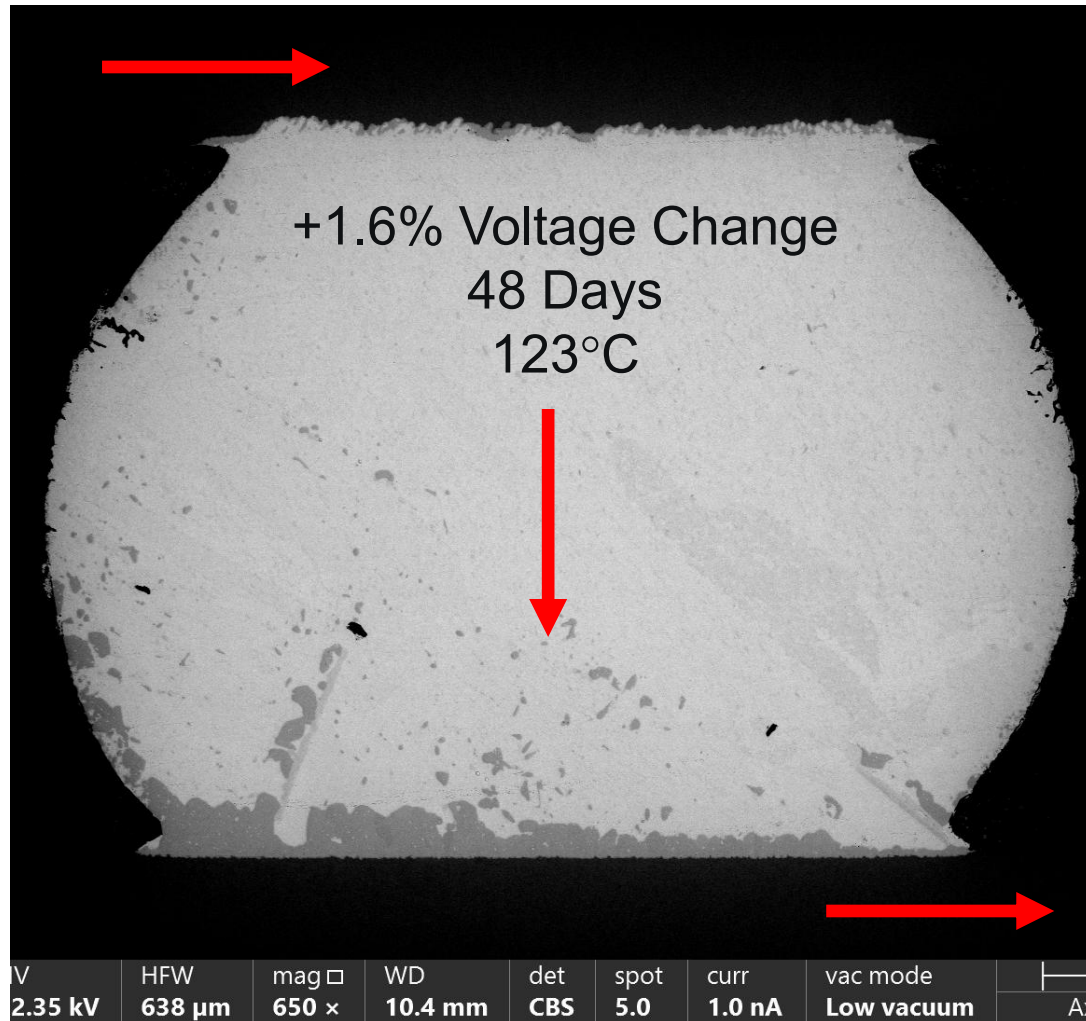
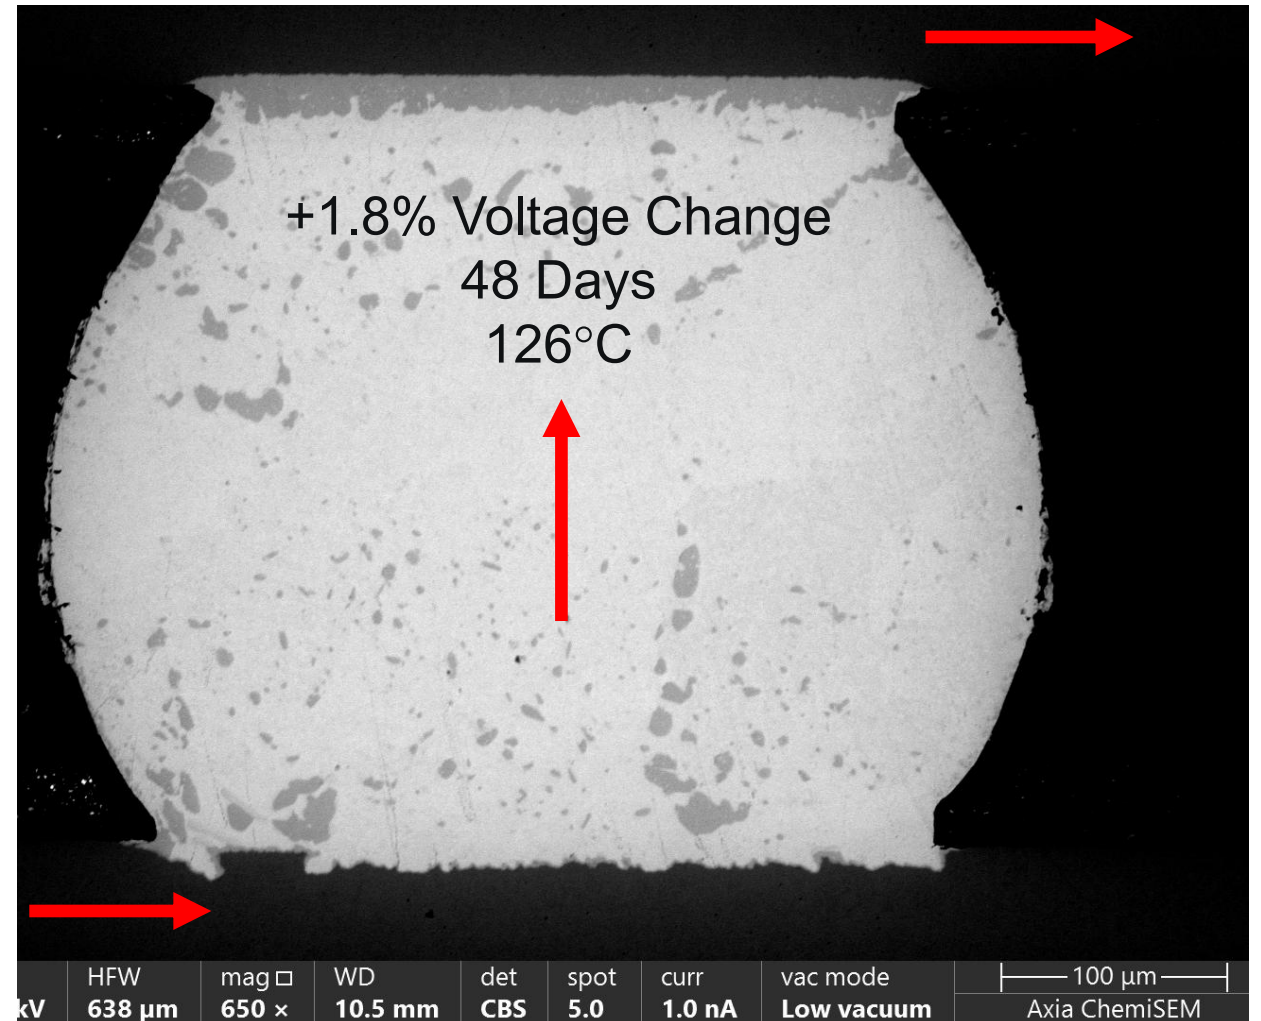
- Cyclomax shows copper degradation, but no discontinuity at less than +2%.

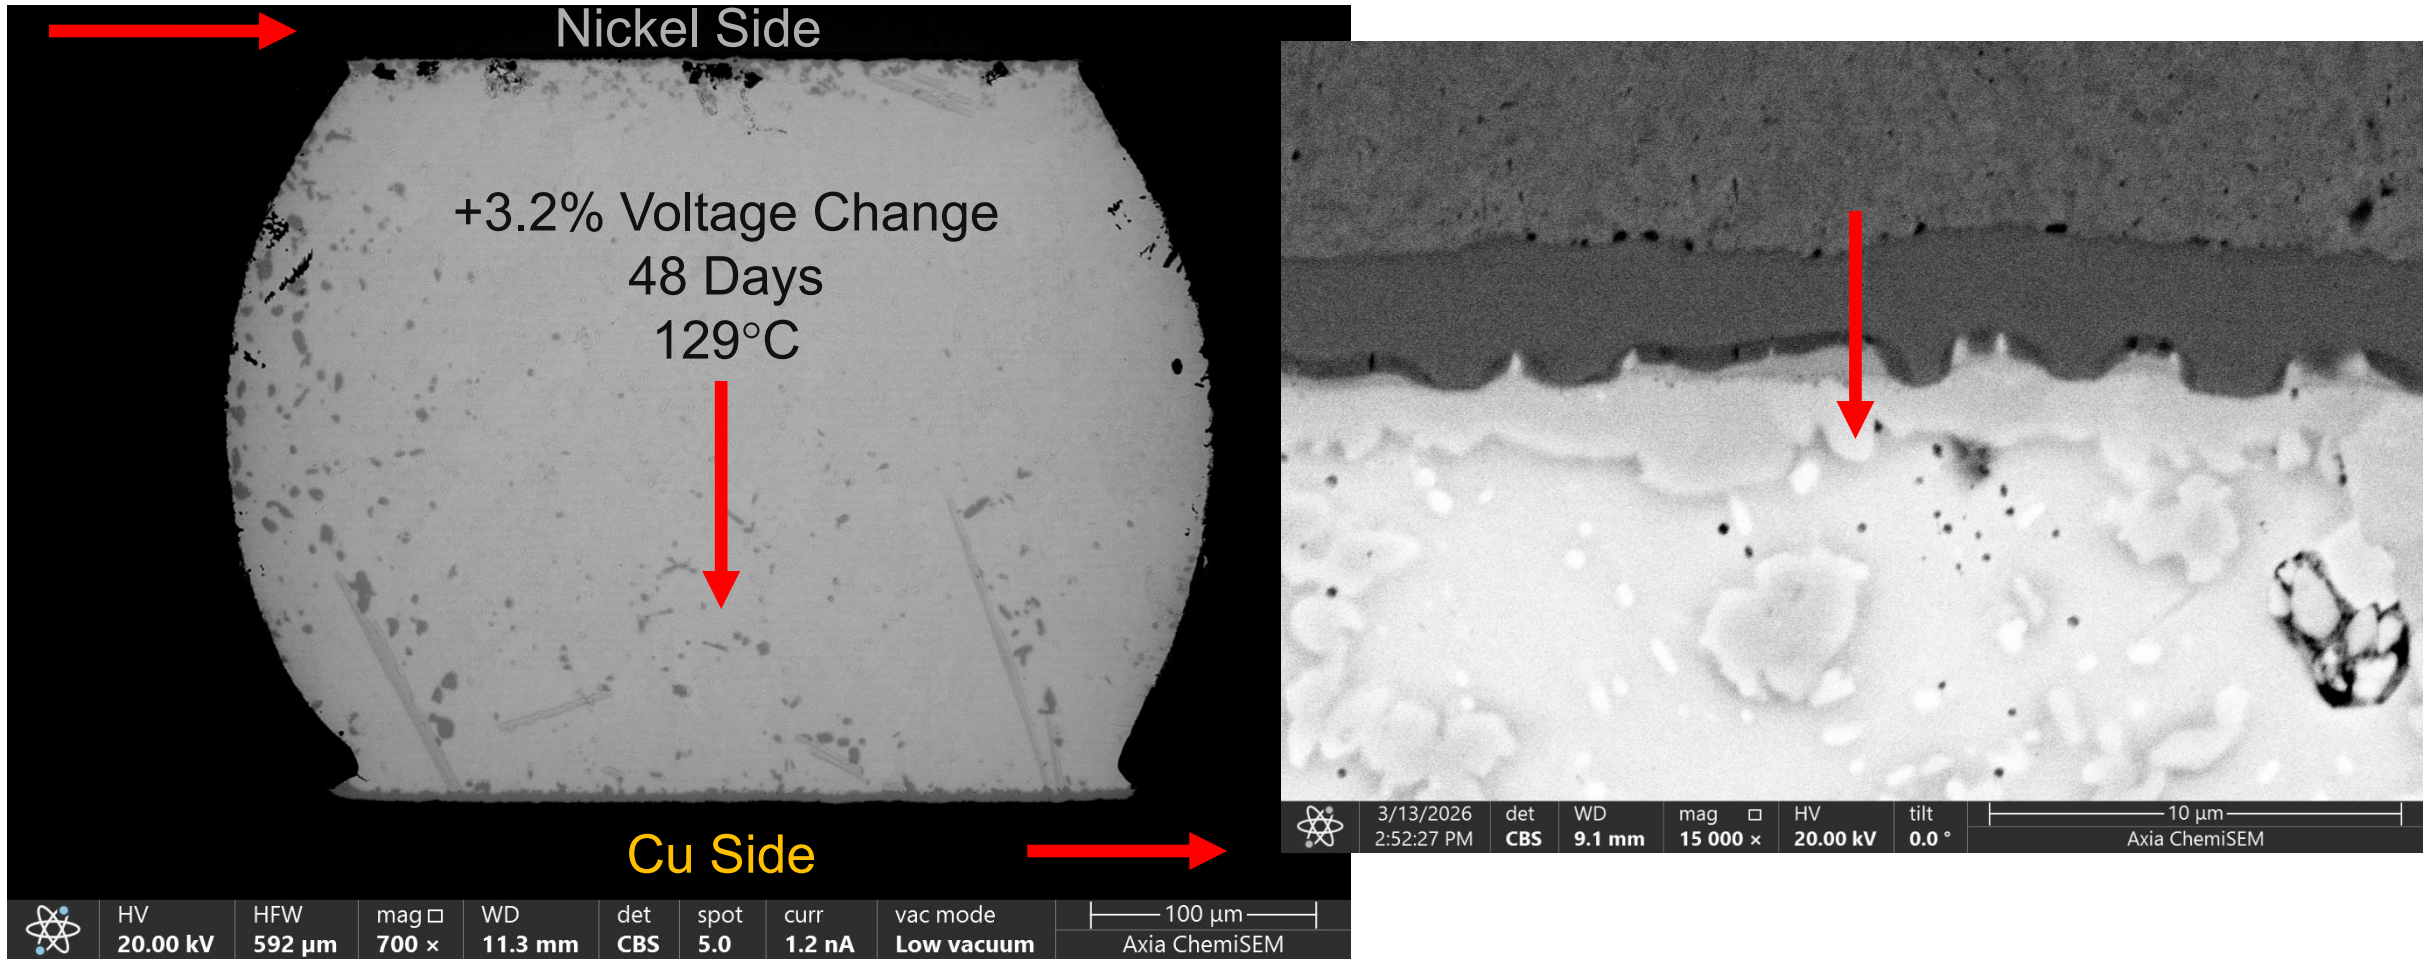
- Cyclomax shows nickel degradation (as expected at cathode) and some discontinuity at +3%

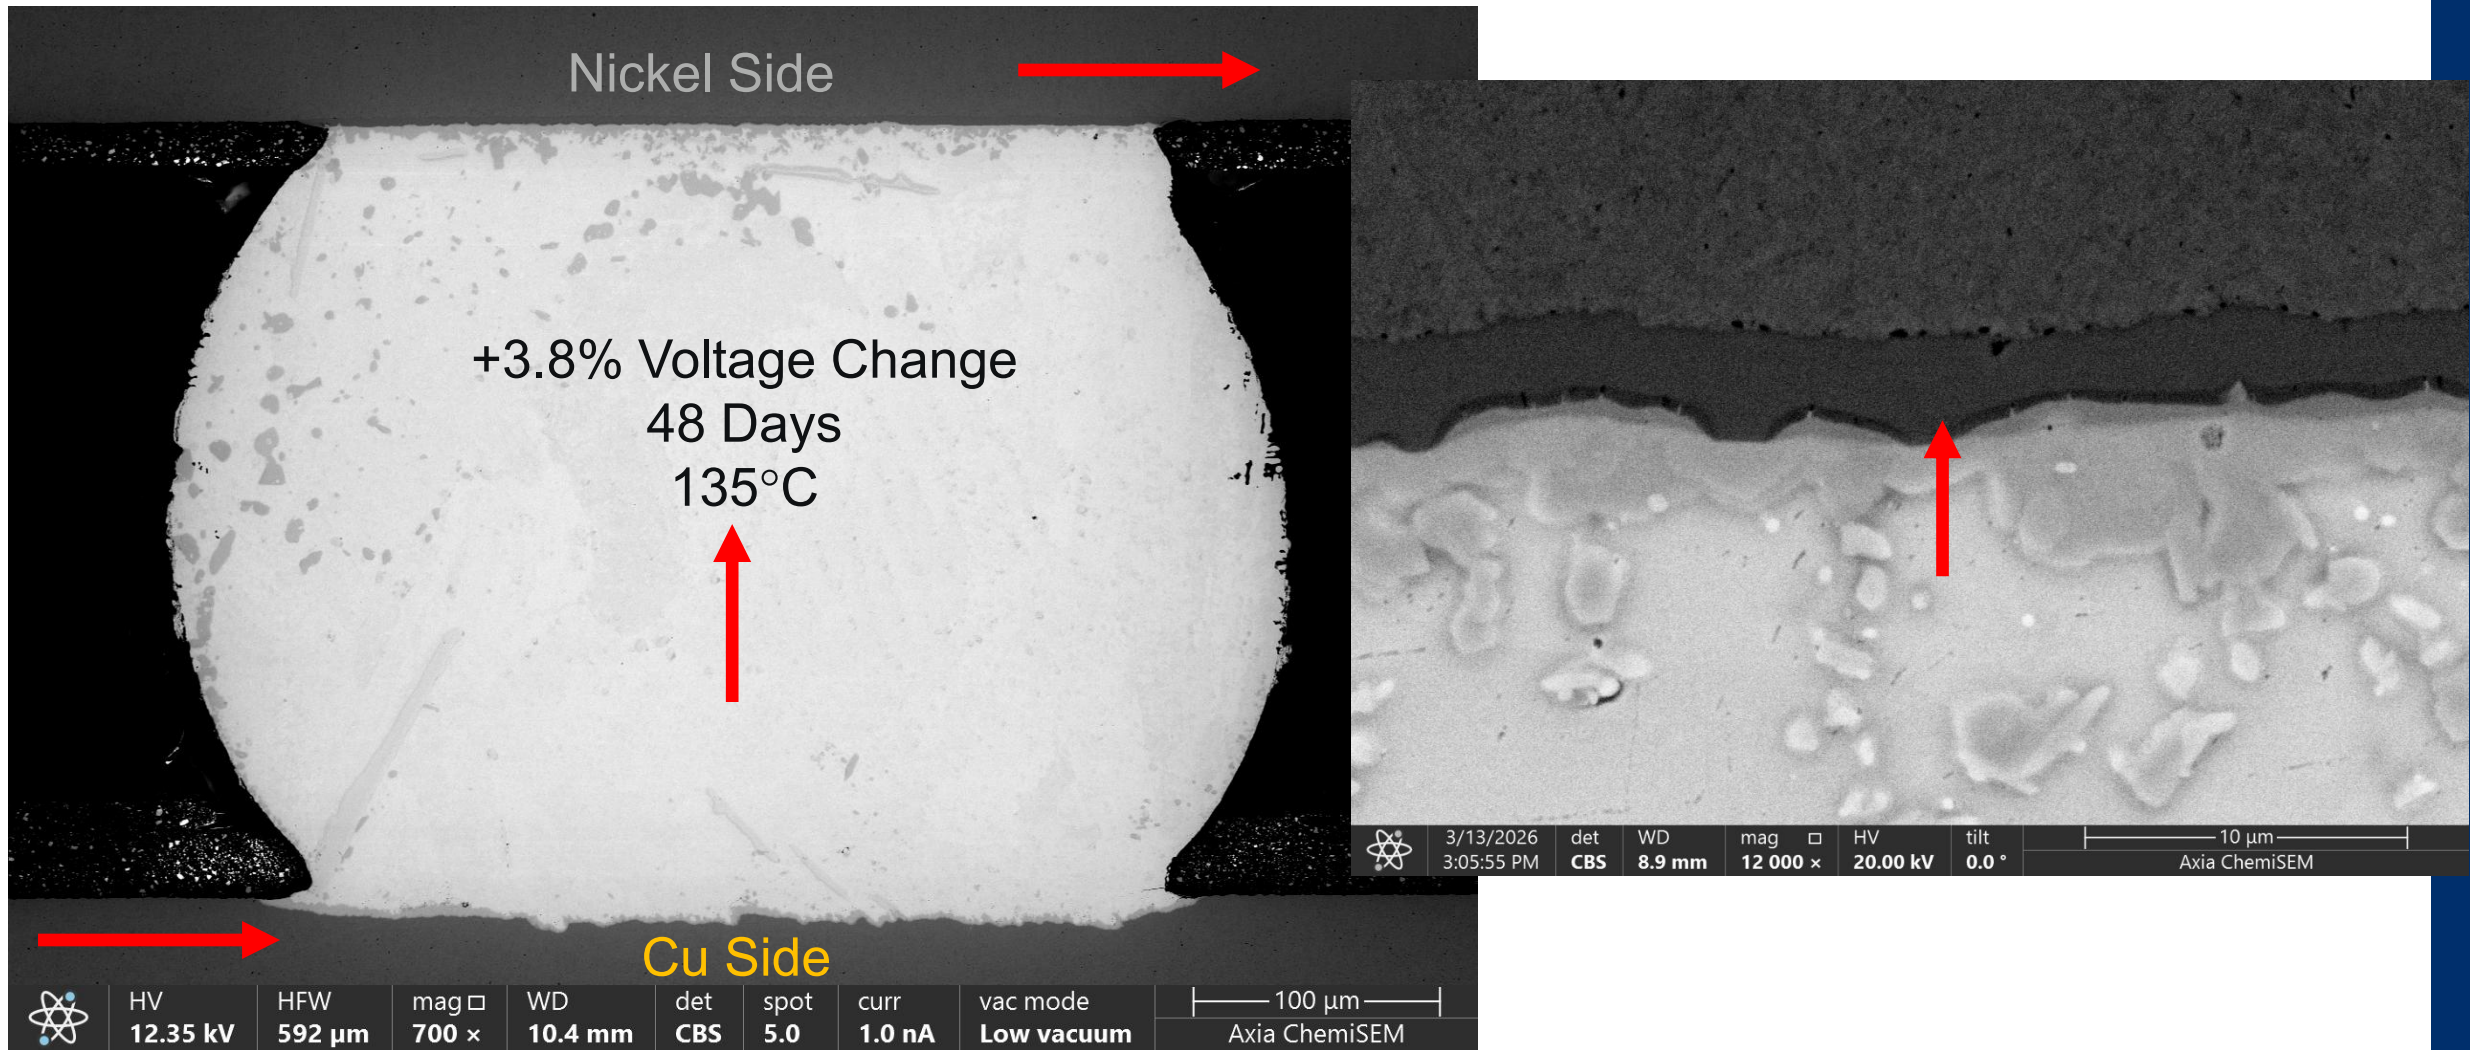
- Cyclomax shows nickel degradation at anode (probably not alloy related)

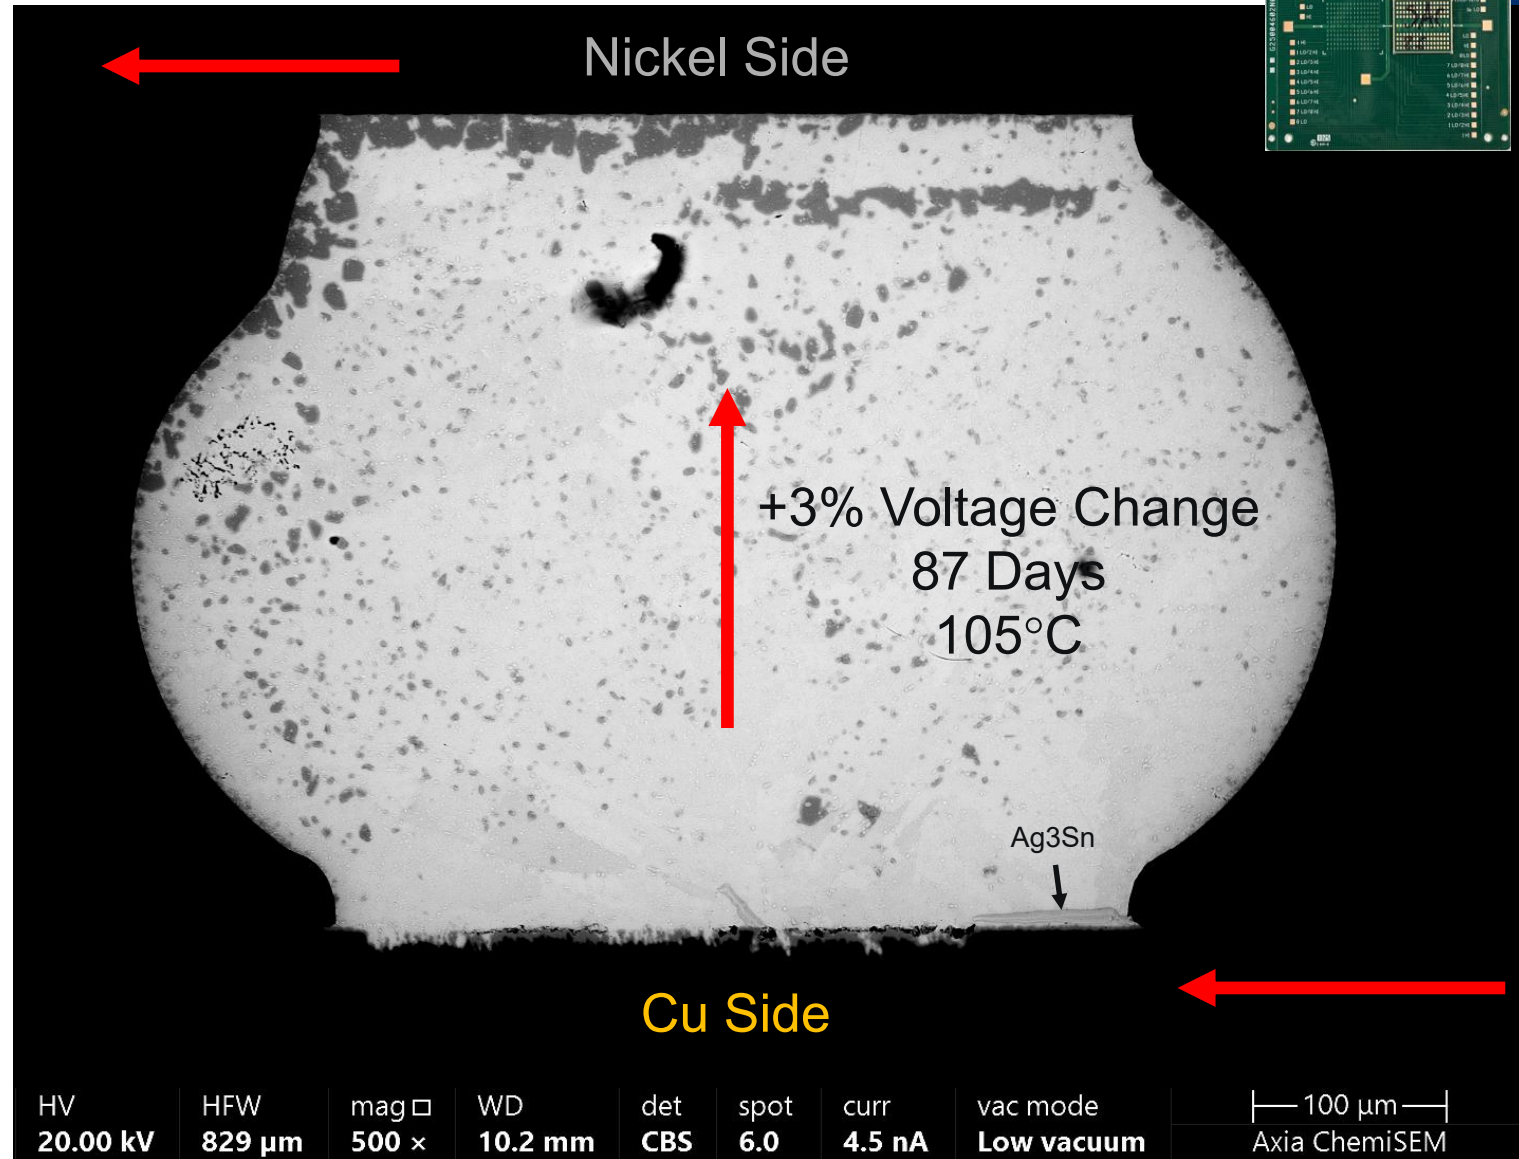
- Dip phase was ~35 days
- Rise is ~linear day 40 to 80
- Interesting Ag<sub>3</sub>Sn platelet effect

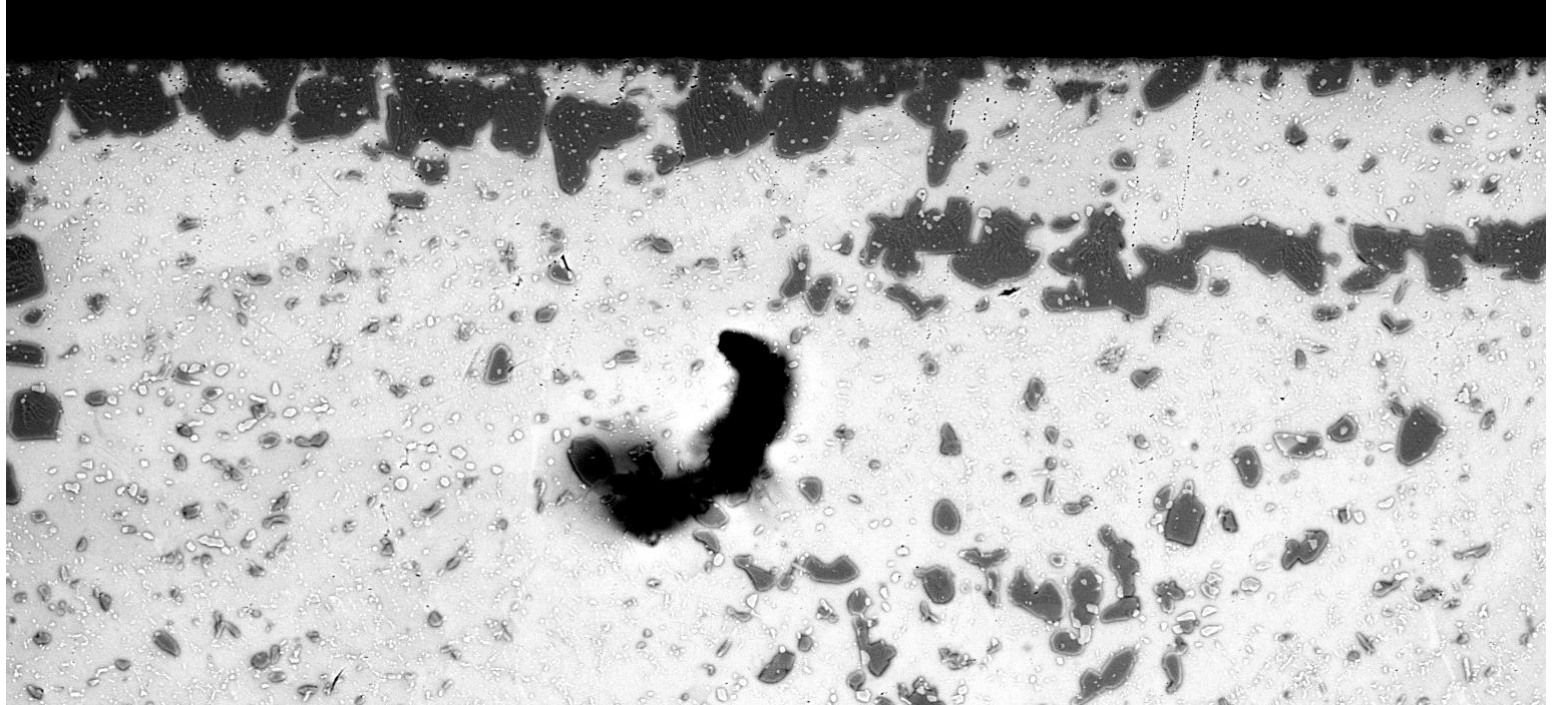
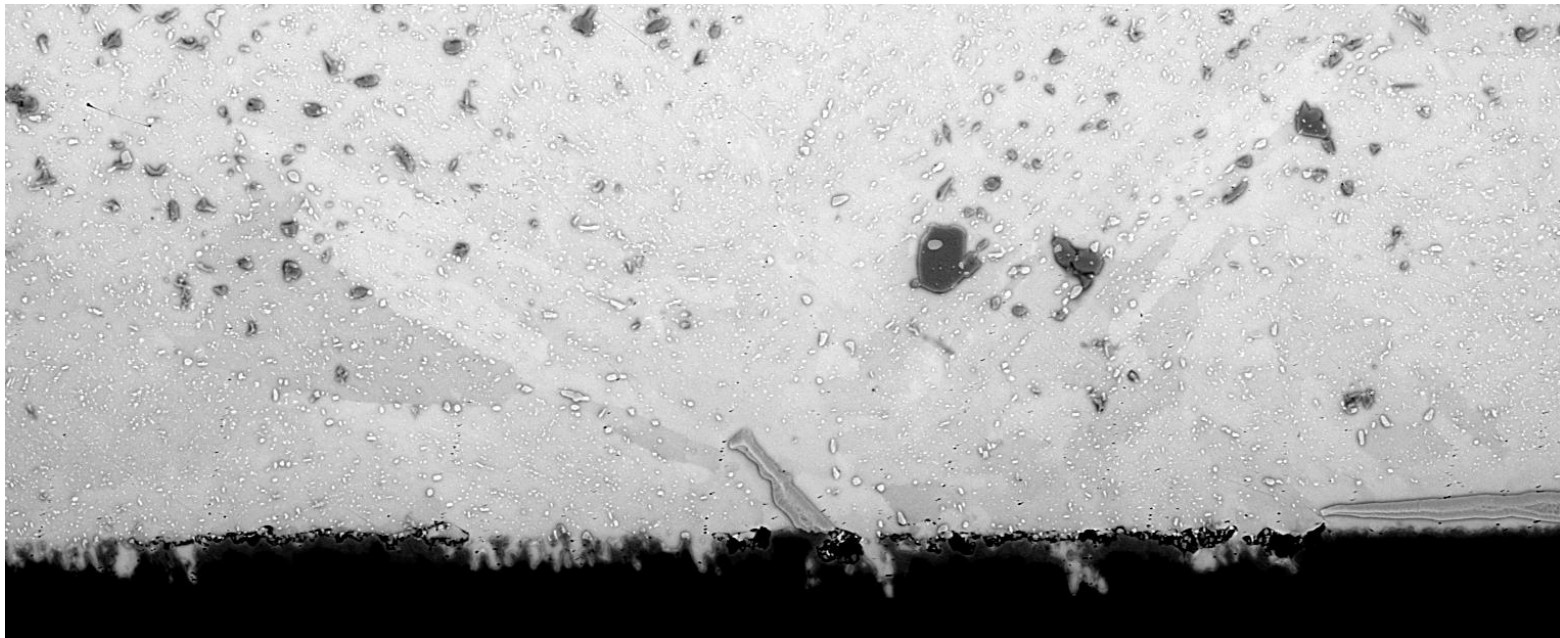
- Here's some enlarged images
- The CuSn appears to be speckled with Ag

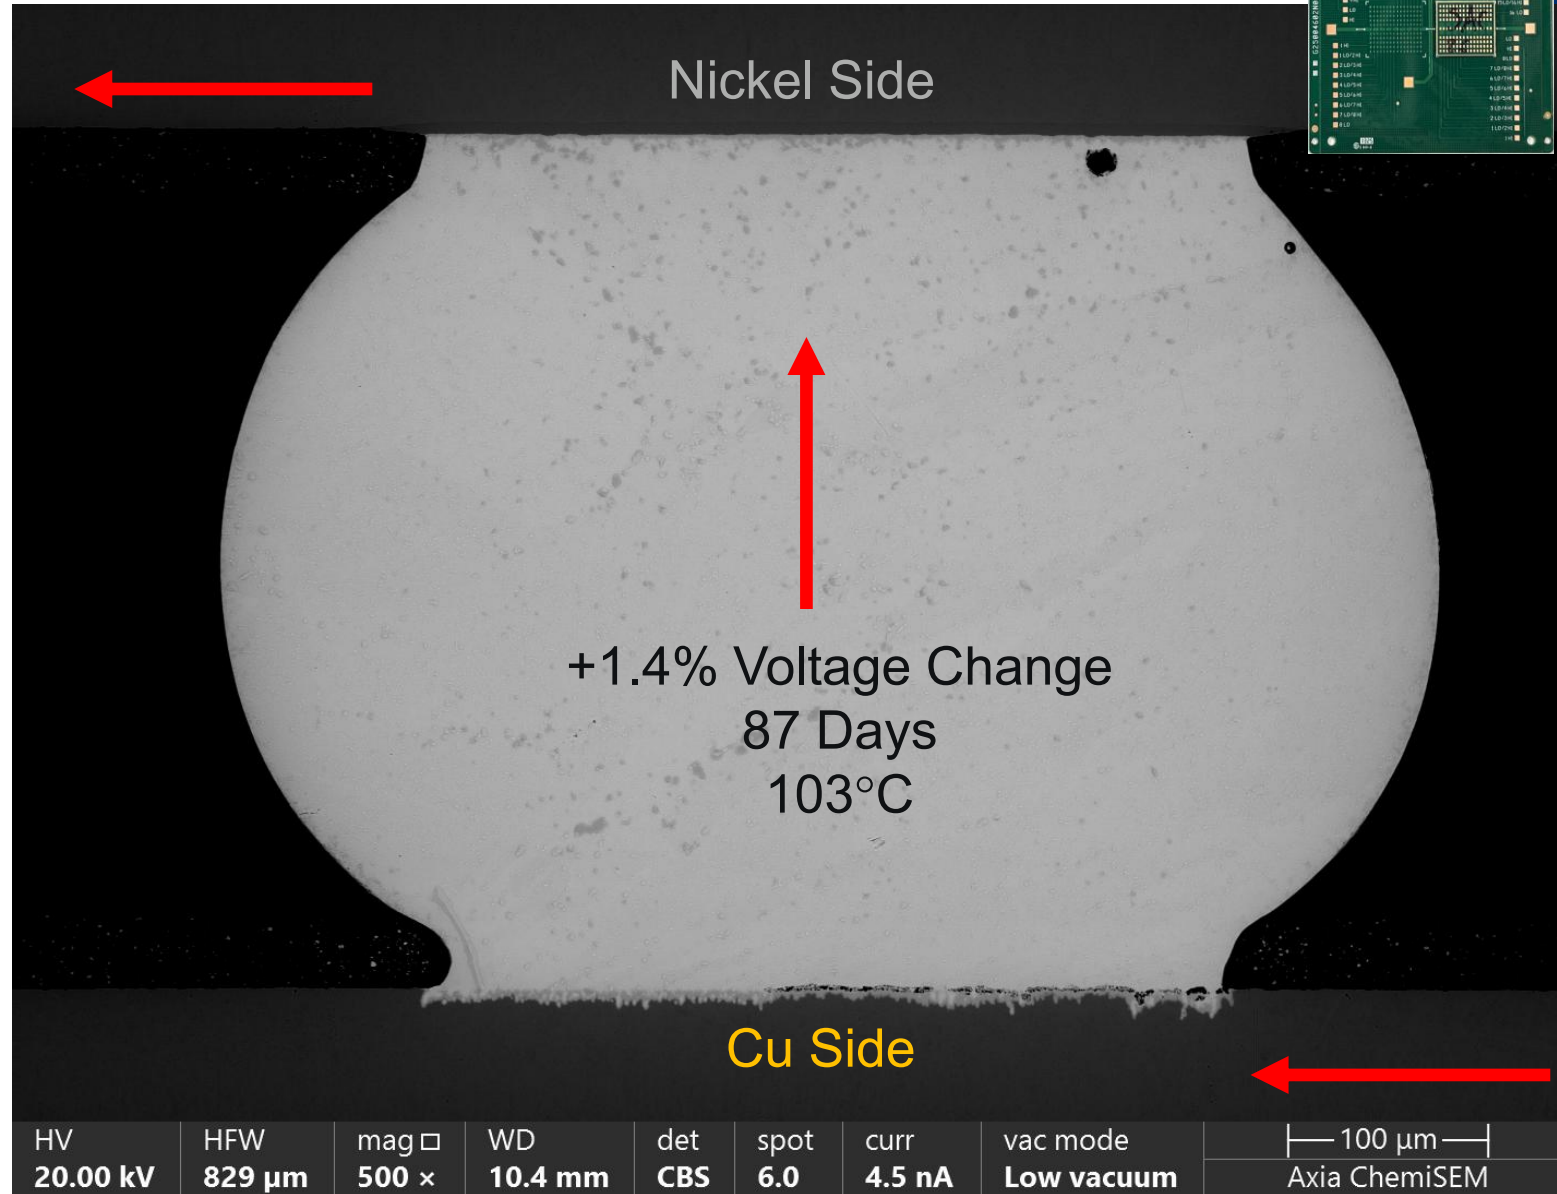
- Significant damage is visible at copper side with just +1.4% voltage rise

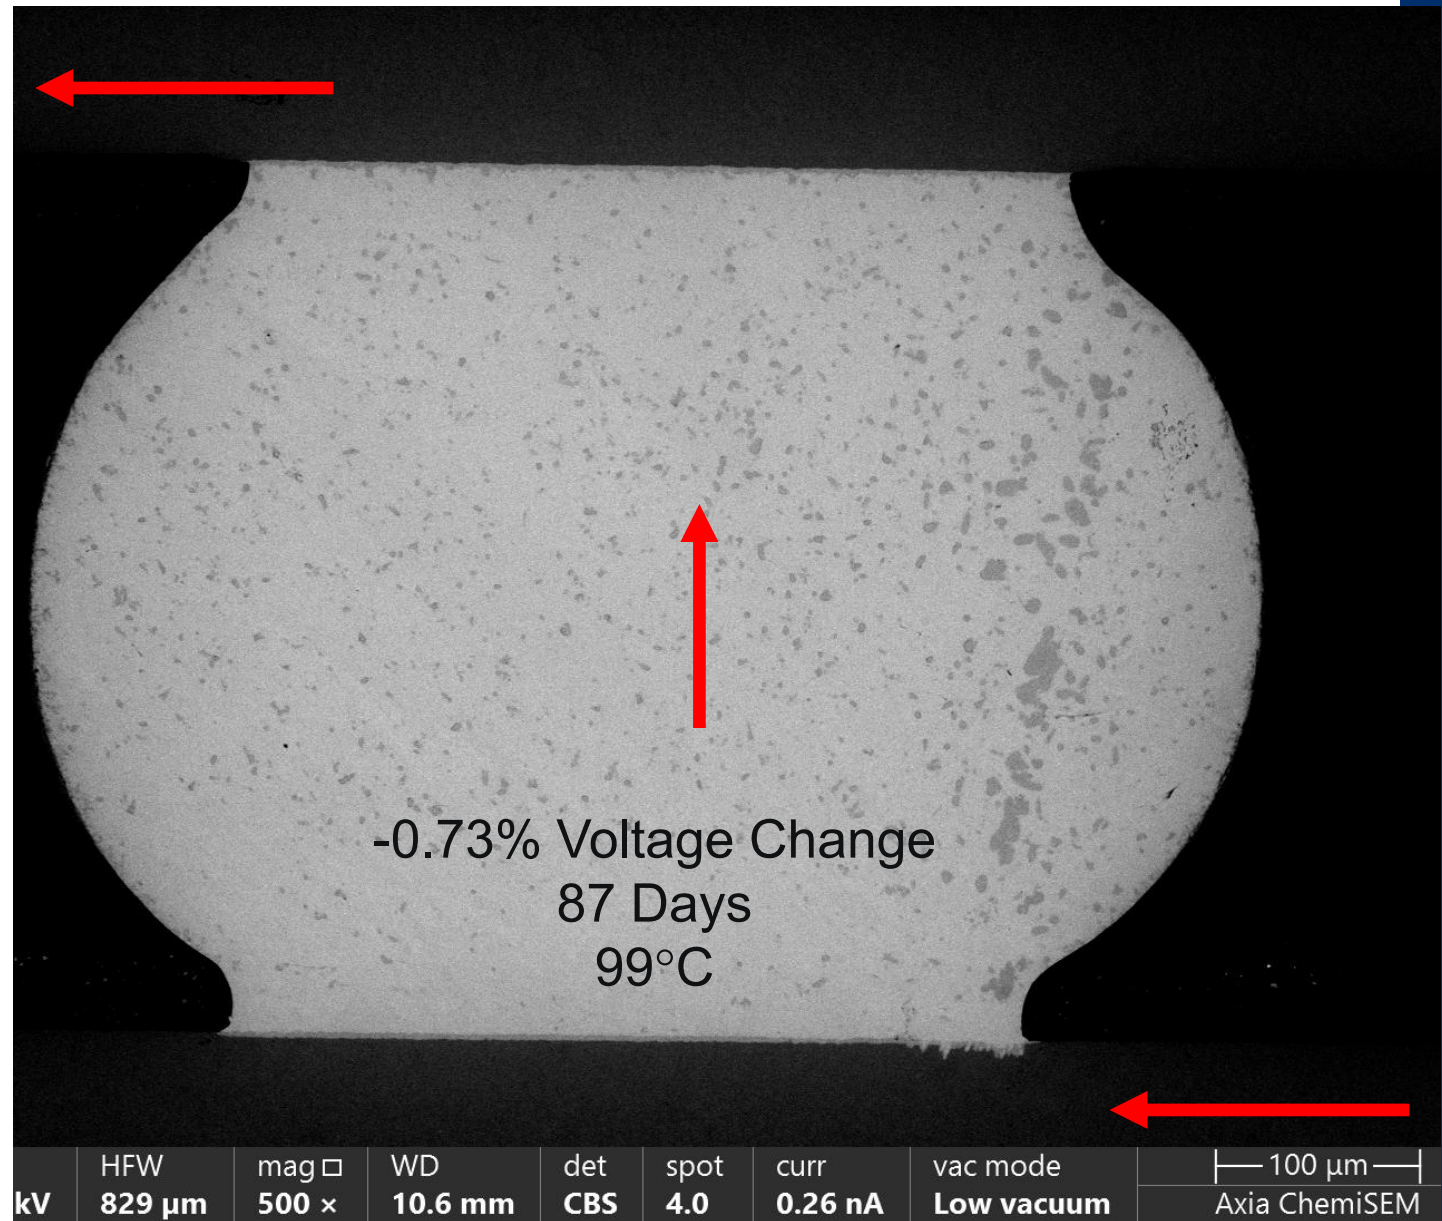
- This was the only "UP" joint not yet showing "rise"
  - -0.73%
  - Average temperature

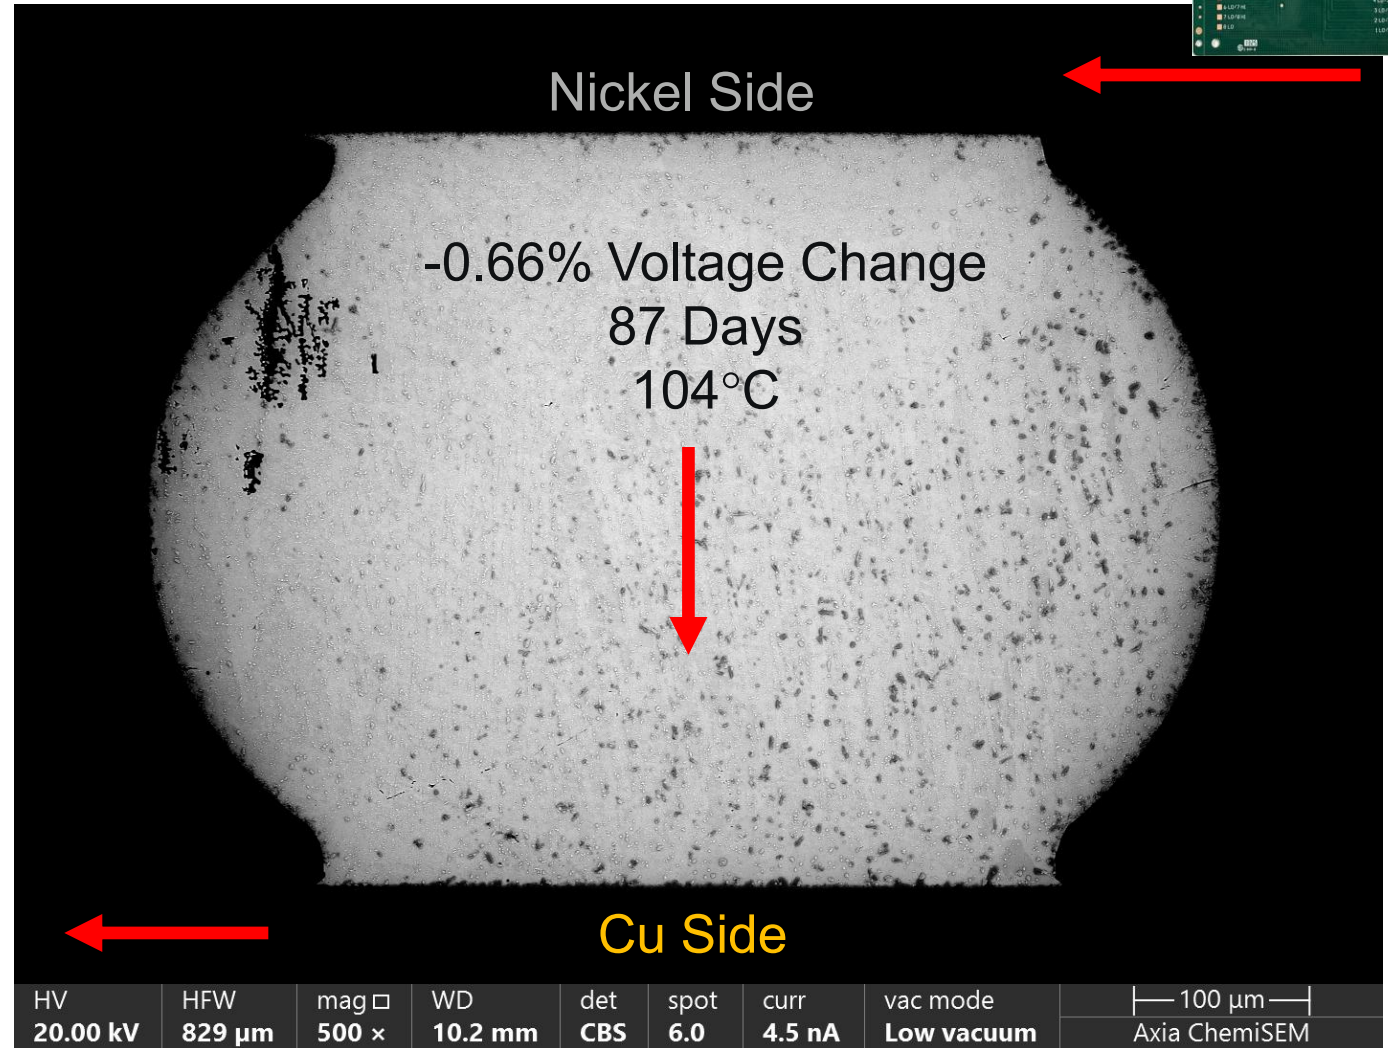
- Electron flow down joint
  - No recovery / rise
  - No visible damage

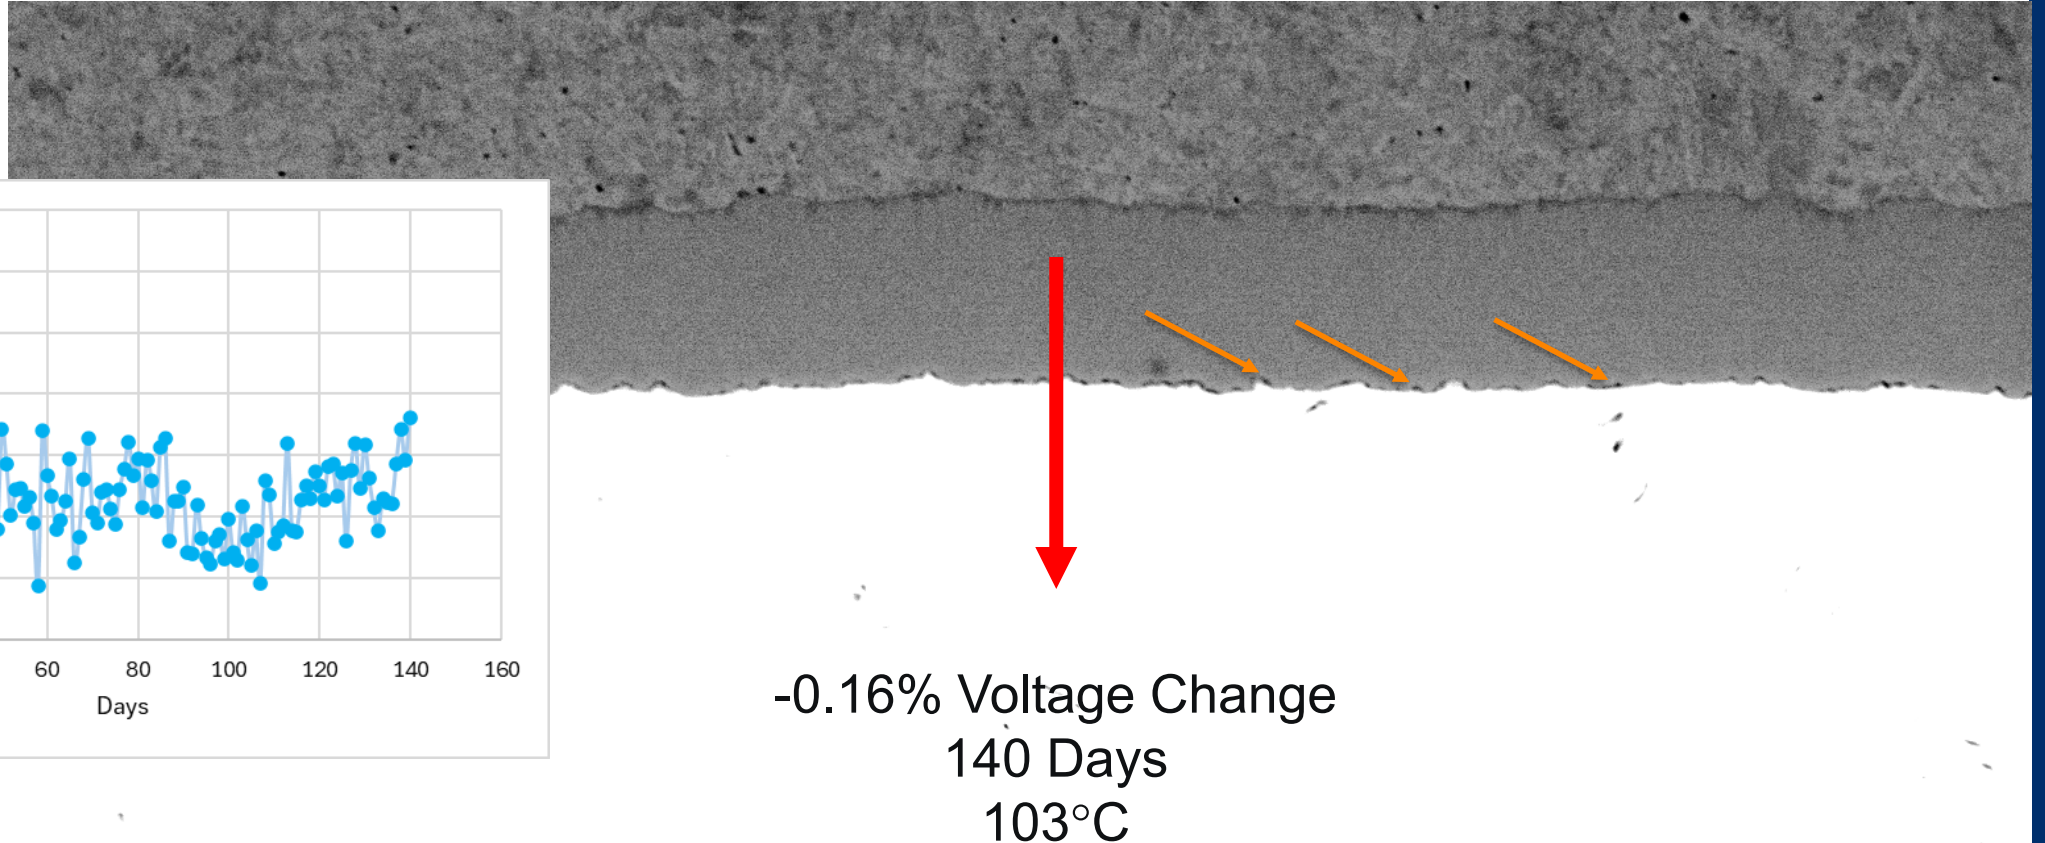
Looks like nickel layer degradation has begun (or was present at start)?
