High Reliability Solder Paste Performance in Thermal Cycling

Michael Meilunas
April 1, 2026

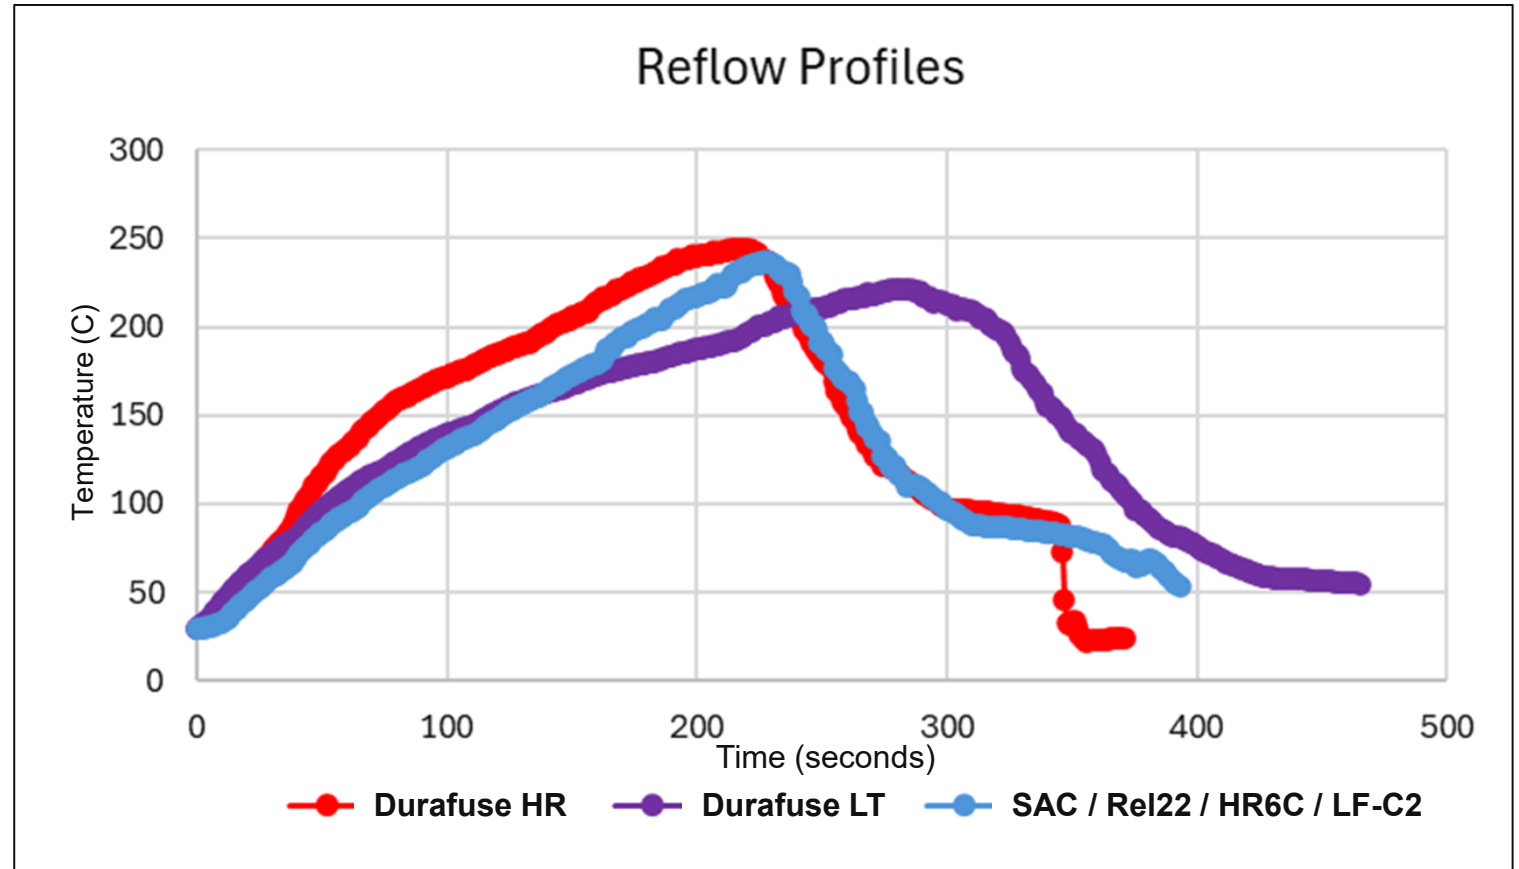
Reflow Profiles

- Nitrogen reflow
 - <300ppm O₂
- SAC, Rel22, HR6C and LF-C2: identical profile (direct ramp)
- Durafuse HR and LT: customized profiles
 - DFHR: similar to SAC profiles
 - DFLT: colder than SAC profiles

Parameter	Durafuse HR	Durafuse LT	SAC / Rel22 / HR6C / LF-C2
Peak Temp (C)	244	221	237
Time above 200C (s)	100	95	64
Time above 217C (s)	71	27	43

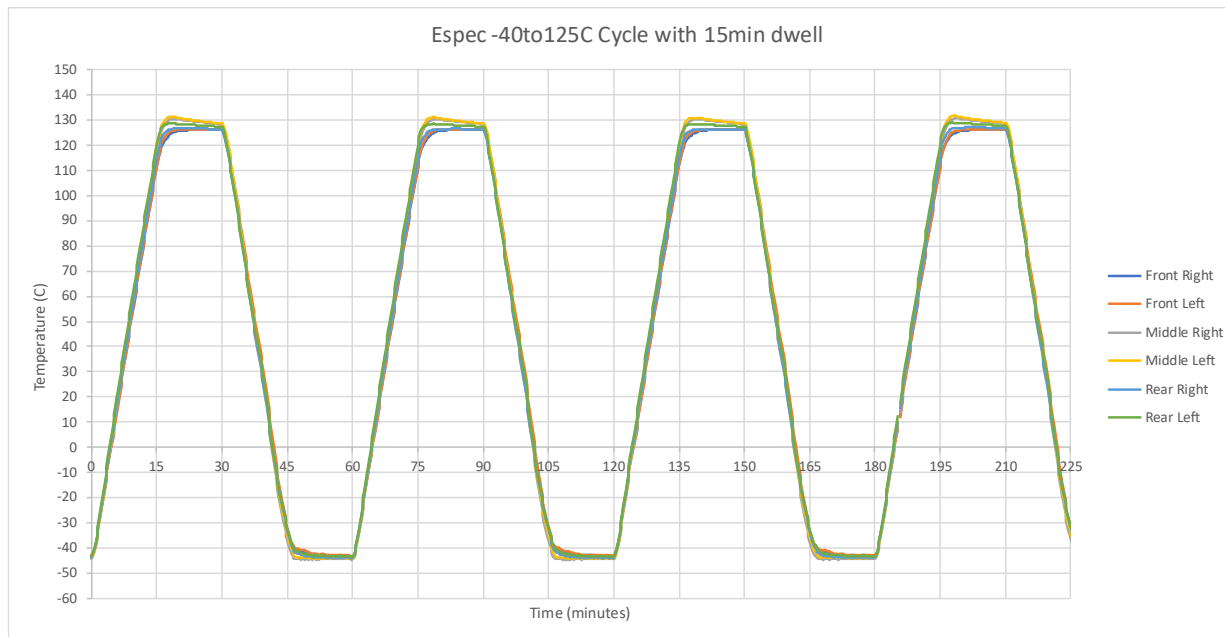
Thermal Cycle Testing

- -40 to 125°C, 60-minute temperature cycle
 - 15-minute dwell times
- Event detection: 500ohm threshold; 200nS duration

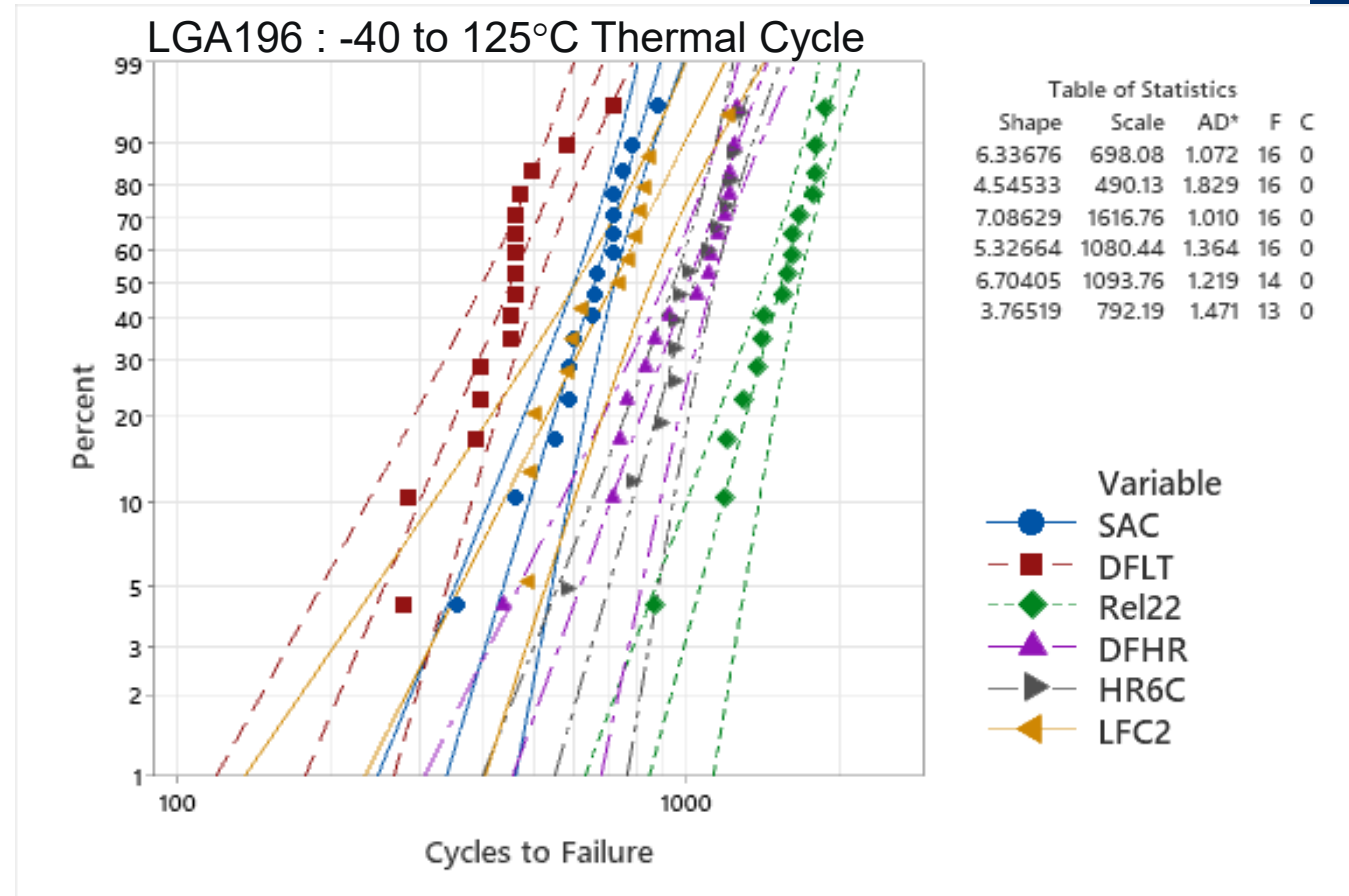
LGA196
1.0mm pitch
15mm body

- The LGA196 assembly is the least reliable assembly among the SAC305 populations
- The “high reliability” pastes all performed as well as or better than SAC305
 - Rel22 results are extremely good
 - Durafuse HR and HR6C also impressive
- The Durafuse LT population did not perform as well as SAC305
 - 30% N63.2 reduction

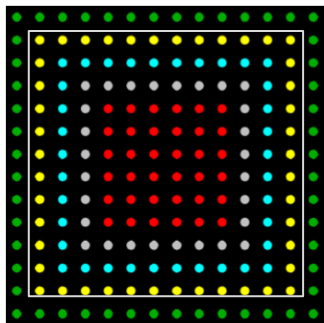
LGA196: LF-C2 (Tied 4th)

- LF-C2 performed similar to SAC (slightly better)
 - At room temperature, we could not find the failure locations using an ohm-meter

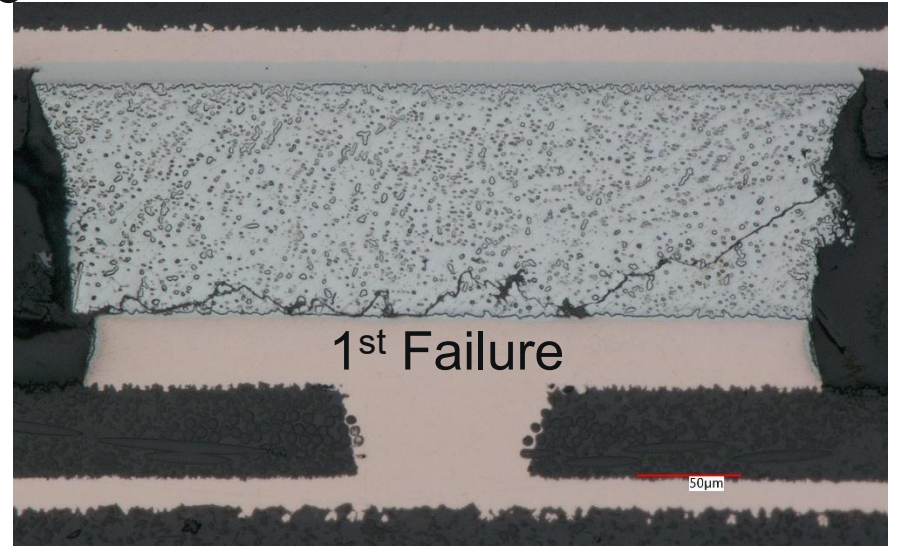
LGA196: Rel22 (1st)

- Rel22 paste resulted in the most reliable LGA196 test assemblies

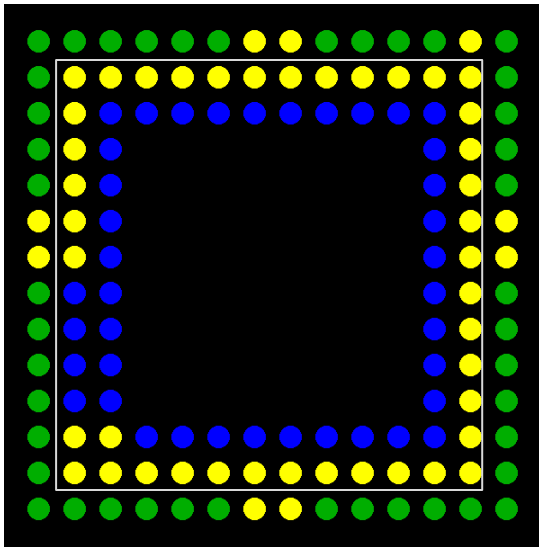
BGA132
0.5mm pitch
8mm body

- Everything is as good as or better than SAC305
- Joints located at yellow positions tend to fail (shear fatigue dominates)

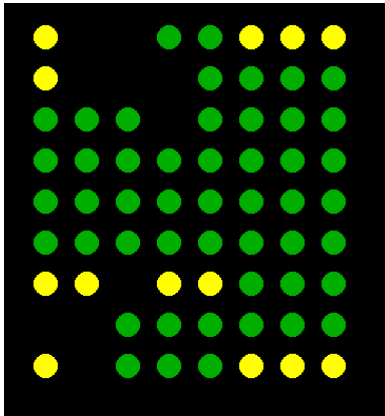
WLCSP72
0.35mm pitch
~3.5x3.2mm body

- Corner joint failures dominate as would be expected
- Rel22 not as good as SAC305, but other alternative alloys are similar to SAC305

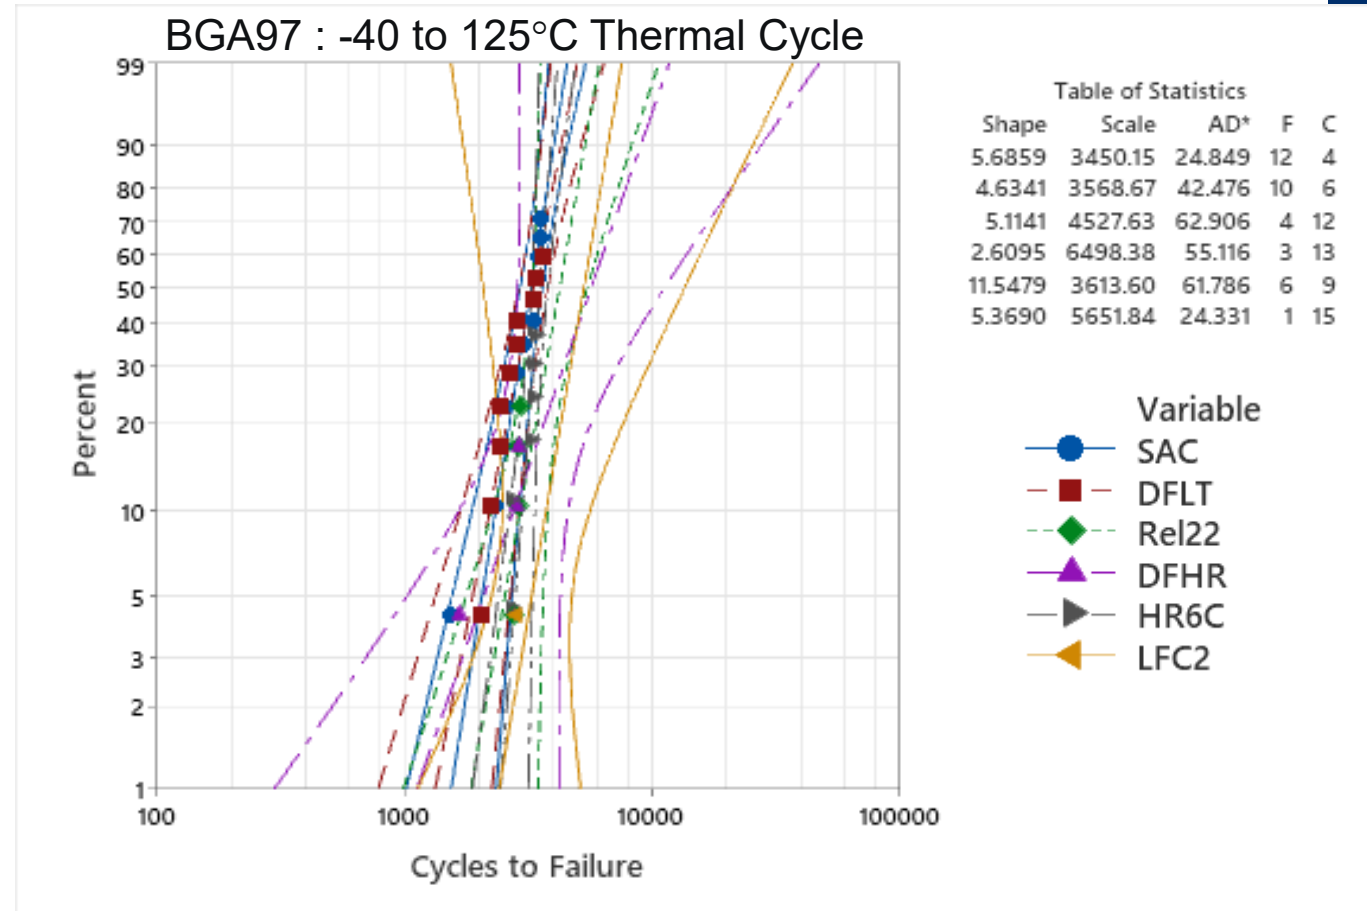
BGA97
0.4mm pitch
5mm body

- This is a small device and tends to survive many cycles
 - Warpage stress is not an issue
 - Parts fail below die shadow, not at corners
- Often, the PCB and component body show damage before we see solder joint failures
- Overall, all paste options perform similarly based on available data
