# Electromigration Update: SAC305 (and Cyclomax)

*Michael Meilunas*  
*April 1, 2026*

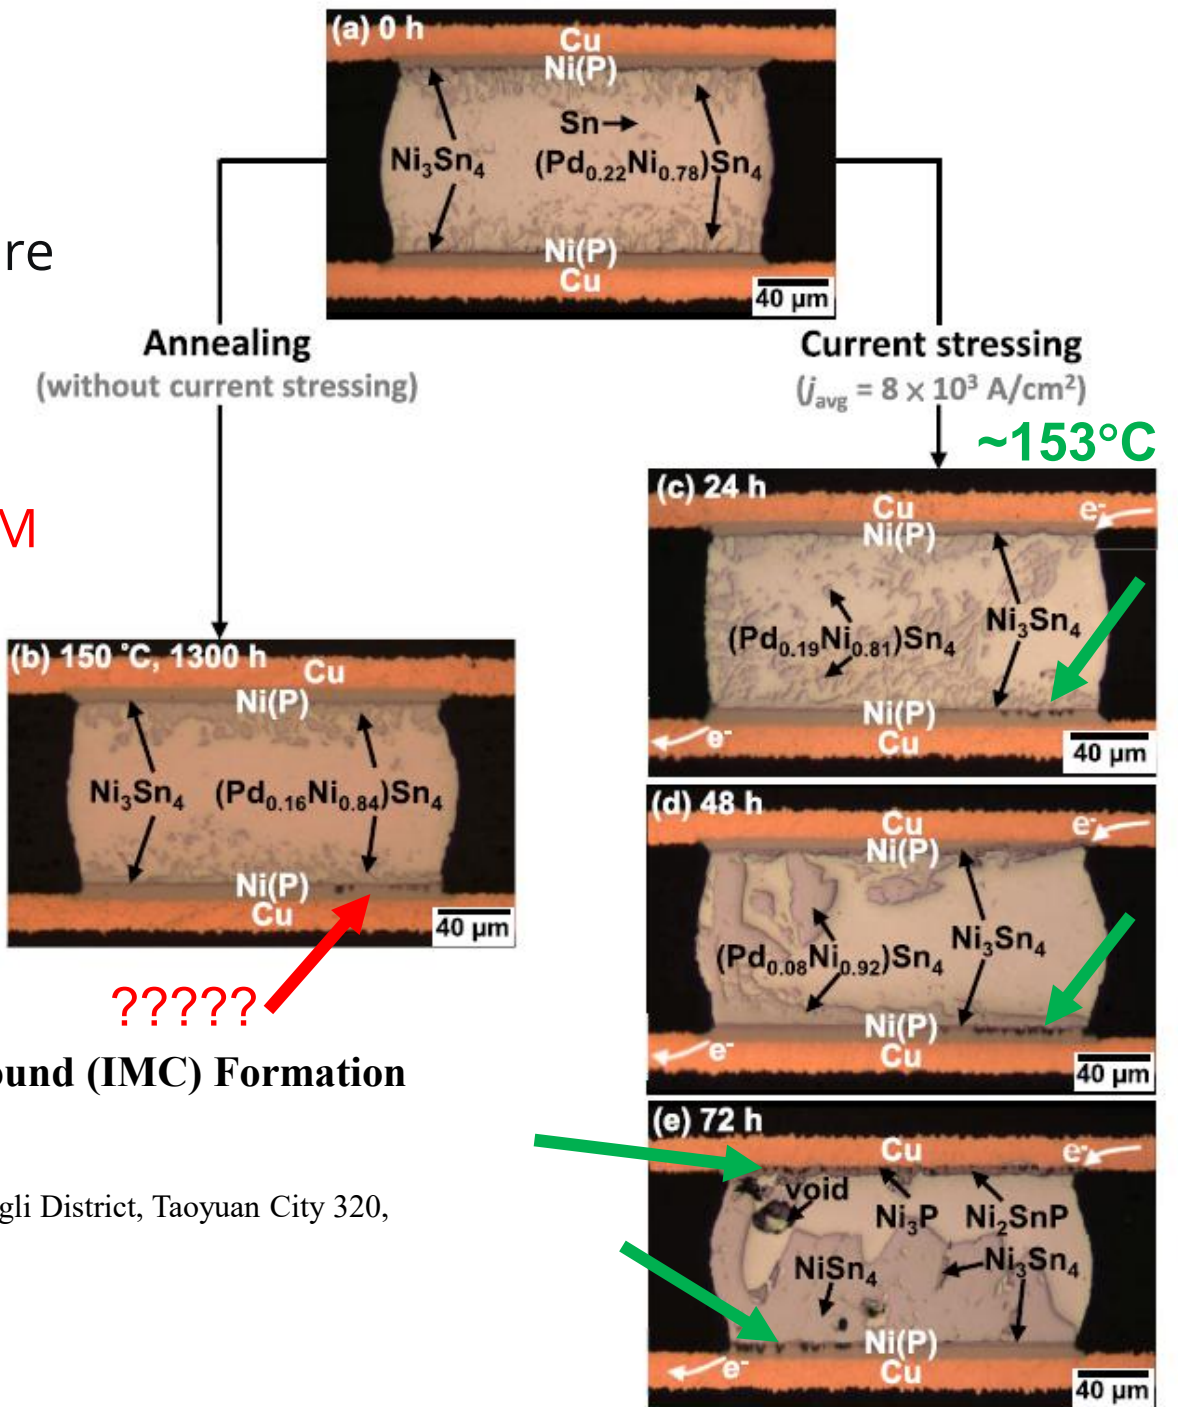
- Reported in literature:
  - Observed under high current and temperature
    - Short test duration
    - Both sides of same joint show some effect?
    - Electron flow direction appeared to matter
  - Looks like it may also be present after non-EM "annealing"
    - 1300 hours @ 150°C

## Electromigration-Induced Remarkable Intermetallic Compound (IMC) Formation in Micro Joints and its Prevention

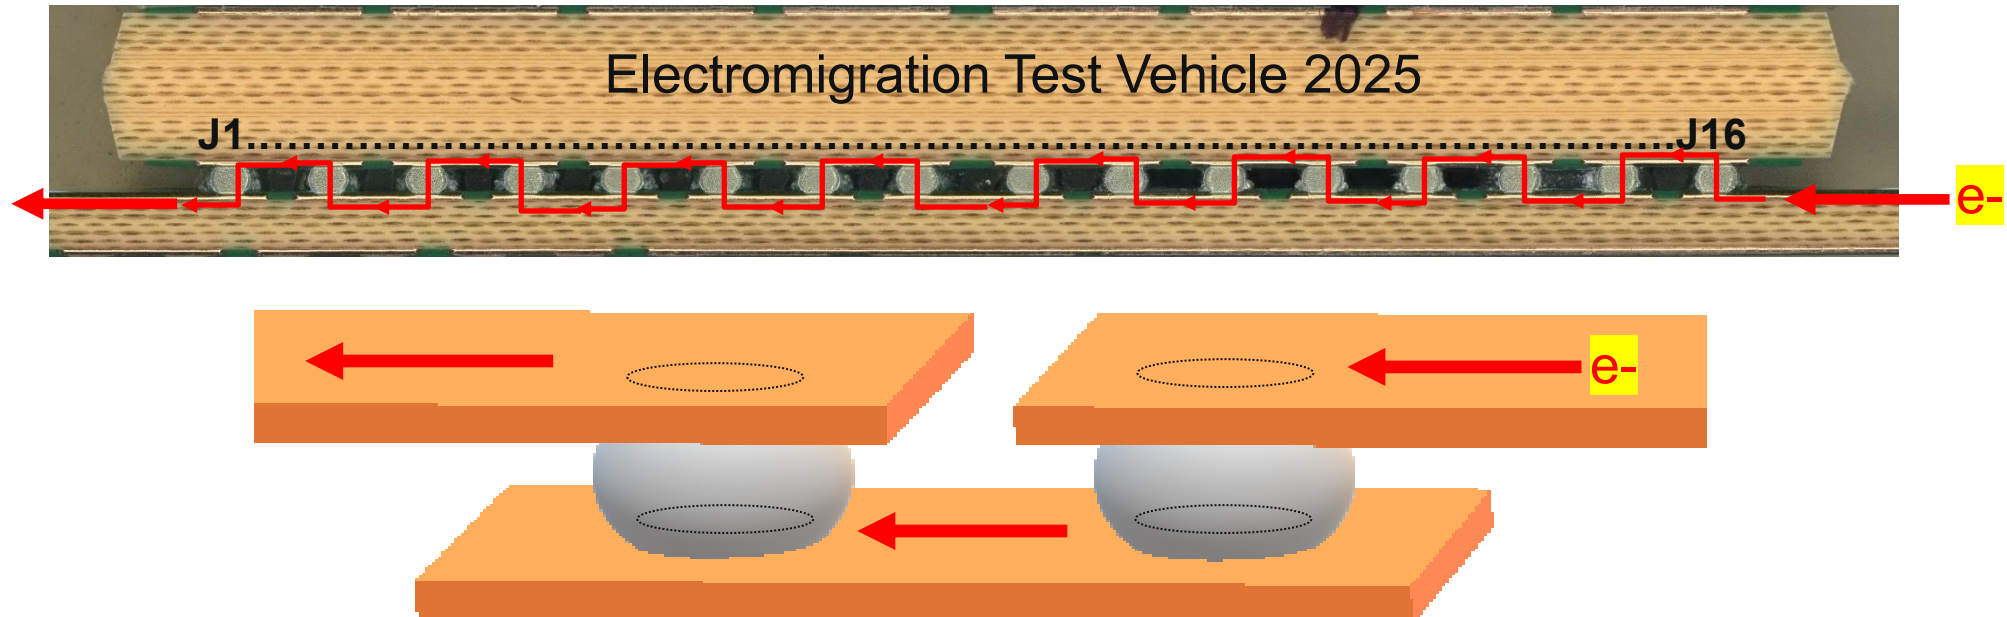
- Current flows across multiple solder joints alternating “up” and “down”.
- Voltage can be measured at all stressed locations (EMTV2025) or at select locations (DTV2022)
- Solder mask defined pads and large, thick traces minimize current crowding and copper trace Joule heating

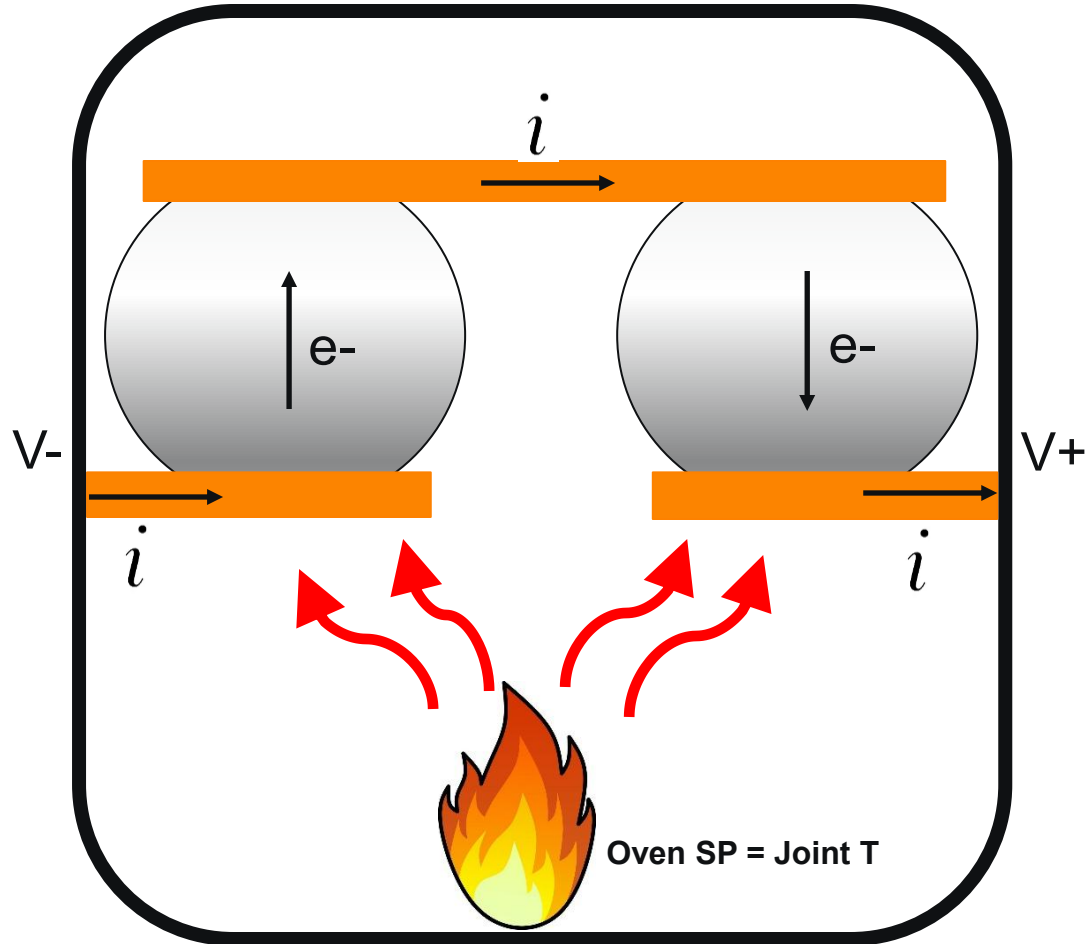
## TEMPERATURE DETERMINATION

Low current; minimal Joule heating  
Externally driven temperature;  
~uniform joint temperatures

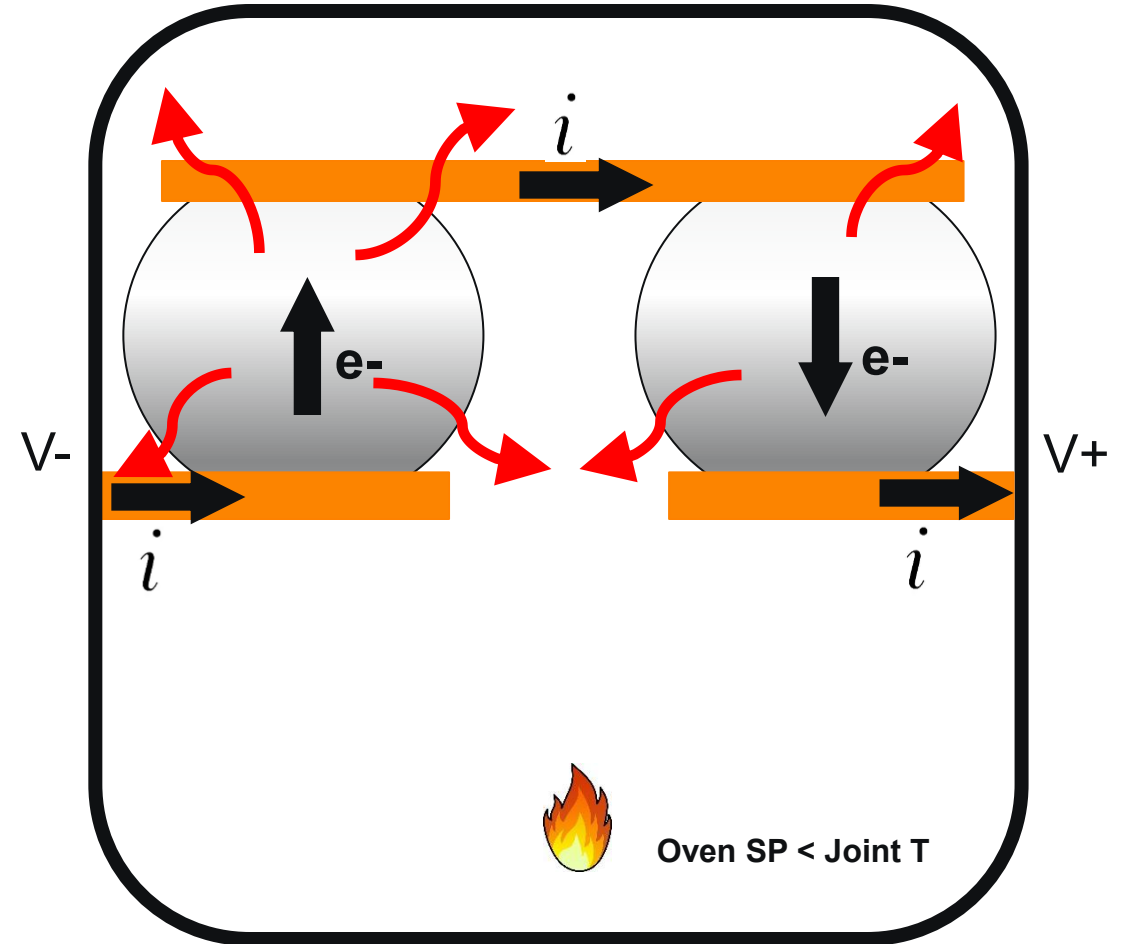
## EM TEST METHOD

High current; significant Joule heating is possible  
environmental temperature "boost";  
non-uniform heating joint-to-joint

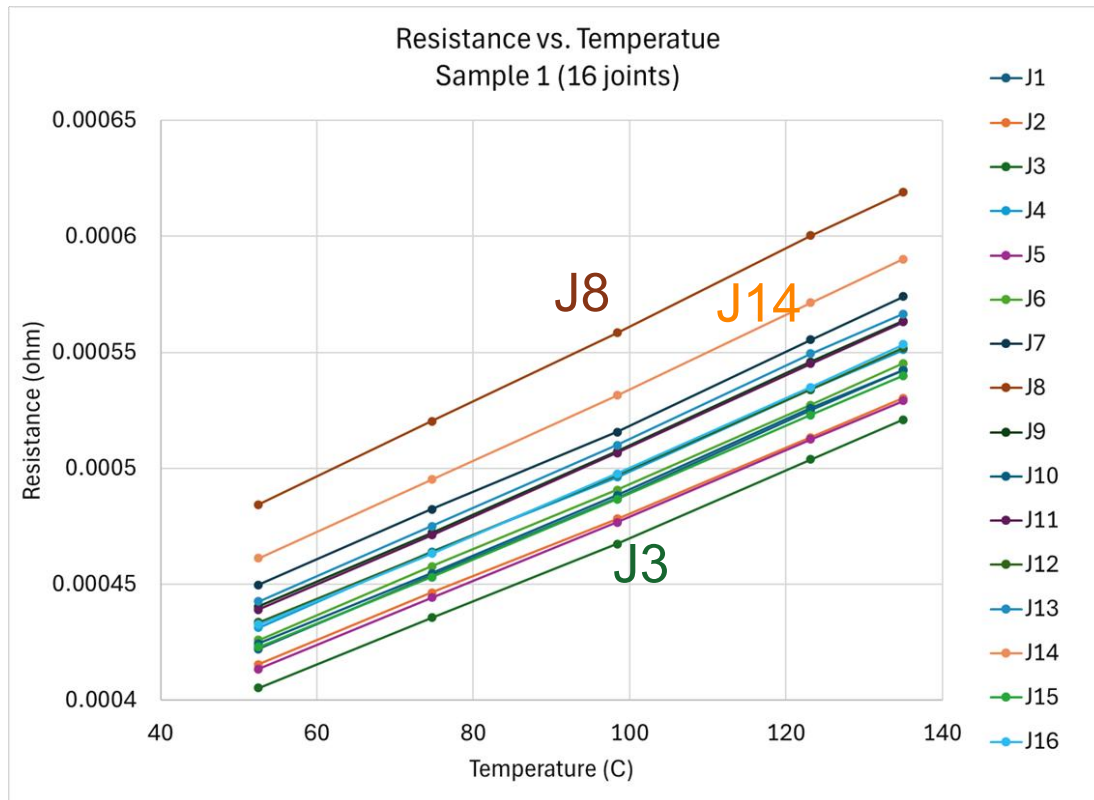
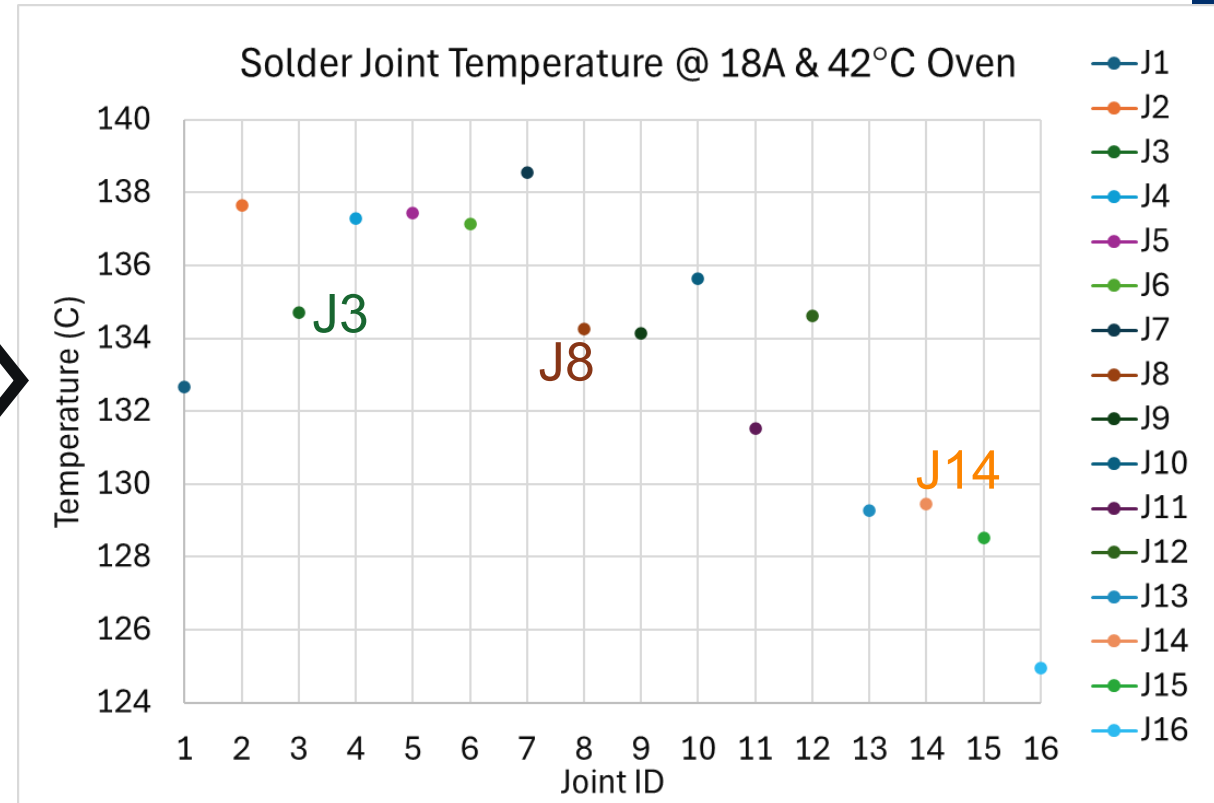
- Resistance ranking does not equal temperature ranking once EM testing has begun
- R vs. T relationship is valid at start of test, it falls apart as testing progresses

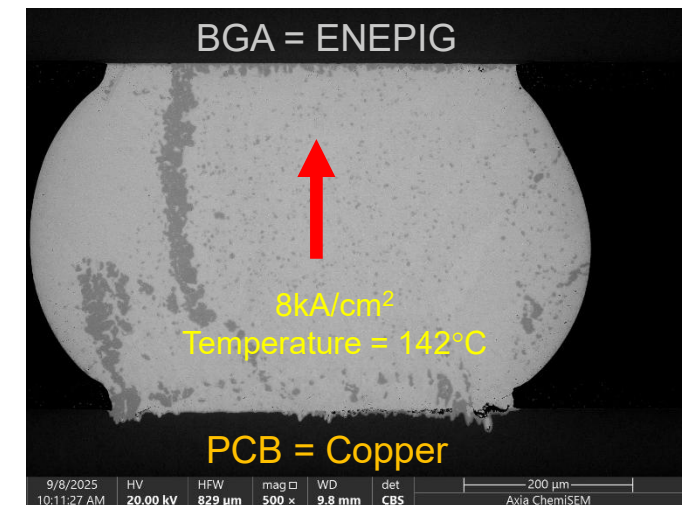
- 9.5kA/cm<sup>2</sup> @ ~150°C : samples demonstrated fast resistance increase resulting in joint melting and **definitive failure** in less than 24 hours
  - Some joints may have been as hot as 180°C at start of test
  - Copper pad consumption and nickel layer break-down were observed
- 9kA/cm<sup>2</sup> @ ~140°C : samples survived less than 3 days **(+50% resistance)**
  - Some joints may have been as hot as 160°C
  - Significant copper pad dissolution observed, but only +5% resistance change
  - Nickel layer degradation resulted in >50% resistance increase
- 8kA/cm<sup>2</sup> @ ~135°C : samples survived 38 days **(~5% resistance increase)**
  - Some joints as hot as 145°C
  - Significant copper pad degradation observed
  - Nickel break-down was not observed
- **Decision: +5% is reasonable failure criteria**

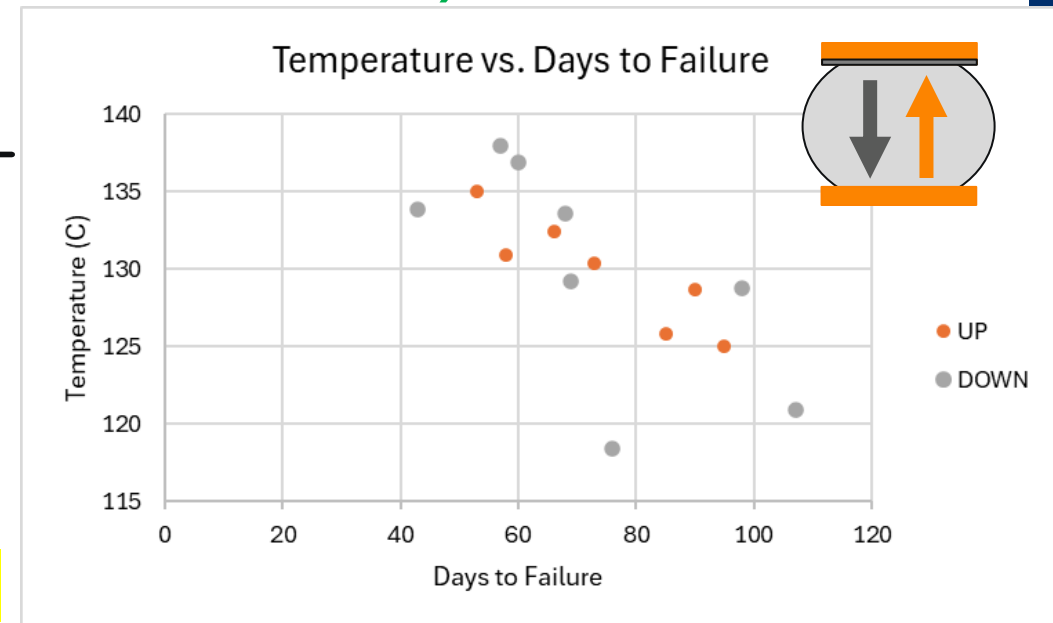
- 7.5kA/cm<sup>2</sup> @ ~150°C : samples survived 10 to 15 days (~5% resistance increase)
  - Nickel issue drove most failures
- 7.0kA/cm<sup>2</sup> @ ~135°C : samples survive 8 to 25 days (~5% resistance increase)
  - Nickel issue appeared at day 8
  - Copper degradation drove most failures
- 5.0kA/cm<sup>2</sup> @ 125°C: 43 to >100 days (~5% resistance increase)
  - Joints may be up to ~138°C
  - Nickel issue at 43 days (**DOWN**)
  - Copper degradation at 53 days (**UP**)
- Nickel issue occurs at relatively low temperature / current densities
  - IS THIS A VALID STATEMENT?
  - What are realistic temperatures /current densities?

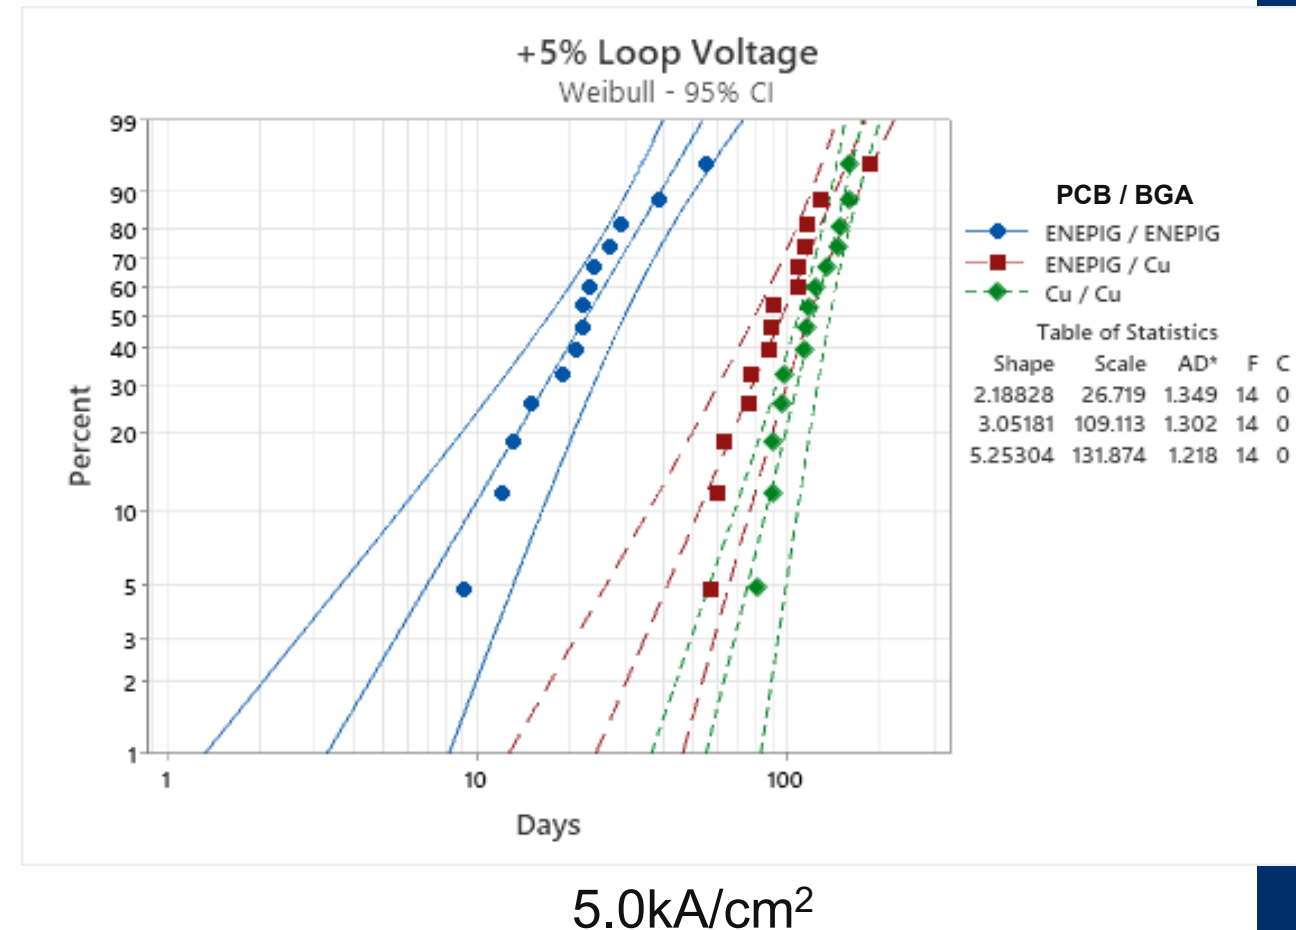
- 3 populations were evaluated @  $5.0\text{kA}/\text{cm}^2$  with target solder joint temperature of  $125^\circ\text{C}$ 
  - ENEPIG PCB / ENEPIG BGA
  - ENEPIG PCB / Copper BGA
  - Copper PCB / Copper BGA
- Failure criteria: Loop voltage increase of 5%
  - Individual joint performance is unknown; one joint or multiple joints may be contributing to voltage rise
    - Results are conservative
  - **Joint temperatures are mostly unknown**

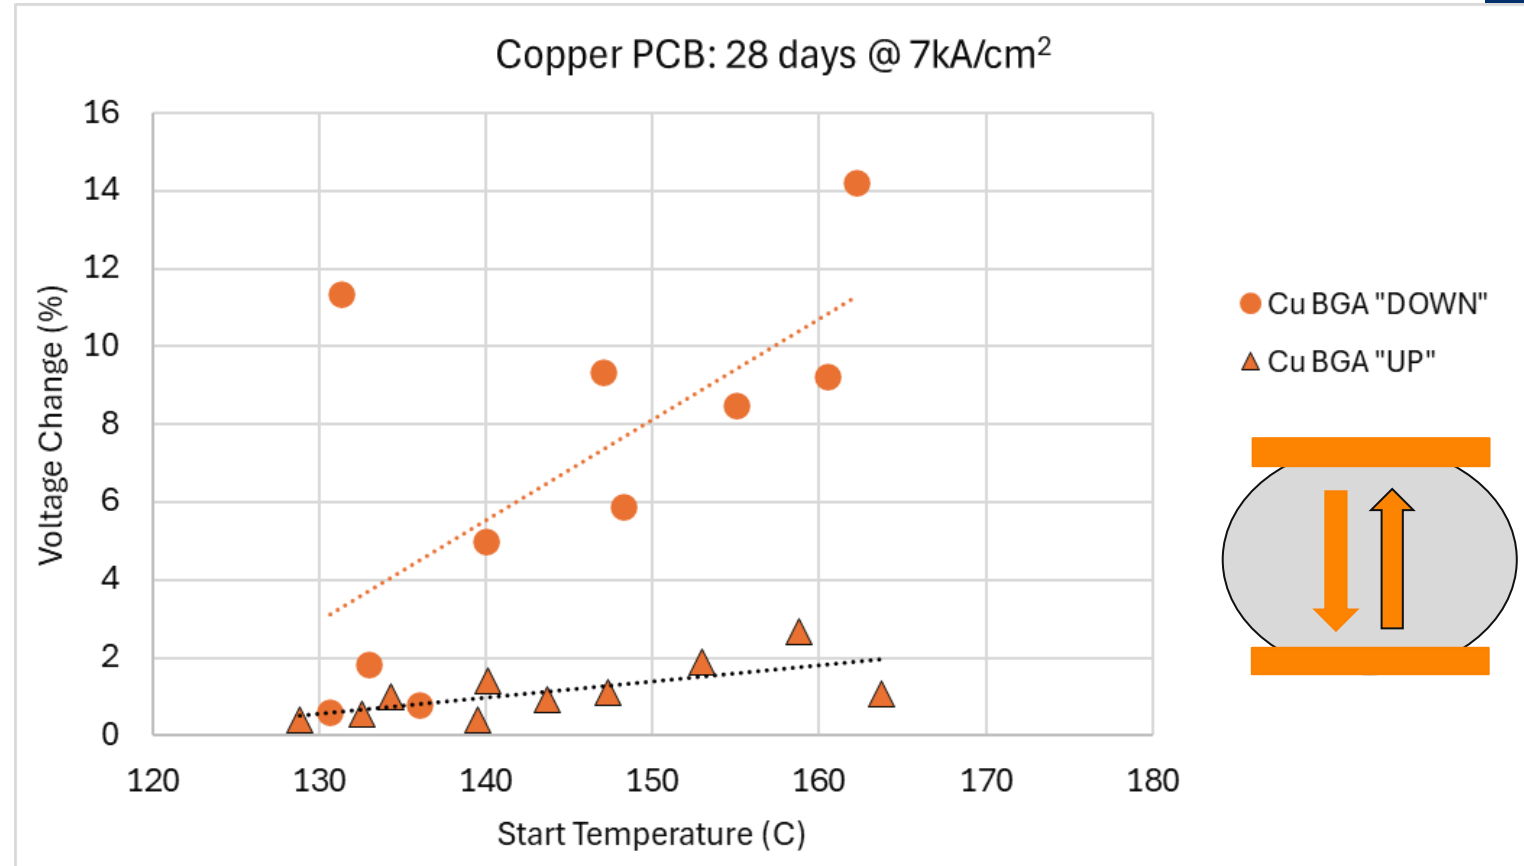
- Copper PCB / Copper BGA is the simplest combination
  - Joints with electron flow from component to PCB (i.e. “Down”) show faster rise in voltage change
    - Possibly implies that joints have a temperature gradient with component side hotter than board side
  - There is a trend with respect to starting temperature for each electron flow direction, but there are outliers

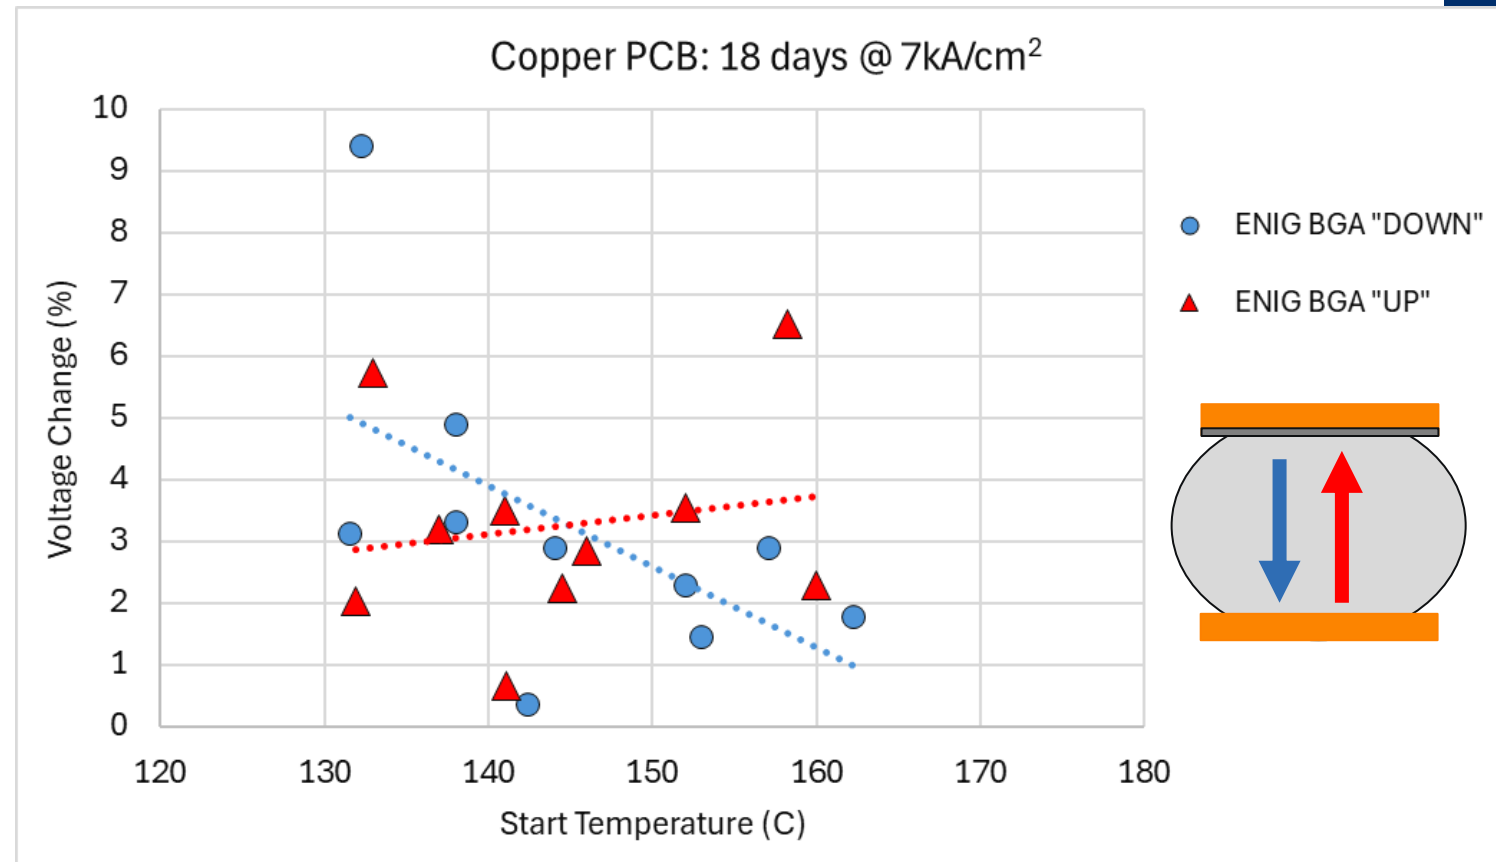
- Copper PCB / ENIG BGA:
  - Example is messy; first joint to +10% is electron flow "DOWN"; but "cold"

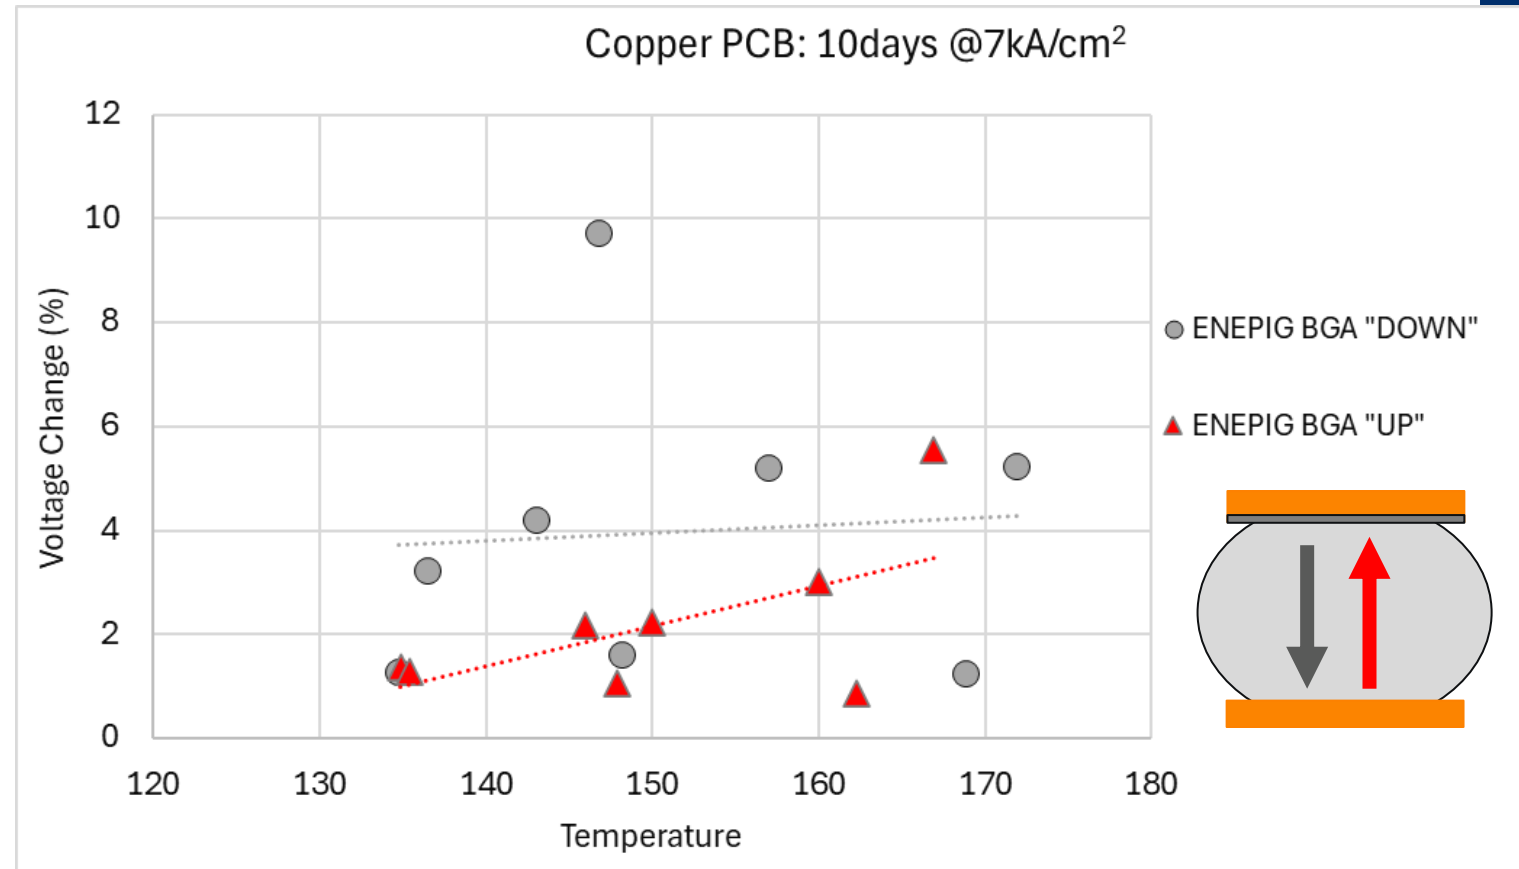
- Copper PCB / ENEPIG BGA:
  - Electron flow “DOWN” shows faster voltage rise
  - Electron flow “UP” shows temperature dependency
    - Much faster rise than Copper/Copper combination?
  - Electron flow “DOWN” does not show temperature dependency

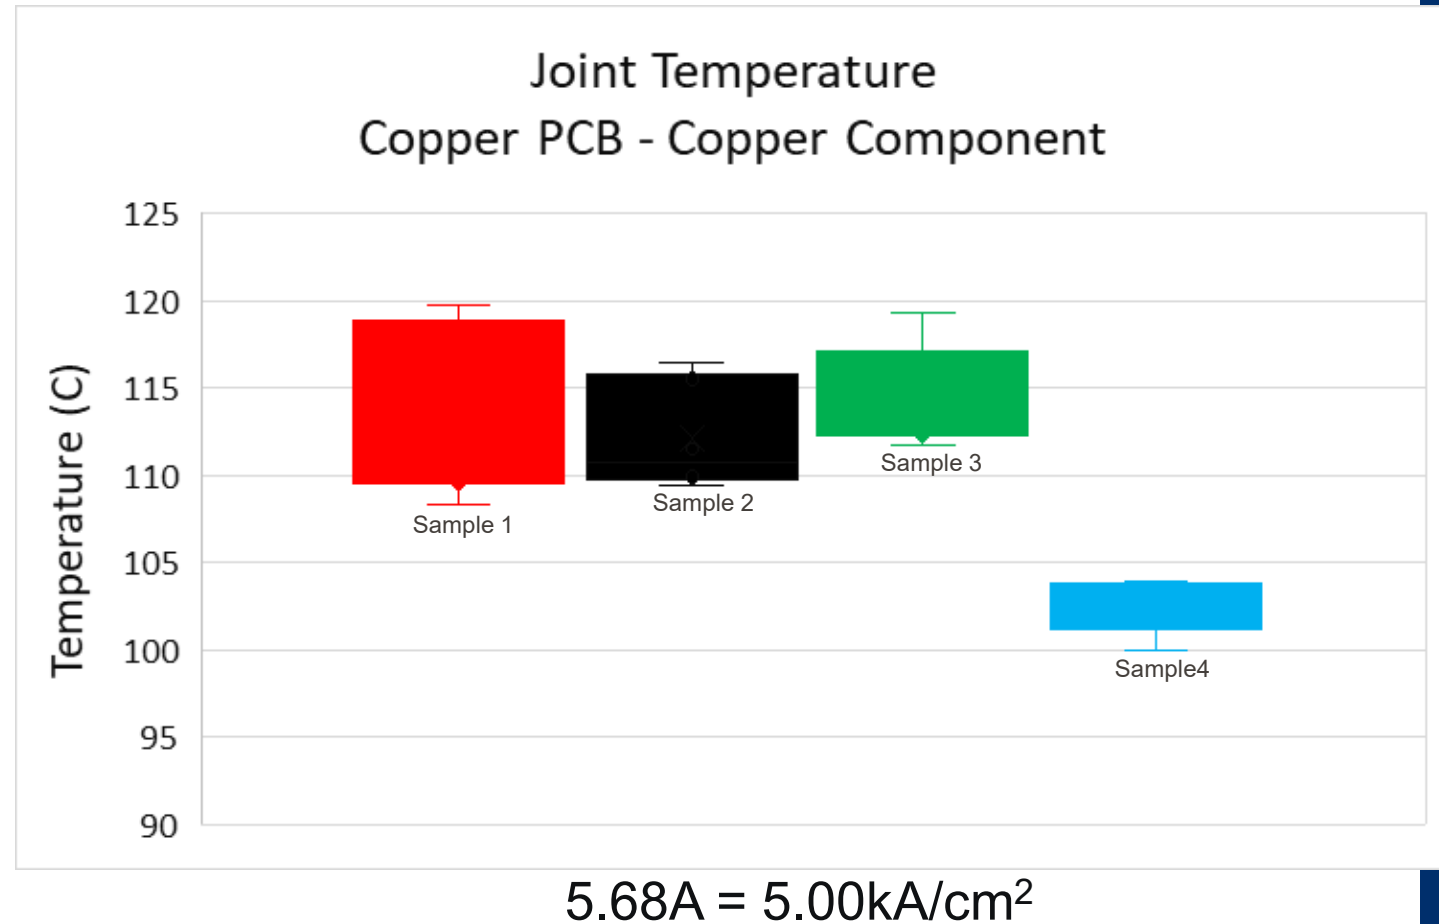
- New samples were constructed and subjected to EM stress while monitoring 6 joints per sample (plus the loop)
- Target temperature was lowered to 115°C
  - Range was 100 to 120°C for Cu/Cu population
- Current Density = 5kA/cm<sup>2</sup>

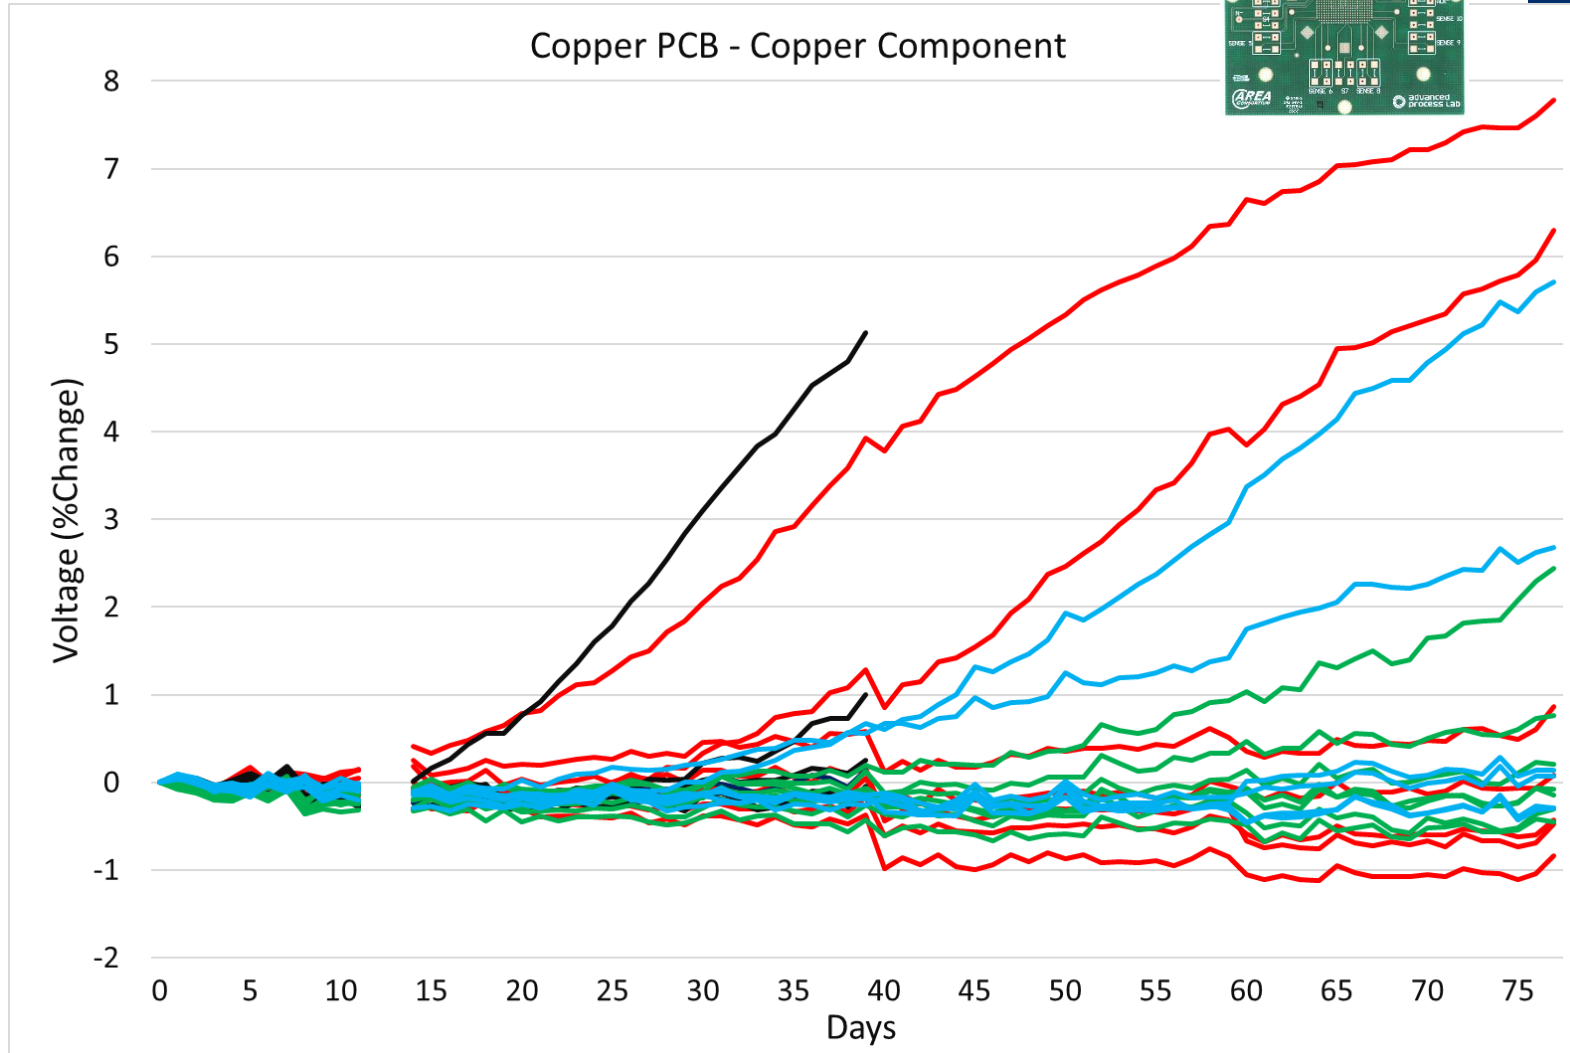
- First solder joint failure (+5%) was detected at day 39
  - Only 7.5% of joints are individually monitored
  - Neighboring joints can impact results – no means to determine this impact

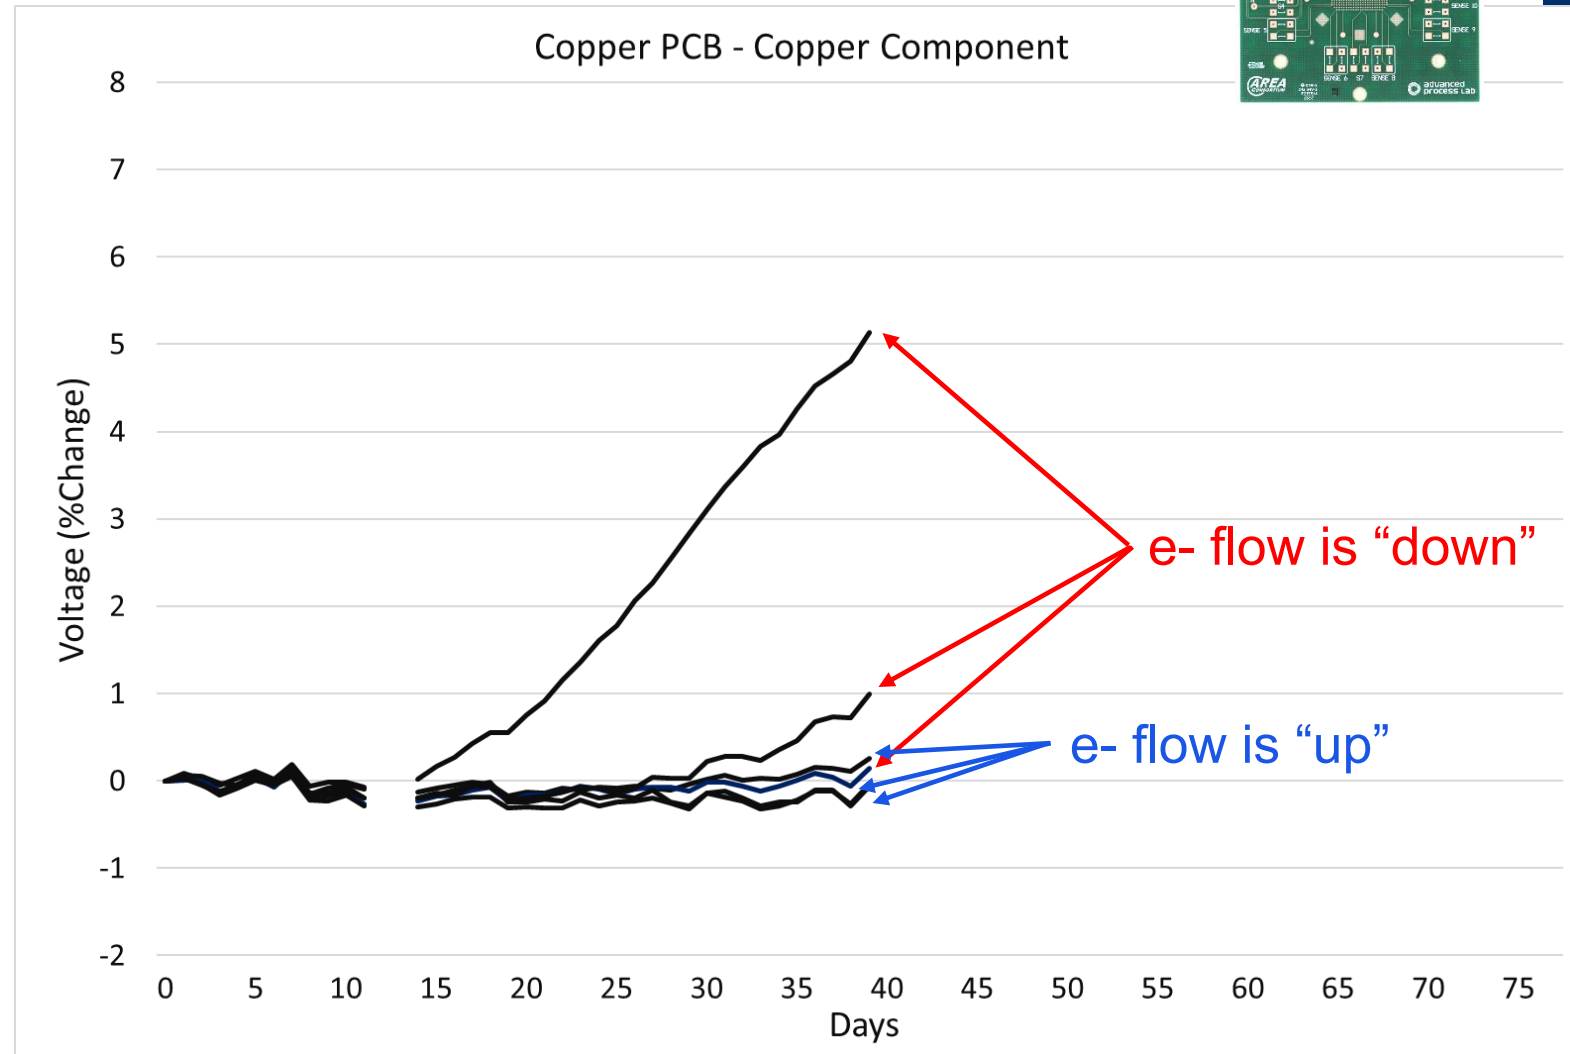
- We need to consider electron flow direction
  - For Copper / Copper combination, electron flow “DOWN” were more likely to demonstrate early voltage rise (Confirming earlier results)

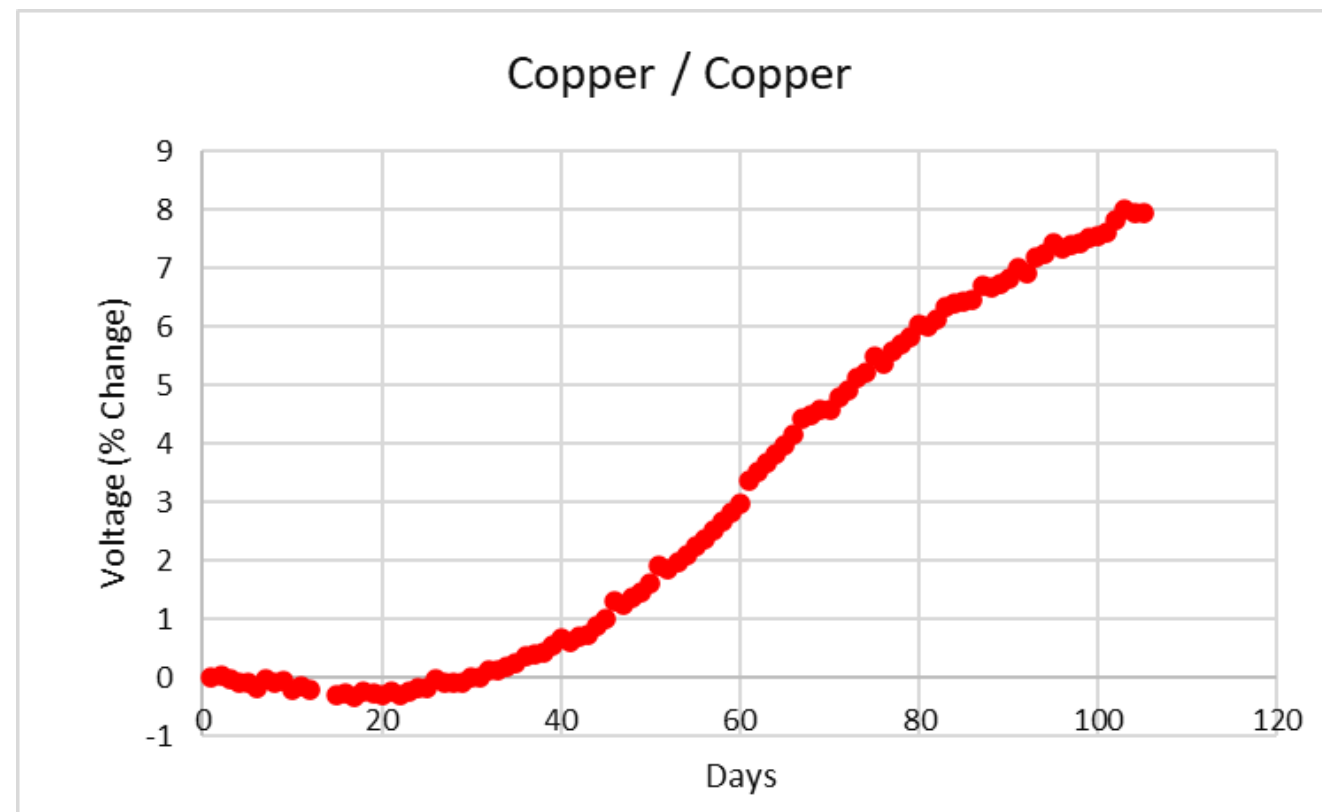
- Interestingly, we observed “parabolic” behavior – if we continue testing beyond ~6%
- Relatively low temperature and reduced current level may not result in “thermal run-away” previously observed under harsher test conditions

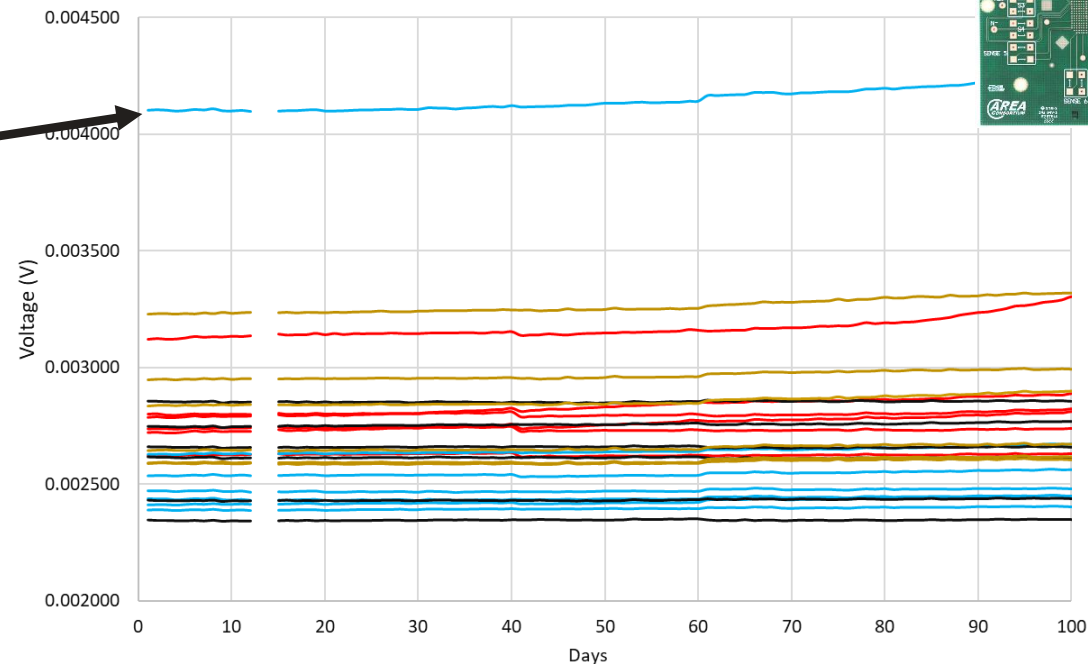
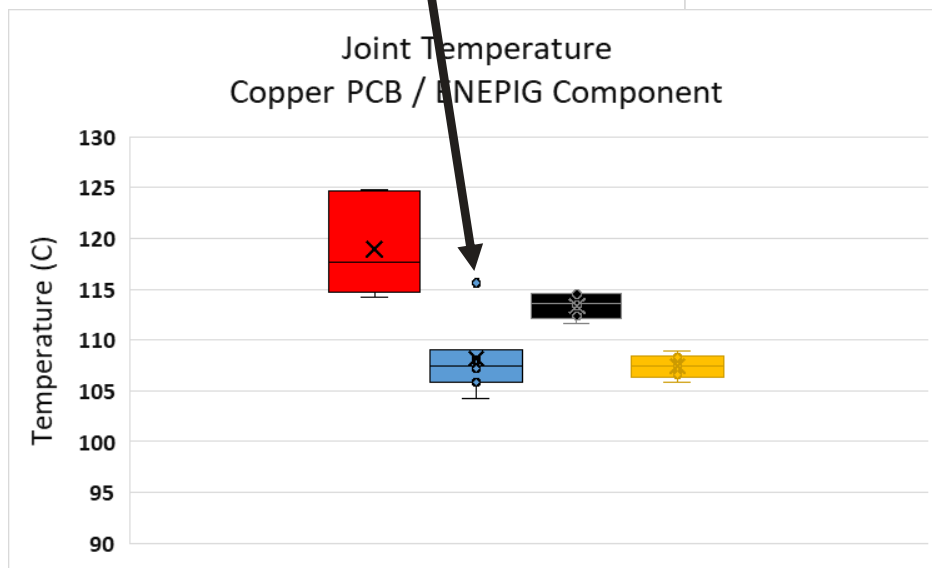
Copper PCB - ENEPIG Component

- The voltage & temperature of one solder joint stands out:
- Samples run about 5°C hotter than Copper / Copper
  - 105 to 125°C range

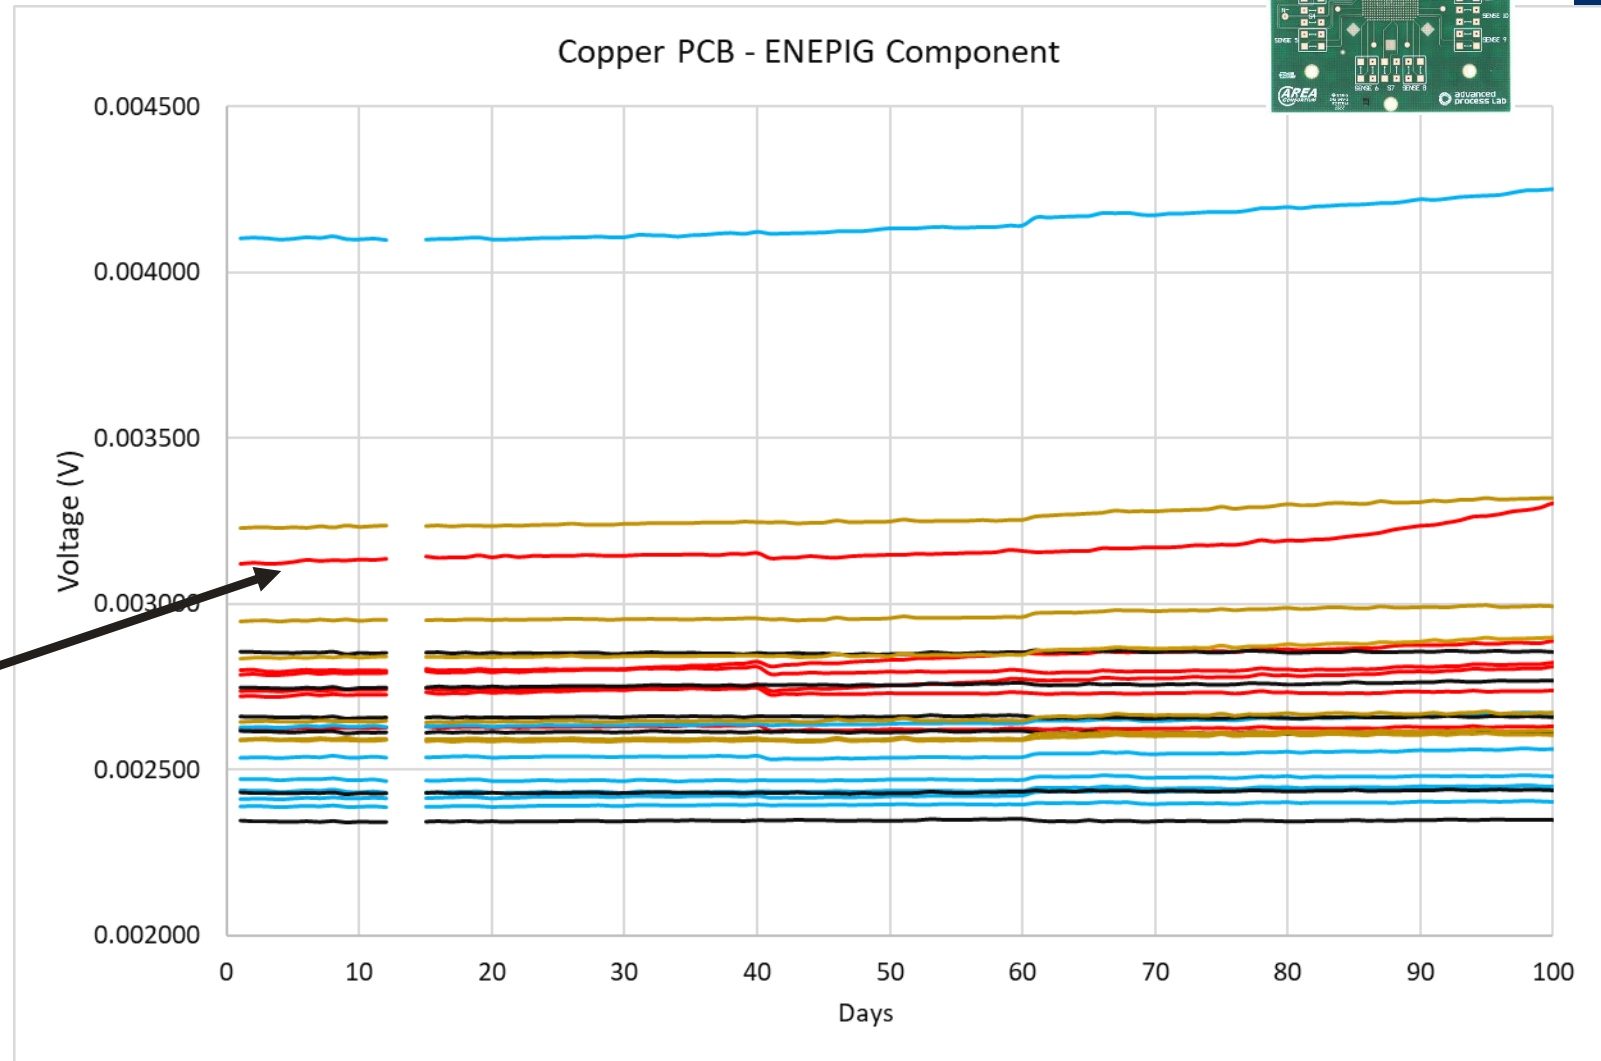
- The first joint to reach +5% was electron flow from component to PCB
