# Electromigration Update: SAC305 (and Cyclomax)

*Michael Meilunas*  
*April 1, 2026*

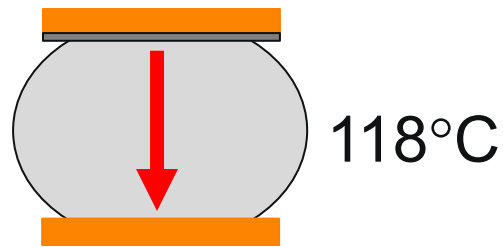
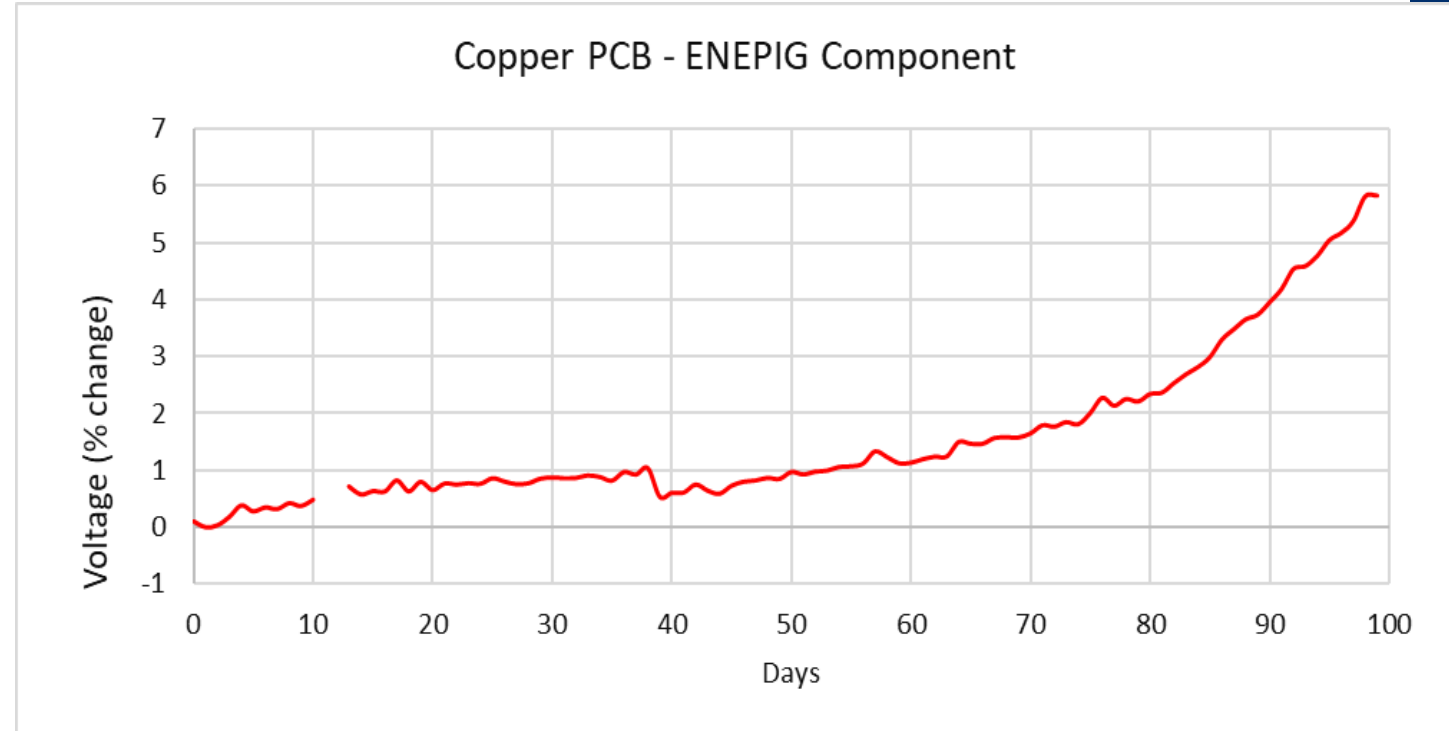
- The first sample (i.e. joint) to reach +5% did so around day 96.
  - Start temperature was 118°C.
  - This joint experienced electron flow from component to PCB.
  - 2.5x more days to +5% than first copper / copper

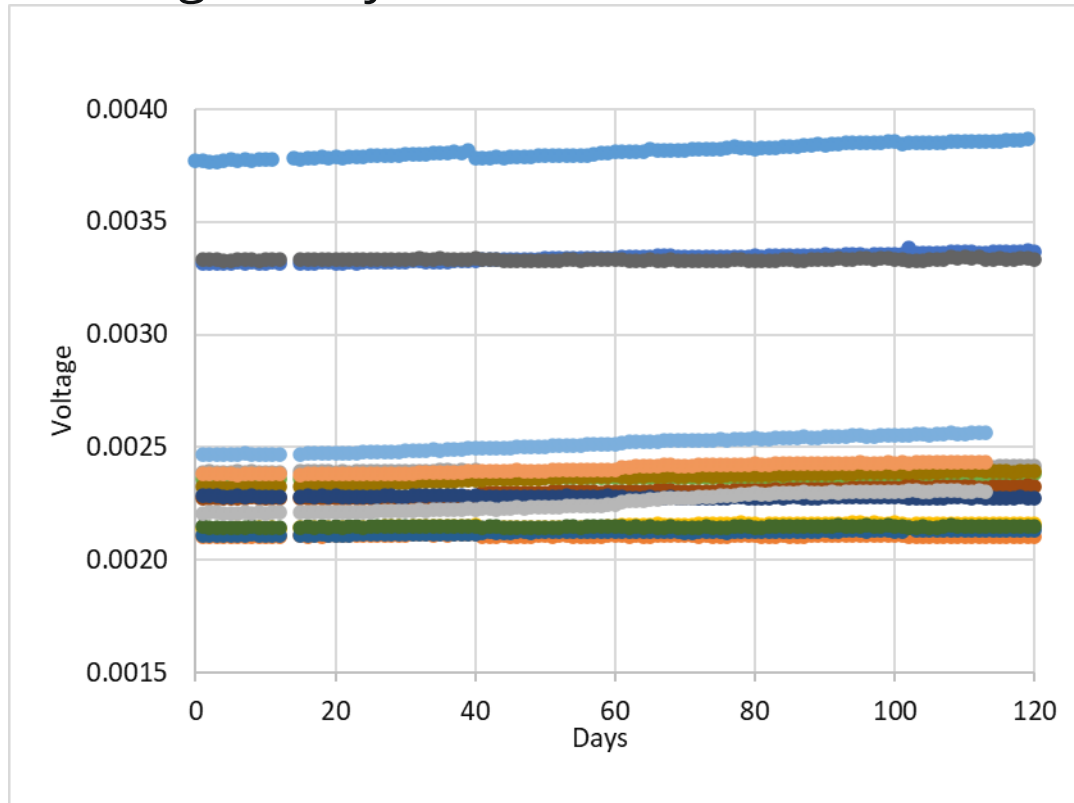
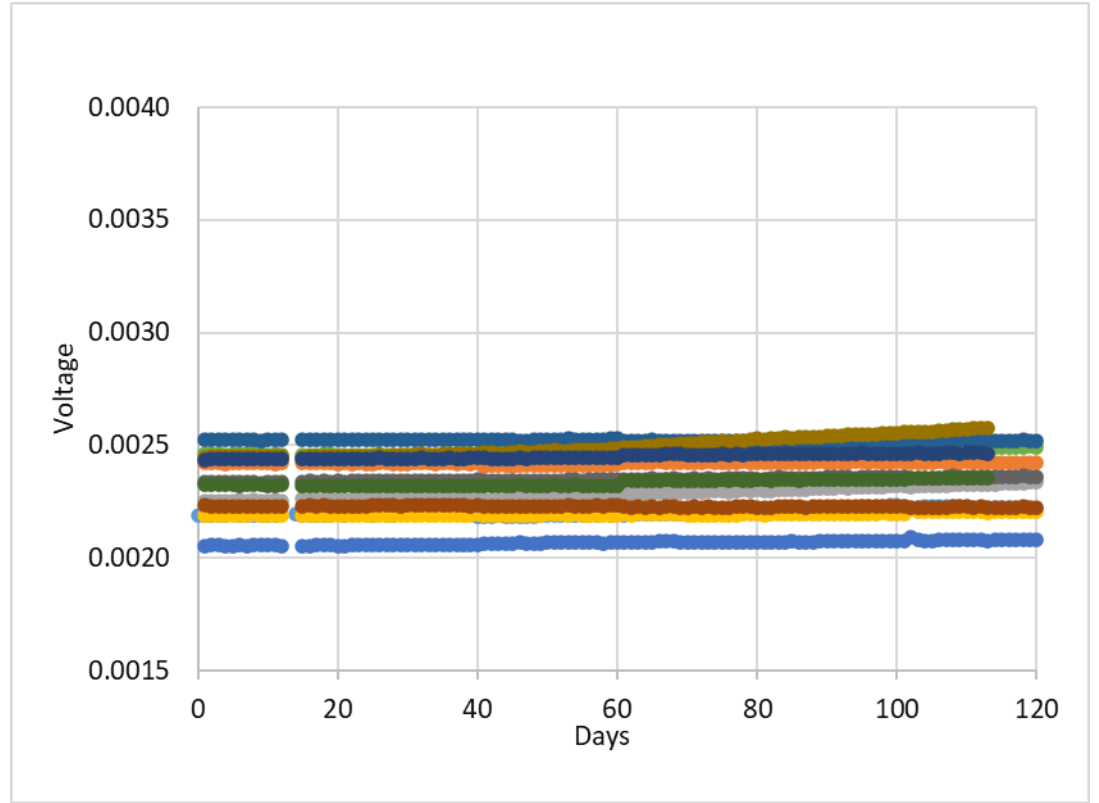
- Three joints have high starting values (all electron flow “down”)
  - In hindsight, maybe this is an indicator of the nickel issue

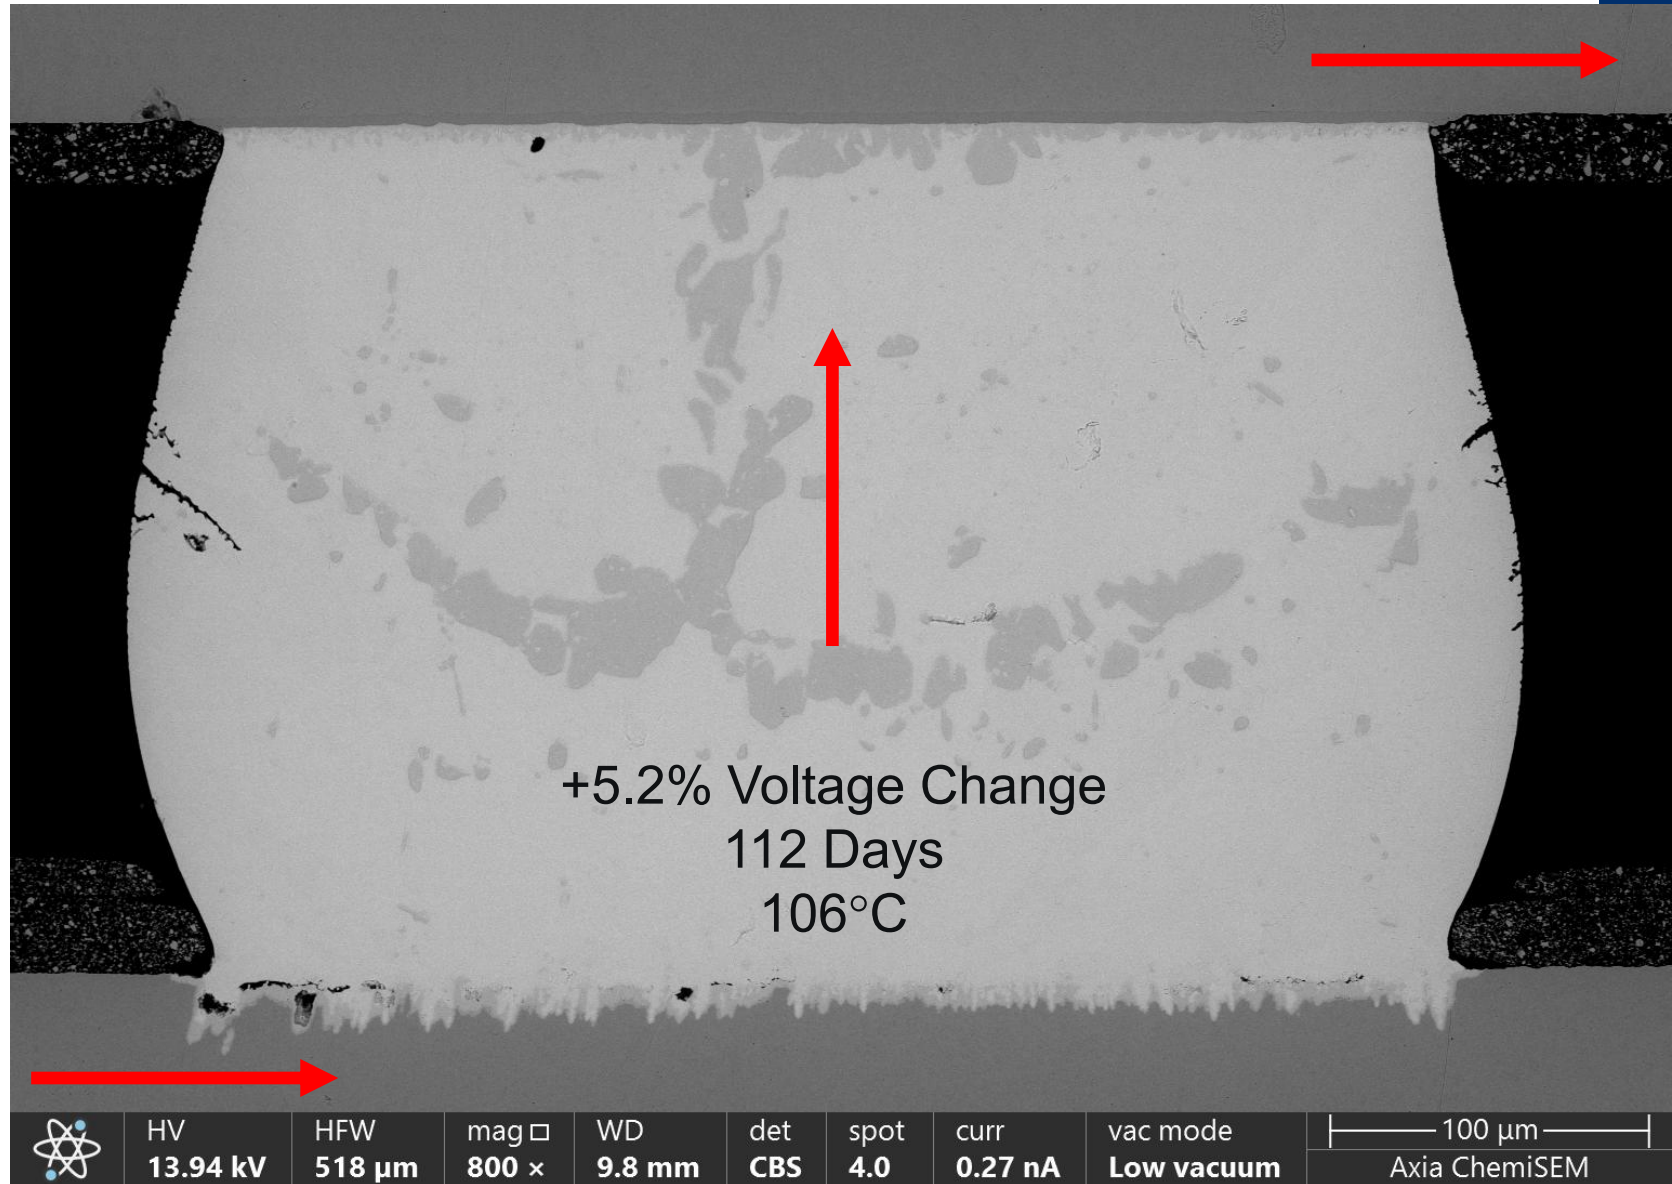
- Cu / ENIG sample to reach +5% did so at an “electron up” solder joint

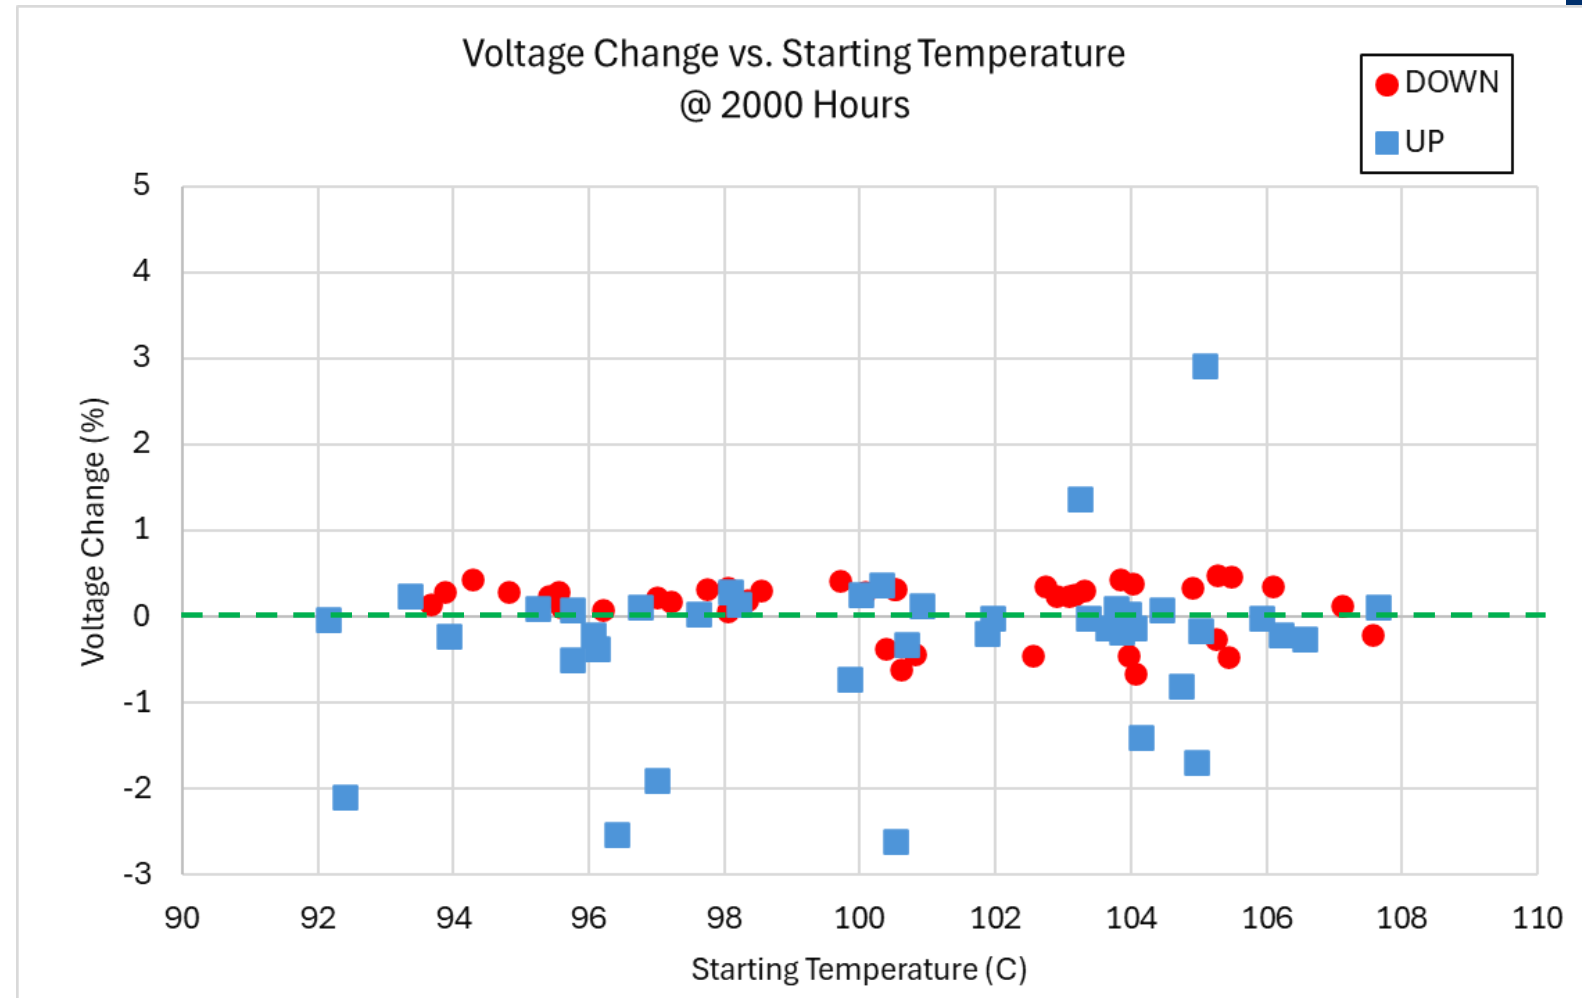
- ~**2000** hours of EM stress plotted (Voltage Change vs. Starting Joint Temperature)

- “UP” electron flow:

- Dip phases
- Rise phases
- No changes

- “Down” electron flow:

- ~No significant change

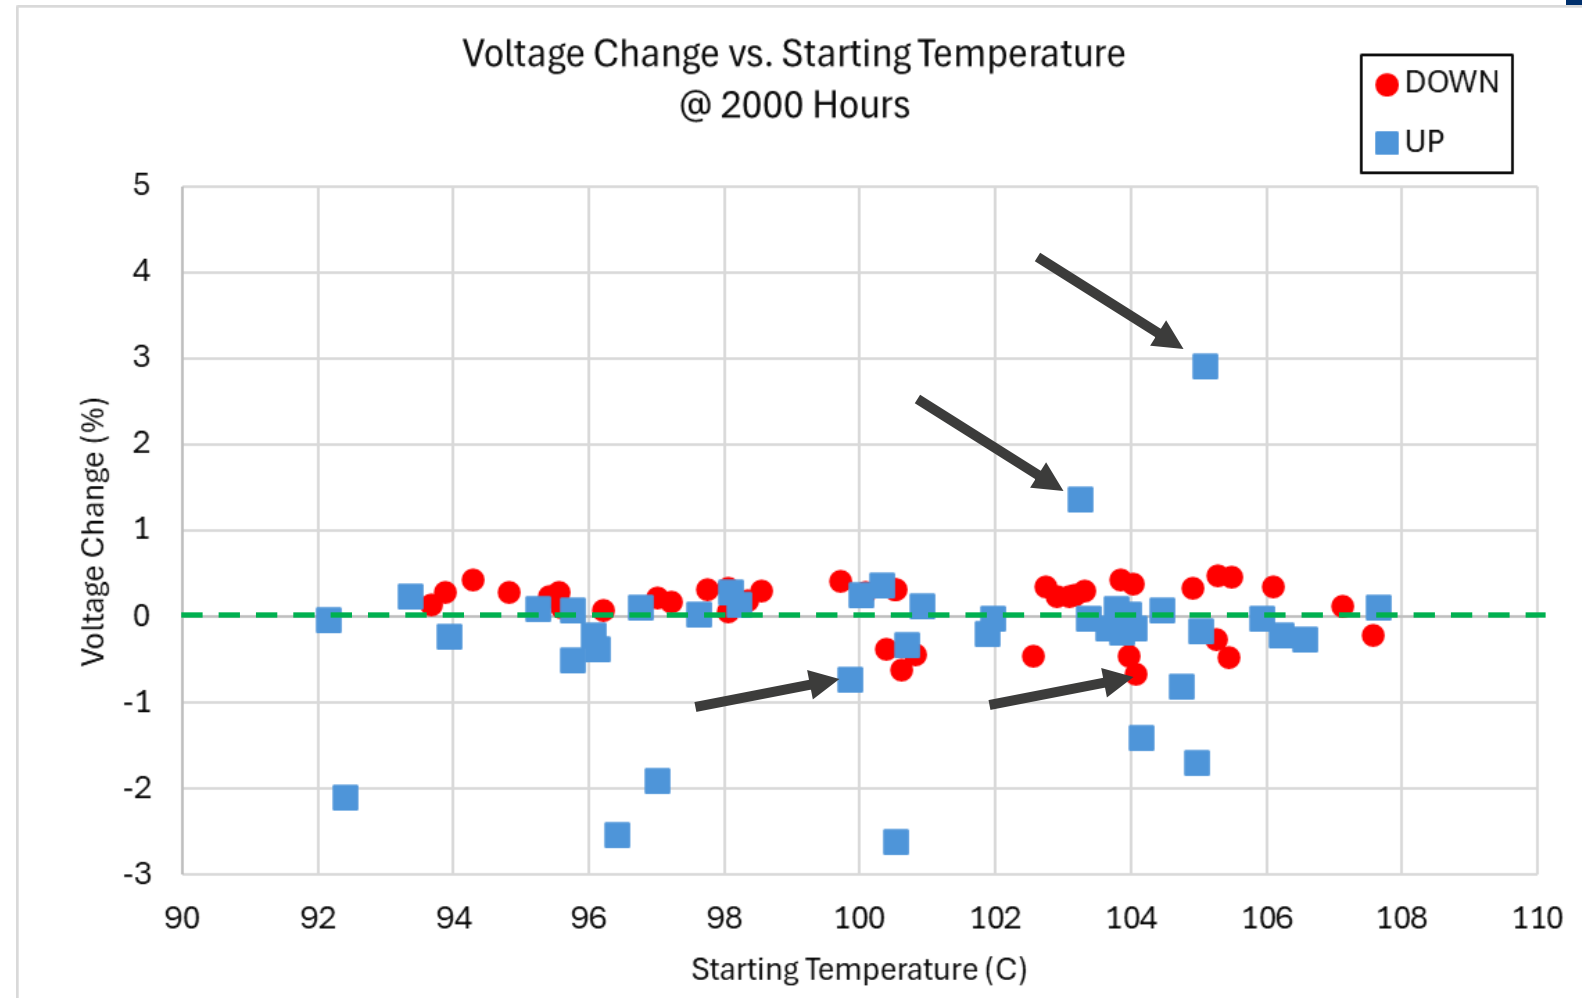
- I got impatient with these samples
- Removed sample with +3% voltage and cross-sectioned
  - +3% joint is on the “hot side” of the spectrum
  - 3 additional joints from sample are included in following slides

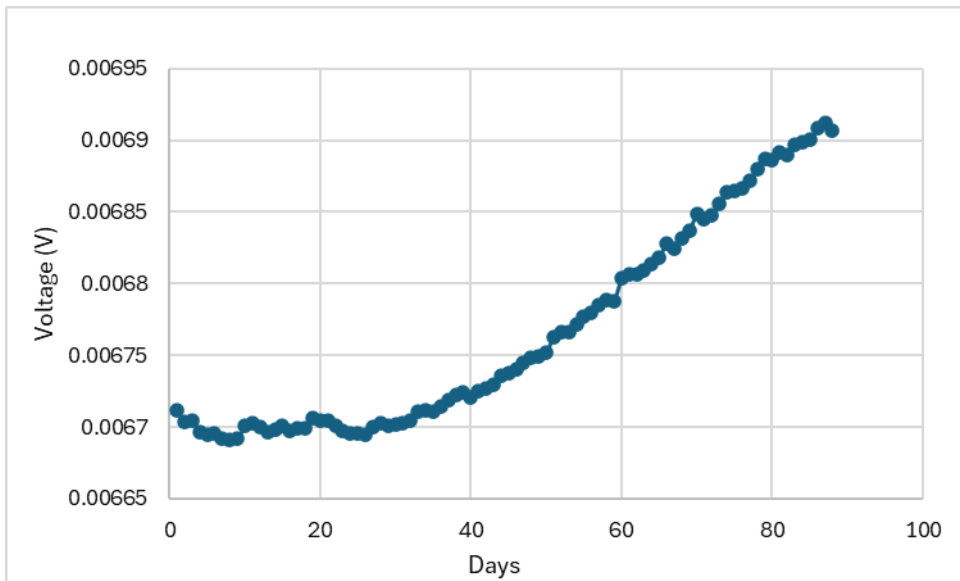
- Dip phase was ~35 days
- Rise is ~linear day 40 to 80
- Interesting Ag<sub>3</sub>Sn platelet effect

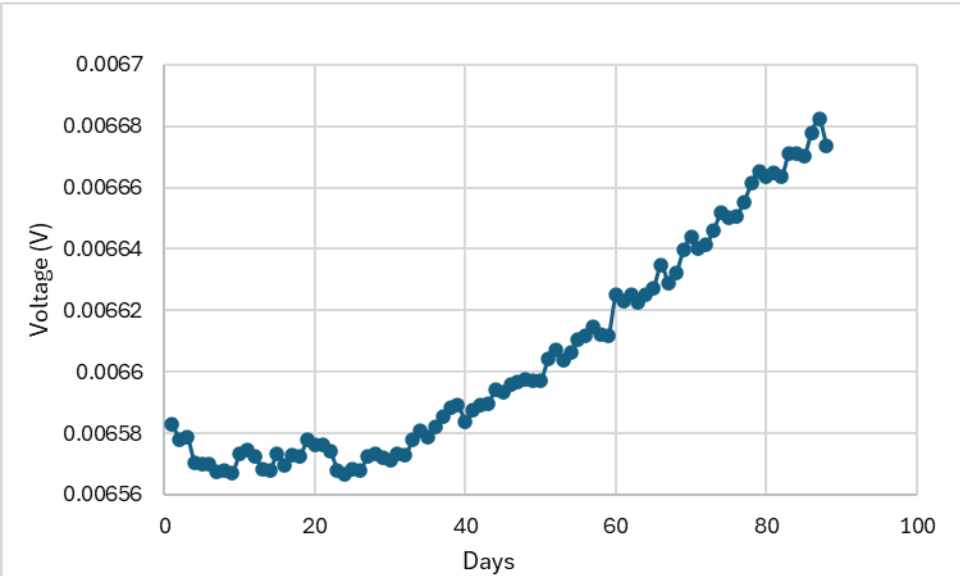
- Significant damage is visible at copper side with just +1.4% voltage rise

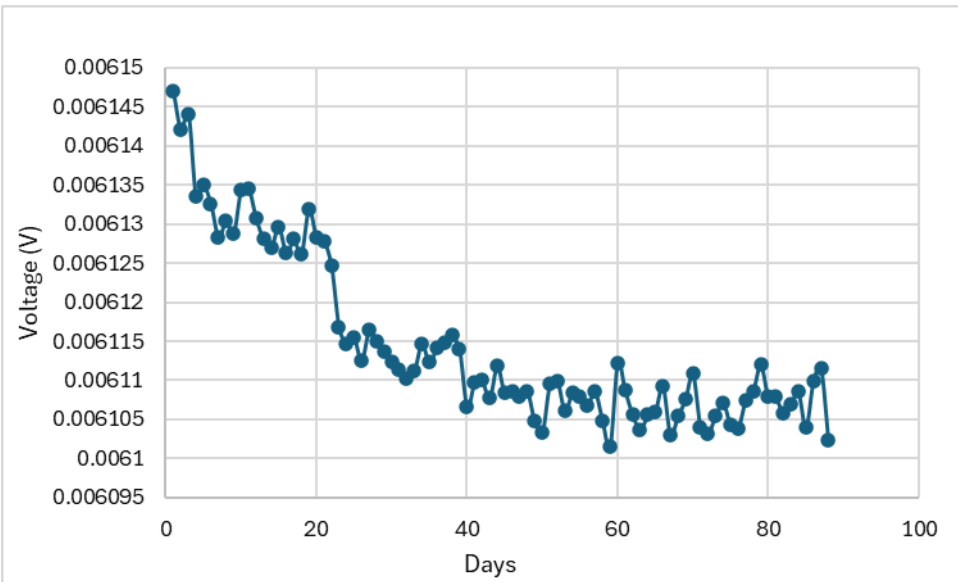
- This was the only "UP" joint not yet showing "rise"
  - -0.73%
  - Average temperature

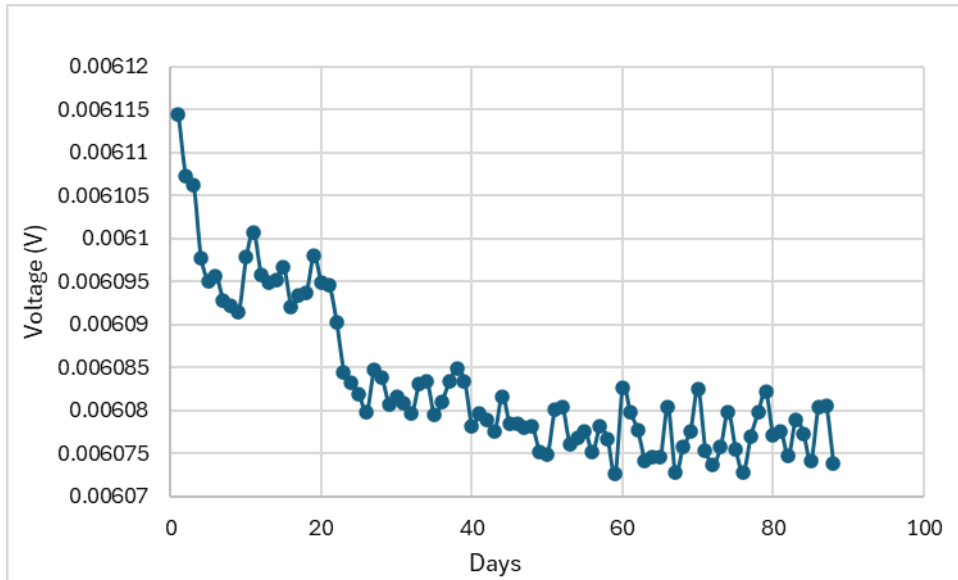
- Electron flow down joint
  - No recovery / rise
  - No visible damage

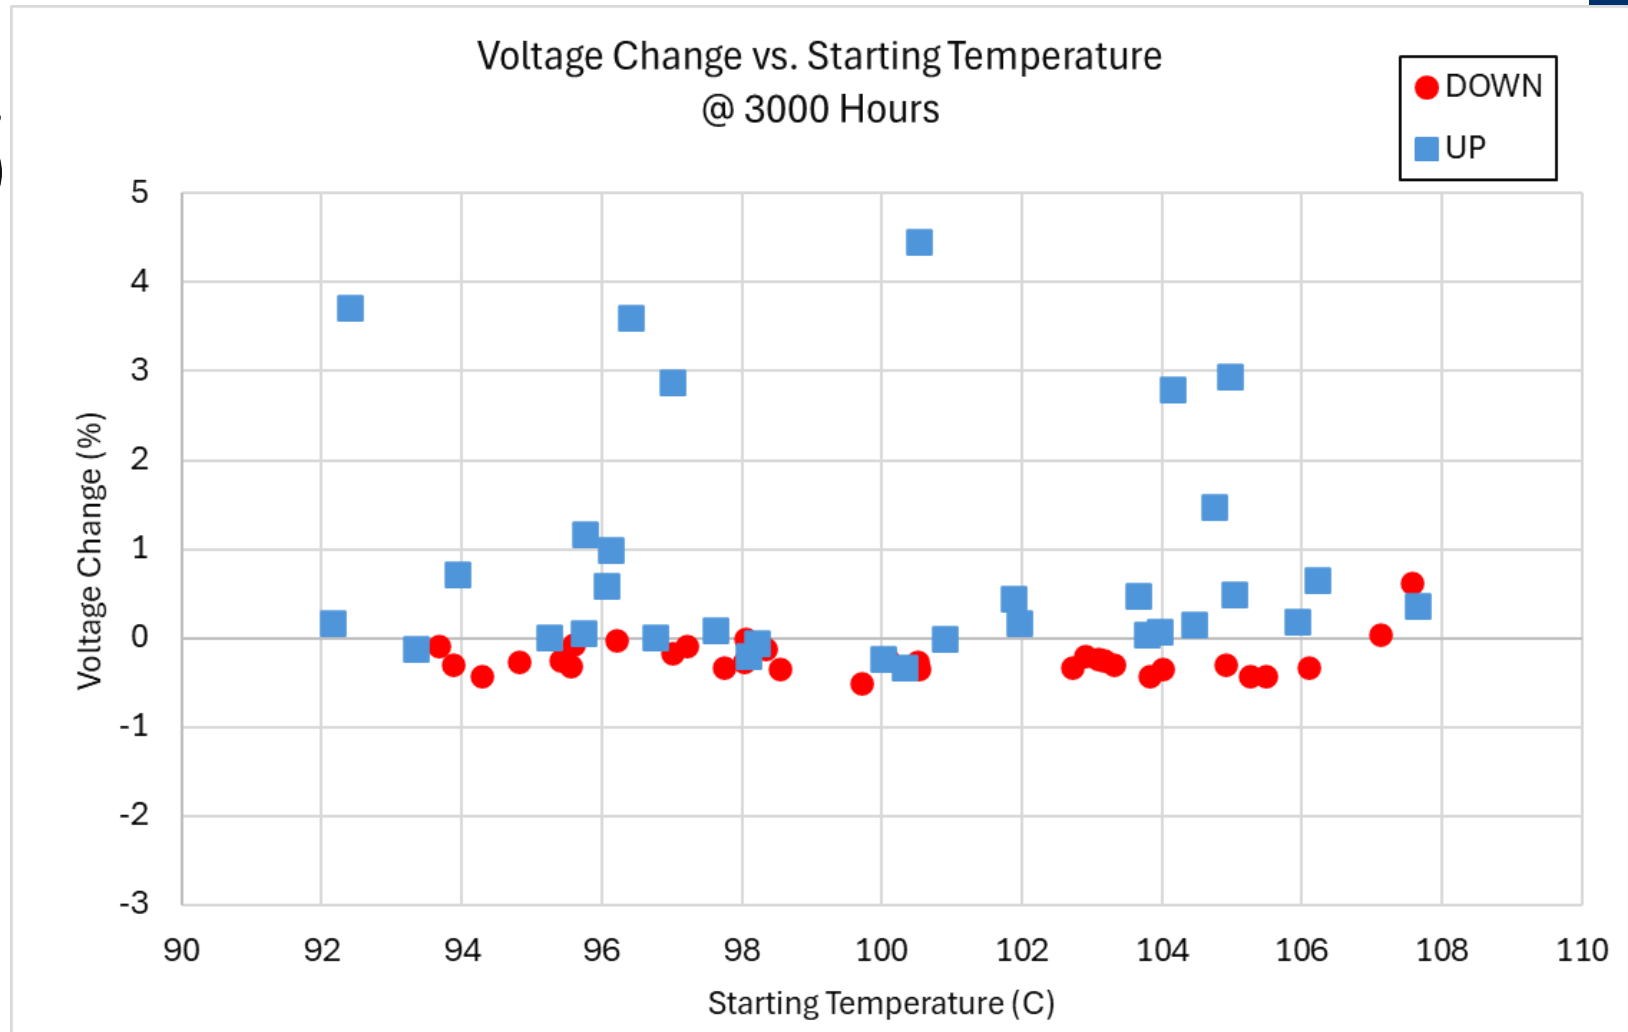
- ~**3000** hours of EM stress plotted (Voltage Change vs. Starting Joint Temperature)
- Voltage rise is greater for electron flow from copper PCB to ENEPIG component
- Starting joint temperature (between 92 and 108°C) does not seem to be huge factor affecting which “UP” joints experience voltage rise.

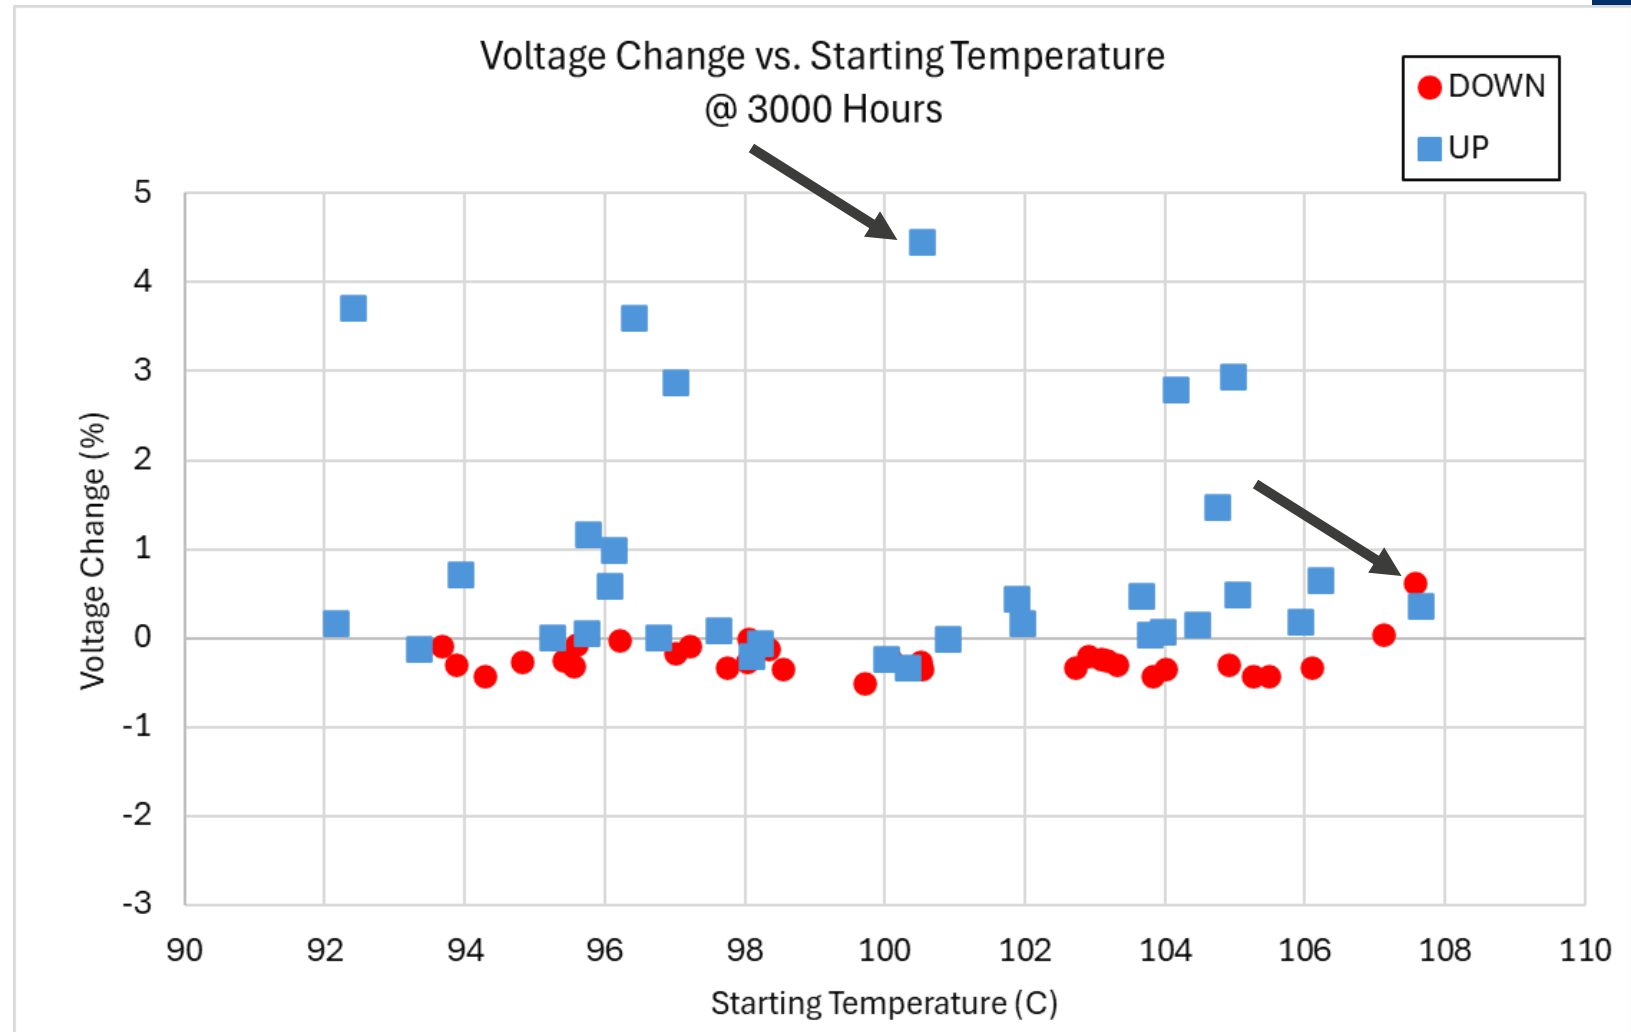
- Sample with largest "UP" rise also contains largest "Down" rise

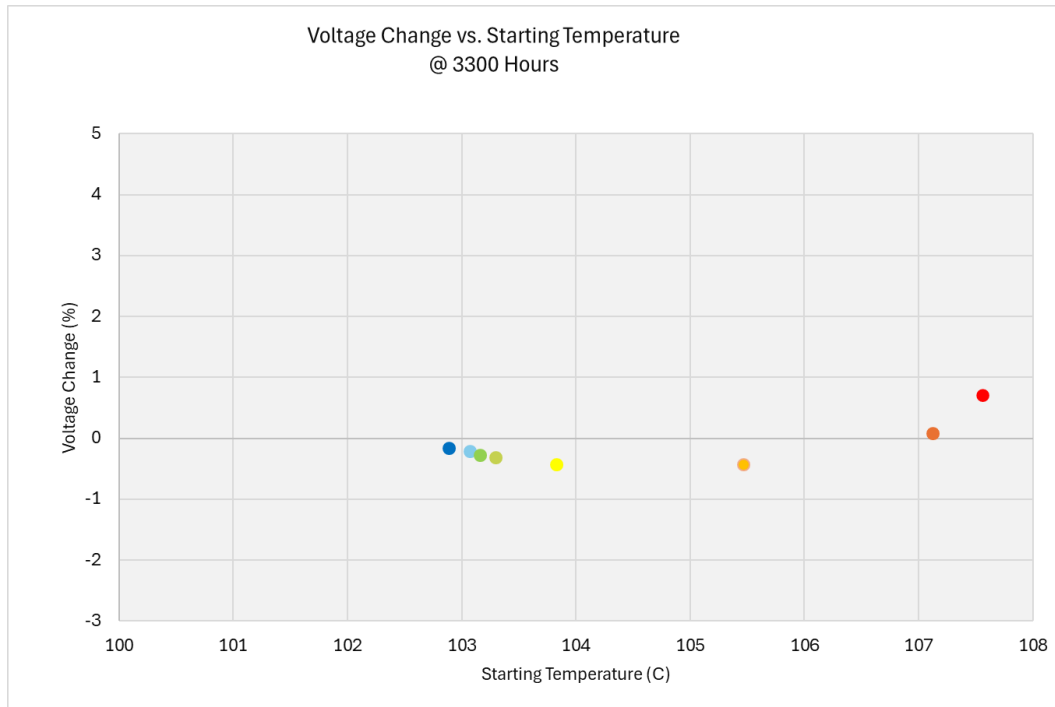
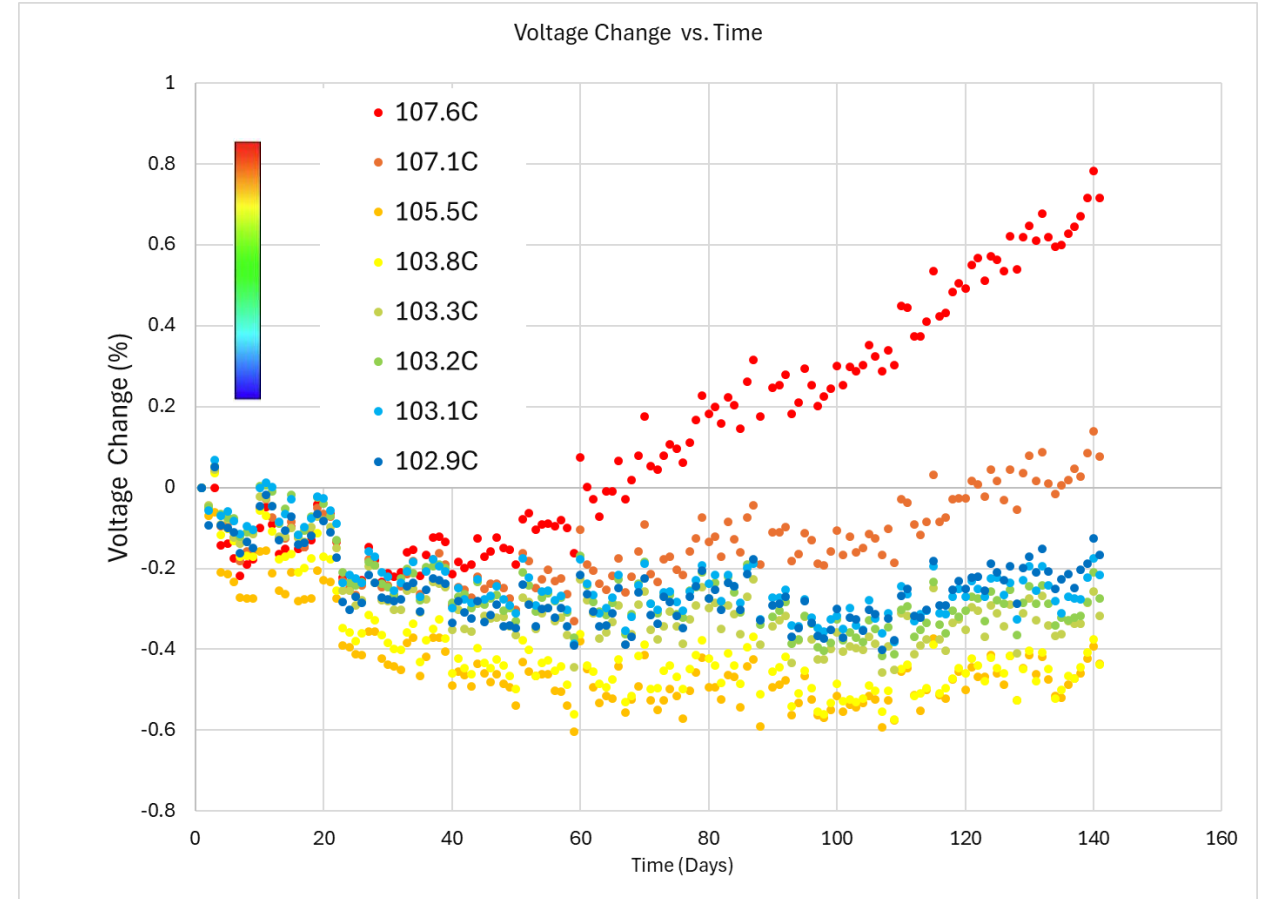
# Cu PCB / ENPIG BGA @ 5.0kA/cm<sup>2</sup>

Trends with respect to joint temperature is complex?

Electron flow “down”:  
Possible trends  
(but small changes)

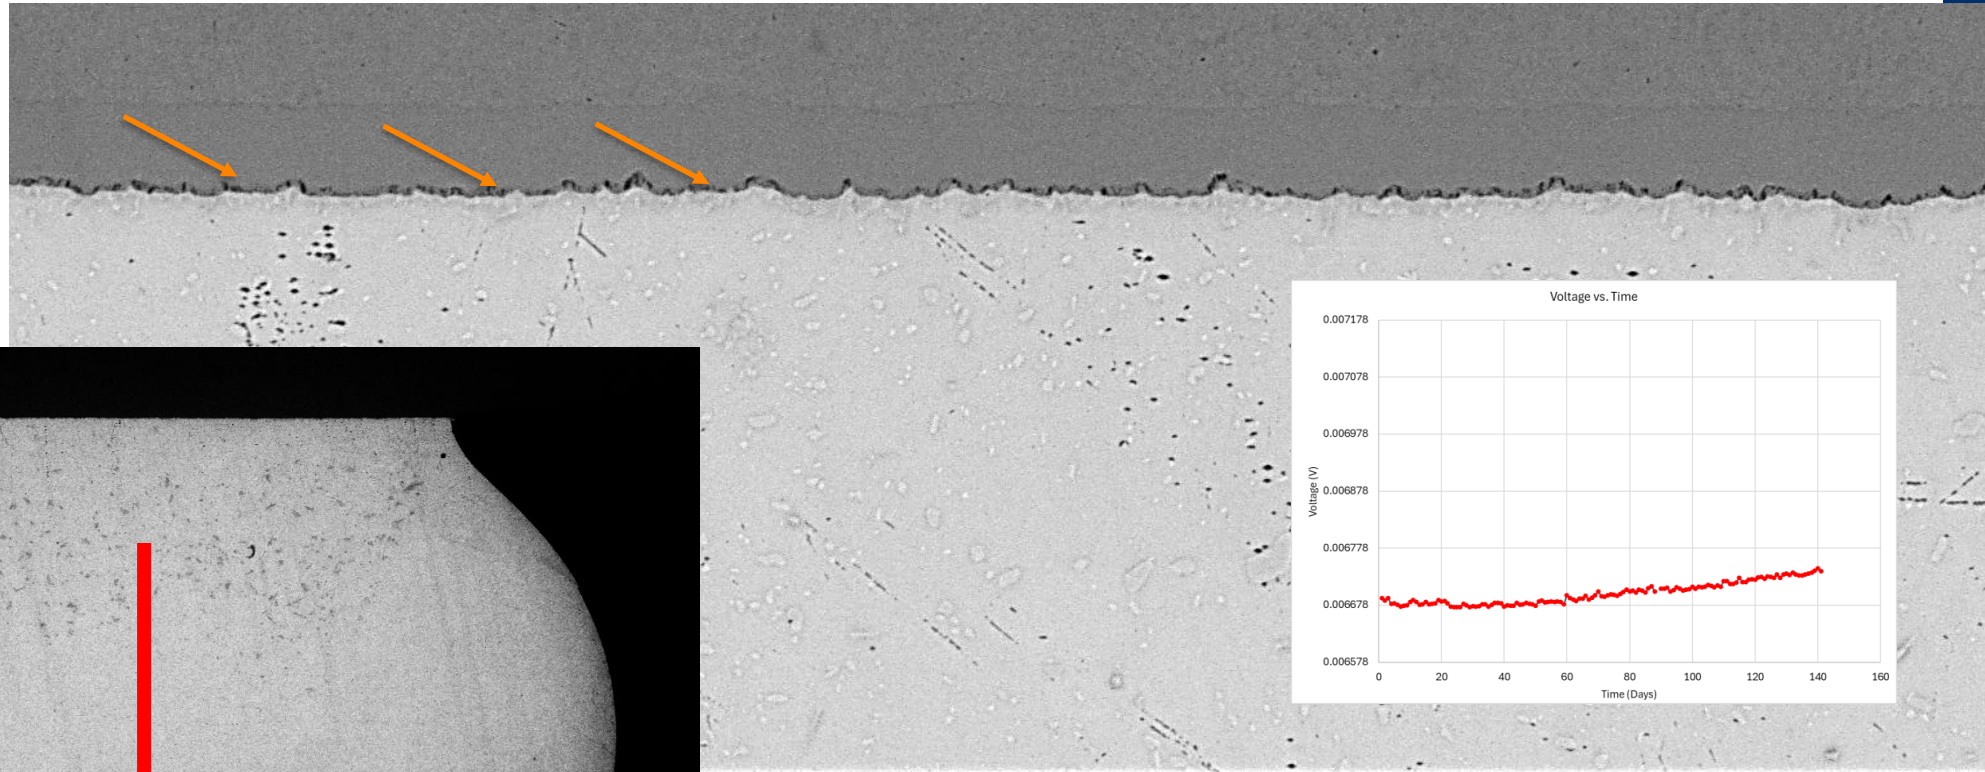
# Cu PCB / ENIG BGA @ 5.0kA/cm<sup>2</sup>

0.79% Voltage Change  
140 Days  
107.7°C

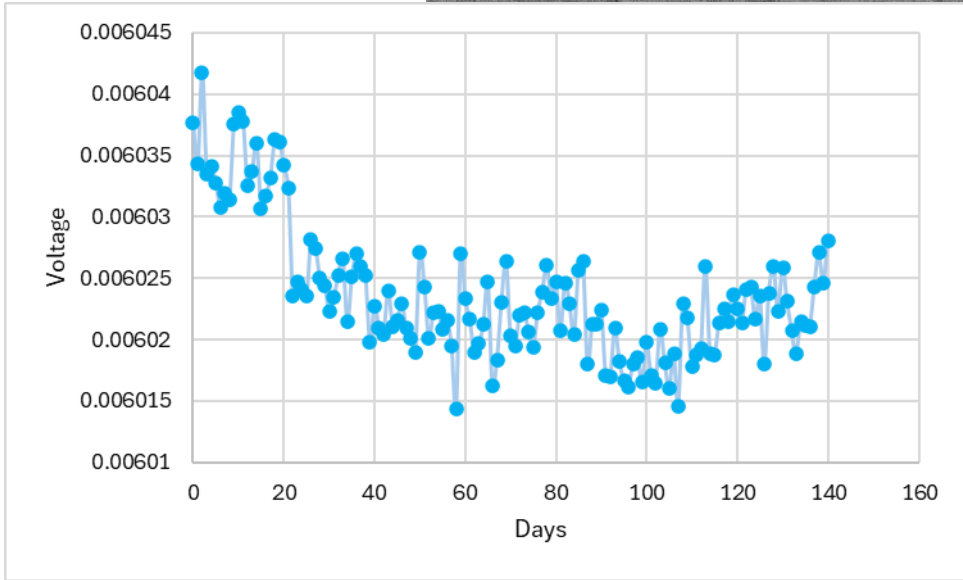
# Cu PCB / ENPIG BGA @ 5.0kA/cm<sup>2</sup>

Looks like nickel layer degradation has begun (or was present at start)?

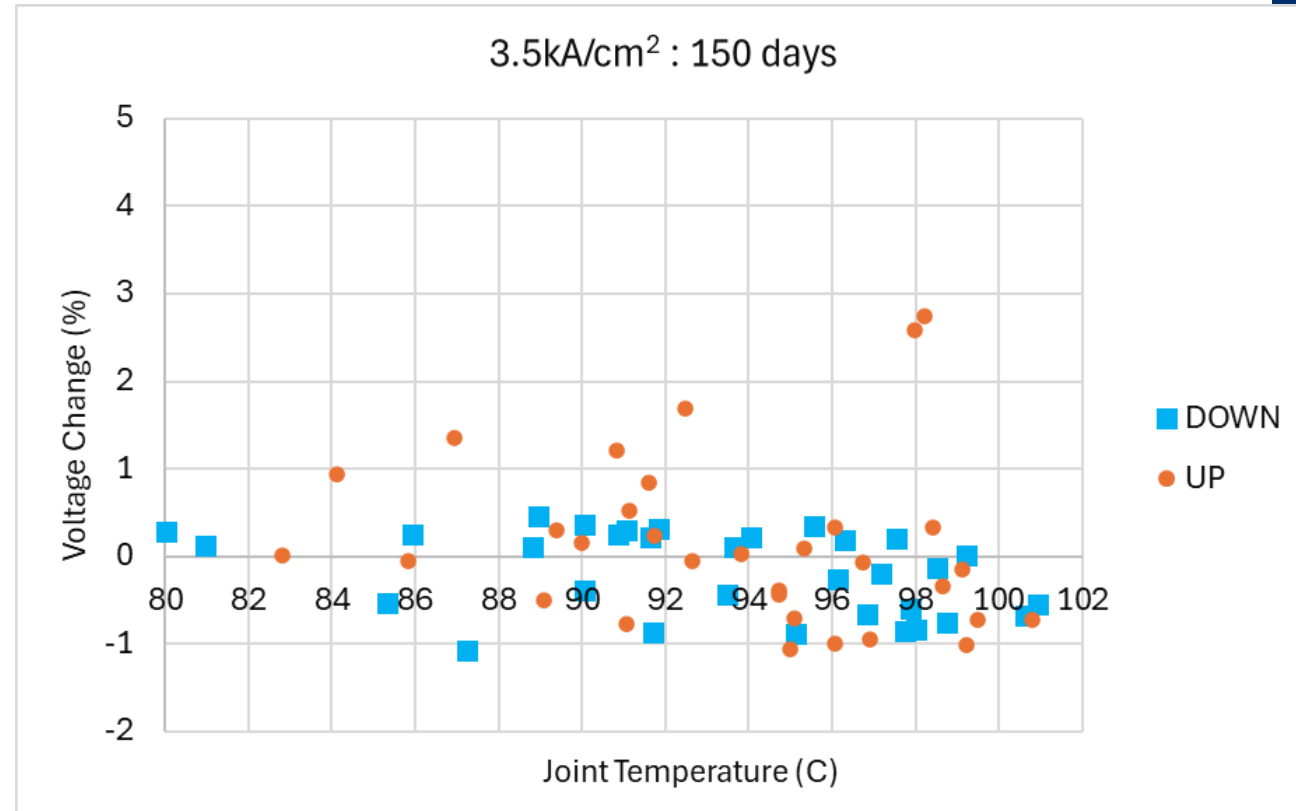
# Cu PCB / ENPIG BGA @ 3.5kA/cm<sup>2</sup>

- 3.5kA/cm<sup>2</sup> @ 85°C was an operating condition provided after the October 2025 AREA meeting
- 150 days: current flow from PCB to BGA have shown measurable resistance increase.
- Prediction: 275 days to +5% for the two joints that have shown the greatest increase to date
  - If voltage rise remains in the “linear” phase
- Nickel issue may be mitigated / inhibited?

Both data sets contain joints at:  
“No change”  
Dip phase  
Rise phase
